Heavy monsoon rains have led to severe flooding which has displaced several thousands of people in northern and eastern Sri Lanka according to BBC's report.

Ministry of Disaster Management, Sri Lanka has activated emergency observation to Sentinel Asia and JAXA has provided before and after disaster image captured using ALOS PALSAR satellite datasets.

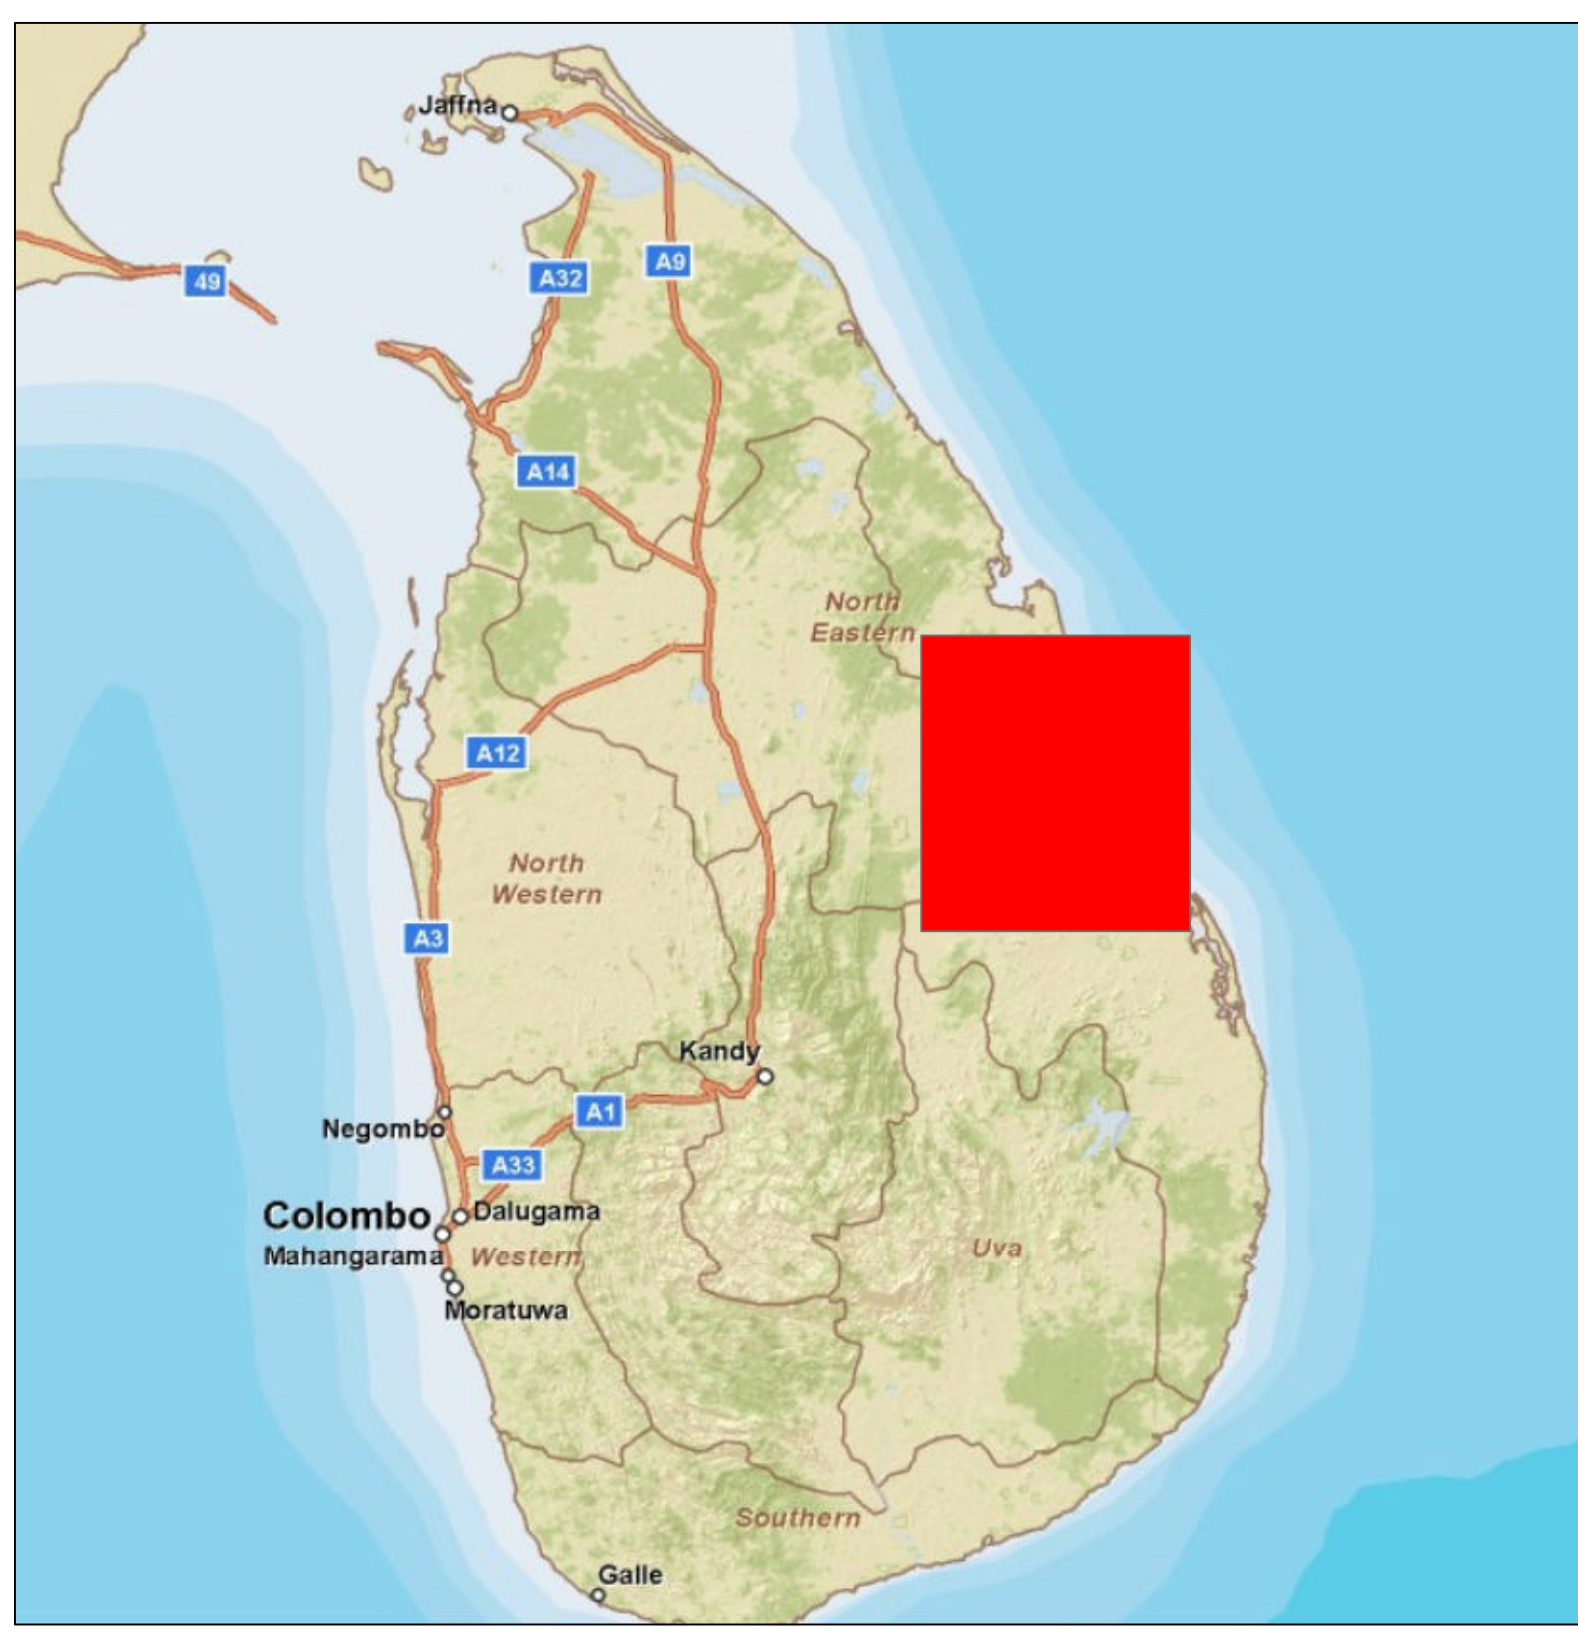
Satellite data used:
 ALOS PALSAR Image - 25 Jan 2011
 ALOS PALSAR Image - 10 Feb 2011

Flood Inundated Areas

Flood inundation map was prepared using this data, based on ISODATA classification procedures. Preliminary results show that areas of Polonnaruwa, Ampara and Batticaloa areas have been worst affected which has inundated farmland and destroyed rice fields.

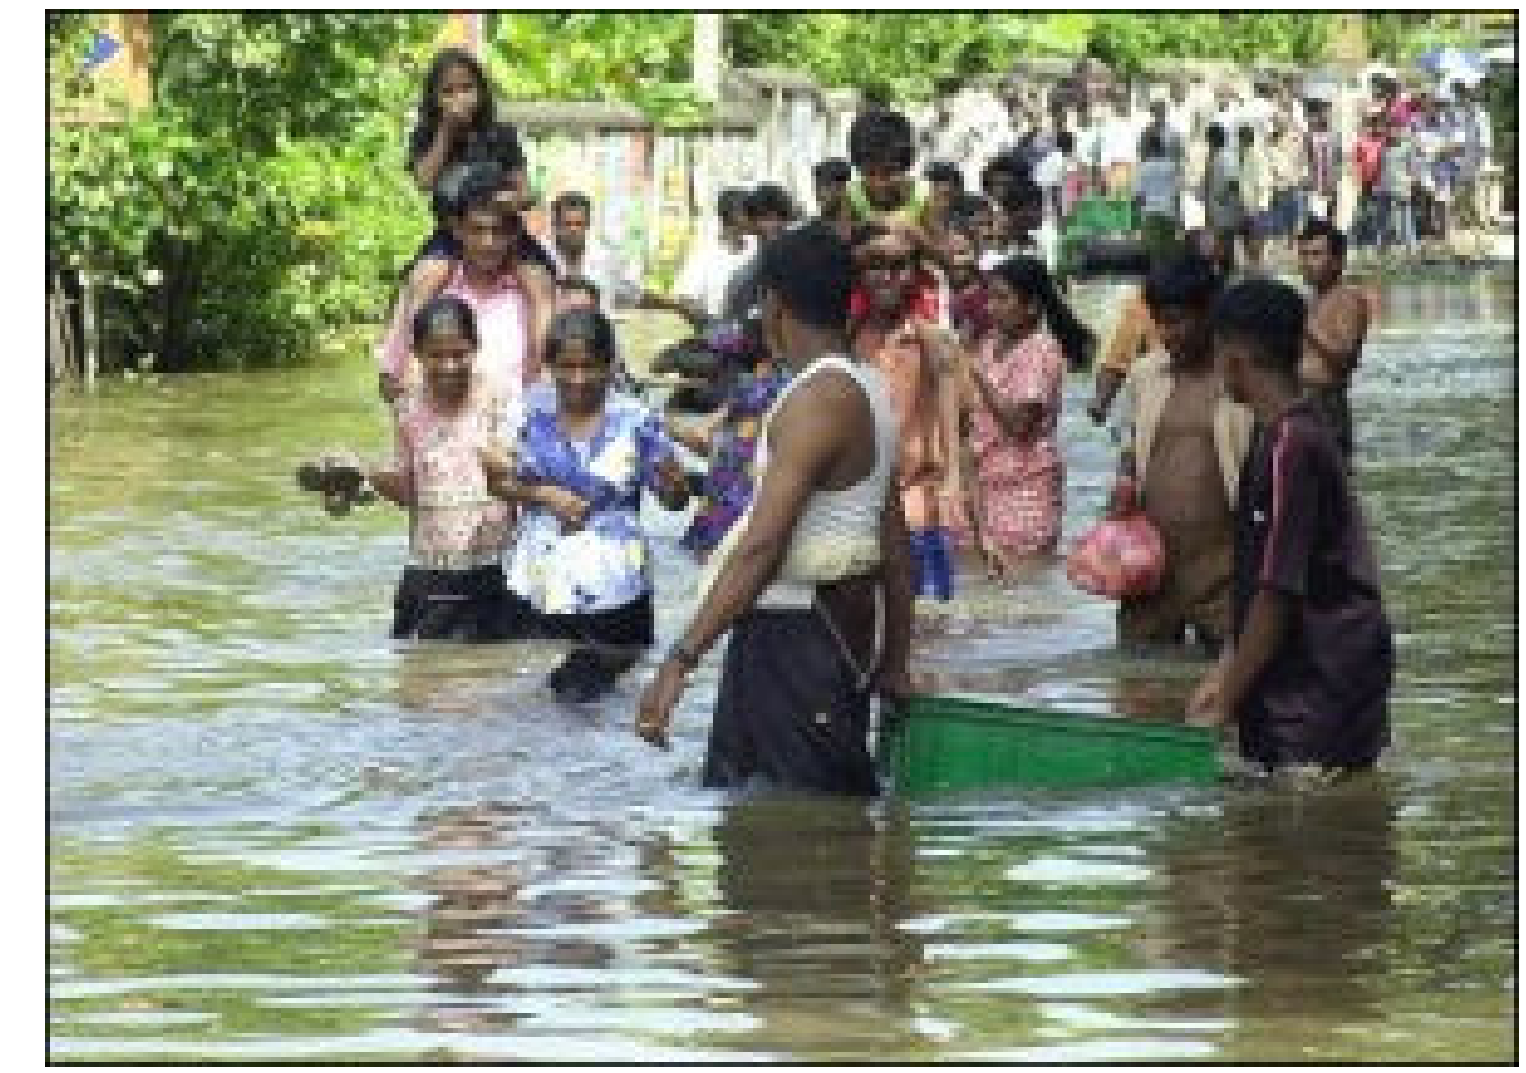
Picture showing flood inundation in Northern and Western Sri Lanka
