Extraction of damaged areas from optical satellite images

Wen LIU and Fumio Yamazaki

Chiba University

Pansharpended WorldView-3 image
2016/4/15T11:08:13 (JST)
Resolution: 0.4-m

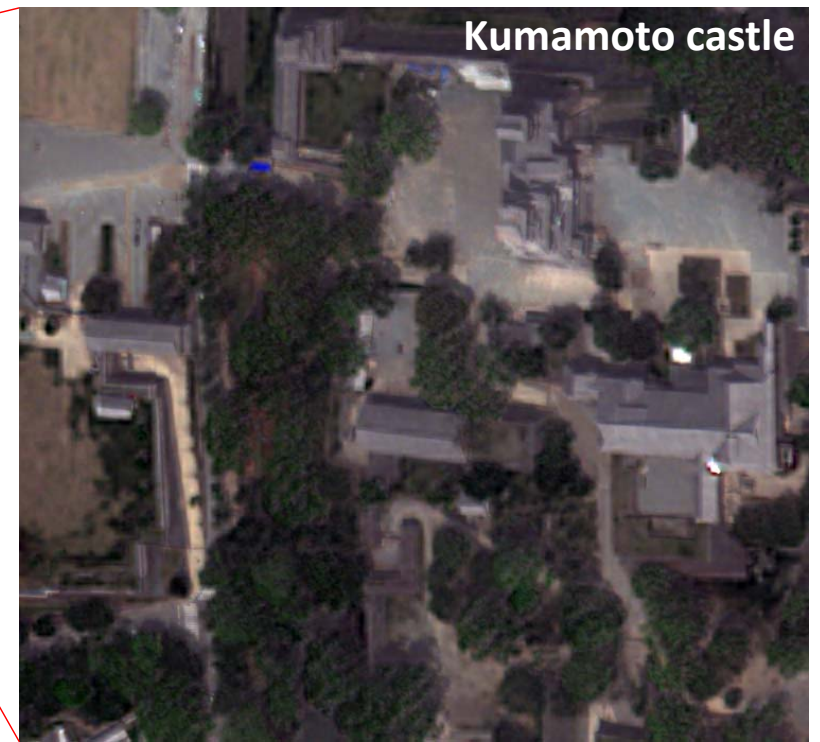
Kumamoto castle

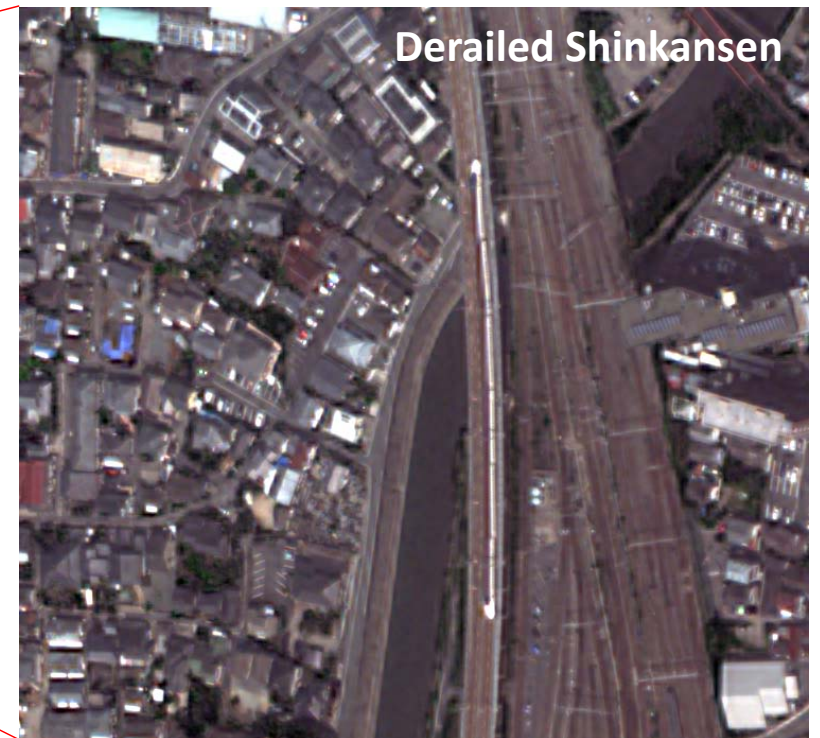
Derailed Shinkansen

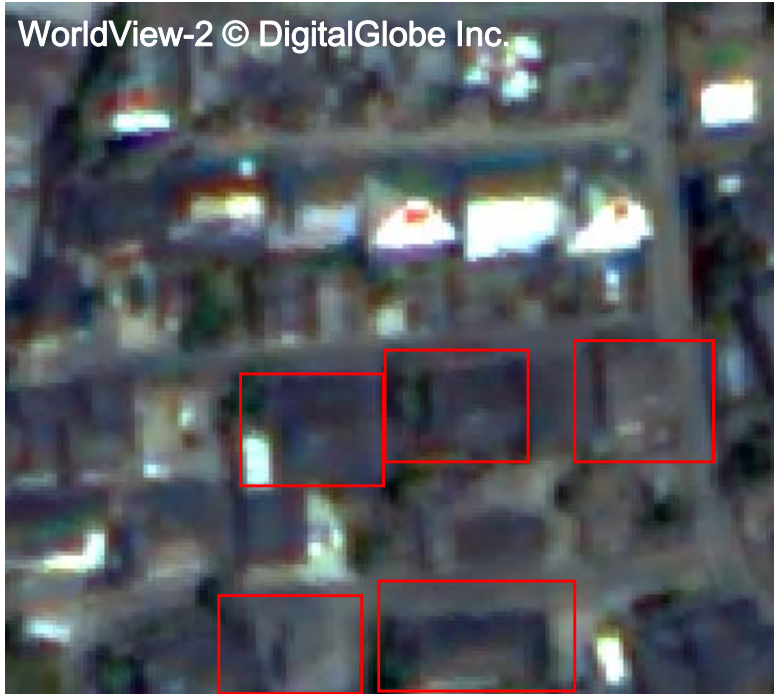
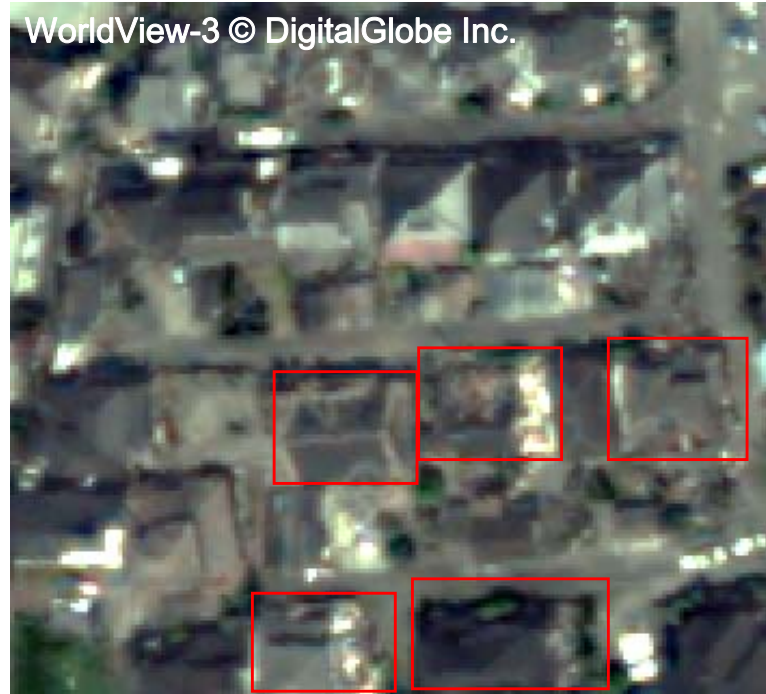
Damaged area A

■ Damaged buildings

Damaged buildings by the visual interpretation from the pansharpened pre- and post-event optical images.

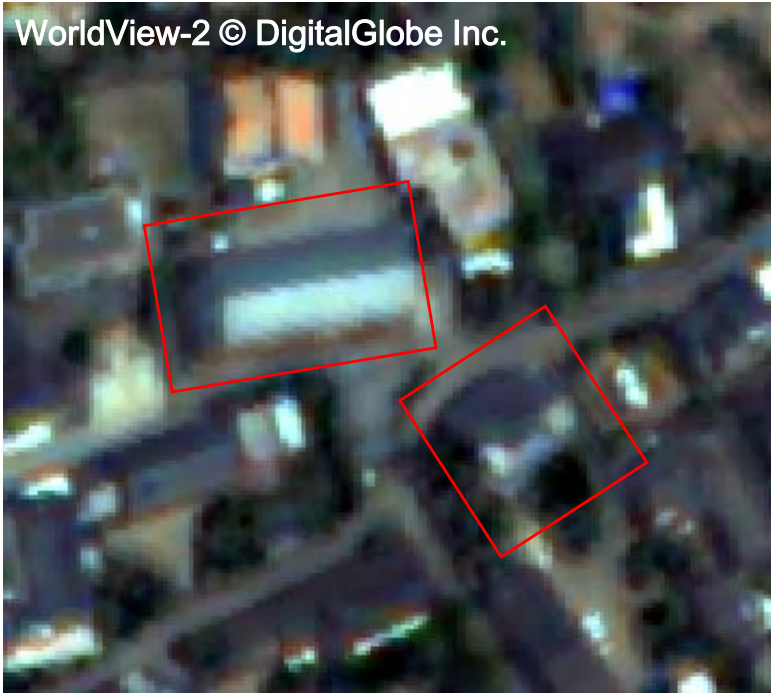
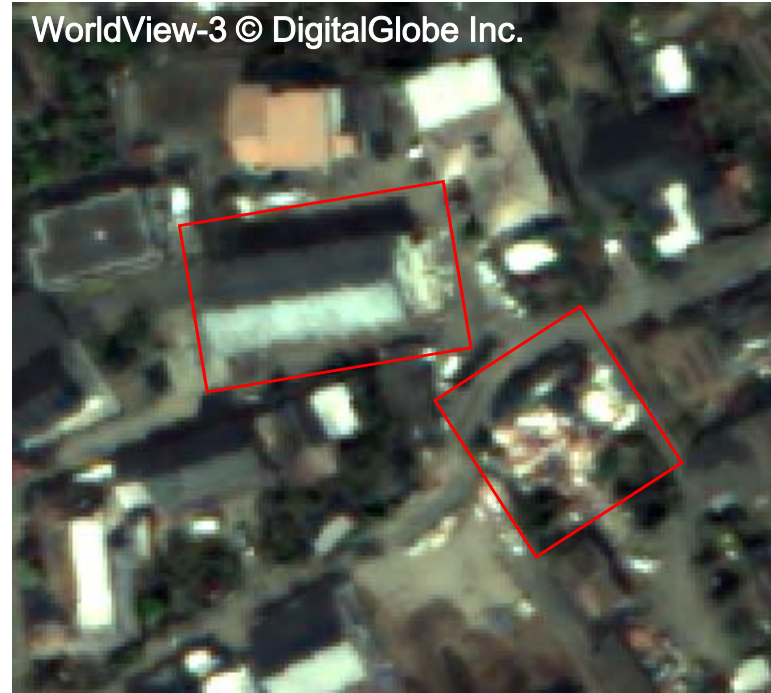
Damaged area C

■ Damaged buildings

Damaged buildings by the visual interpretation from the pansharpened pre- and post-event optical images.
