Estimation of Building Damage due to the 2016 Kumamoto Earthquakes Using PALSAR-2 Images - Post April 16 event (M7.3) -

Masashi Matsuoka, Kento Kagawa

Tokyo Tech, Japan

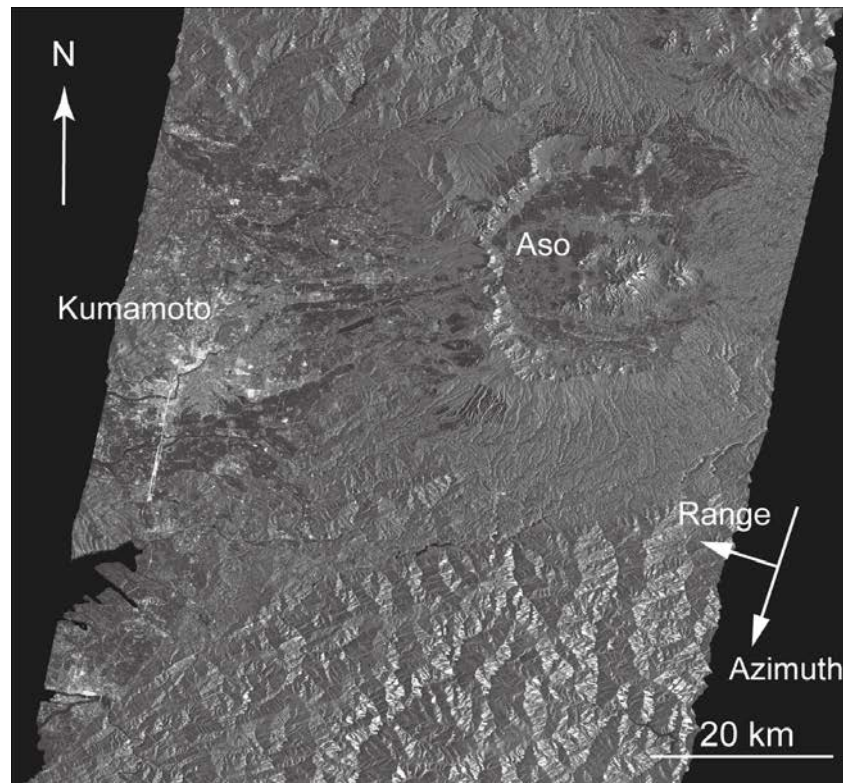
(a) 2015/11/30

PALSAR-2 Multi-look Images

Mode: FBS (HH), Offnadir angle: 32.8 degree, Orbit: Descending, Pixel Spacing: 10m

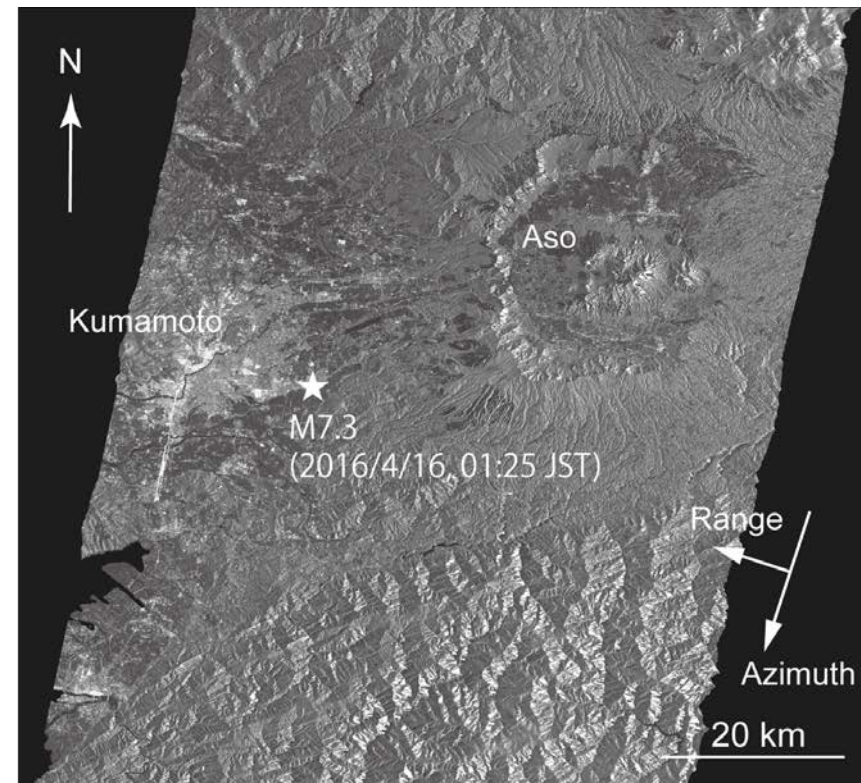
(b) 2016/4/18

The M7.3 earthquake was occurred between two acquisition dates.

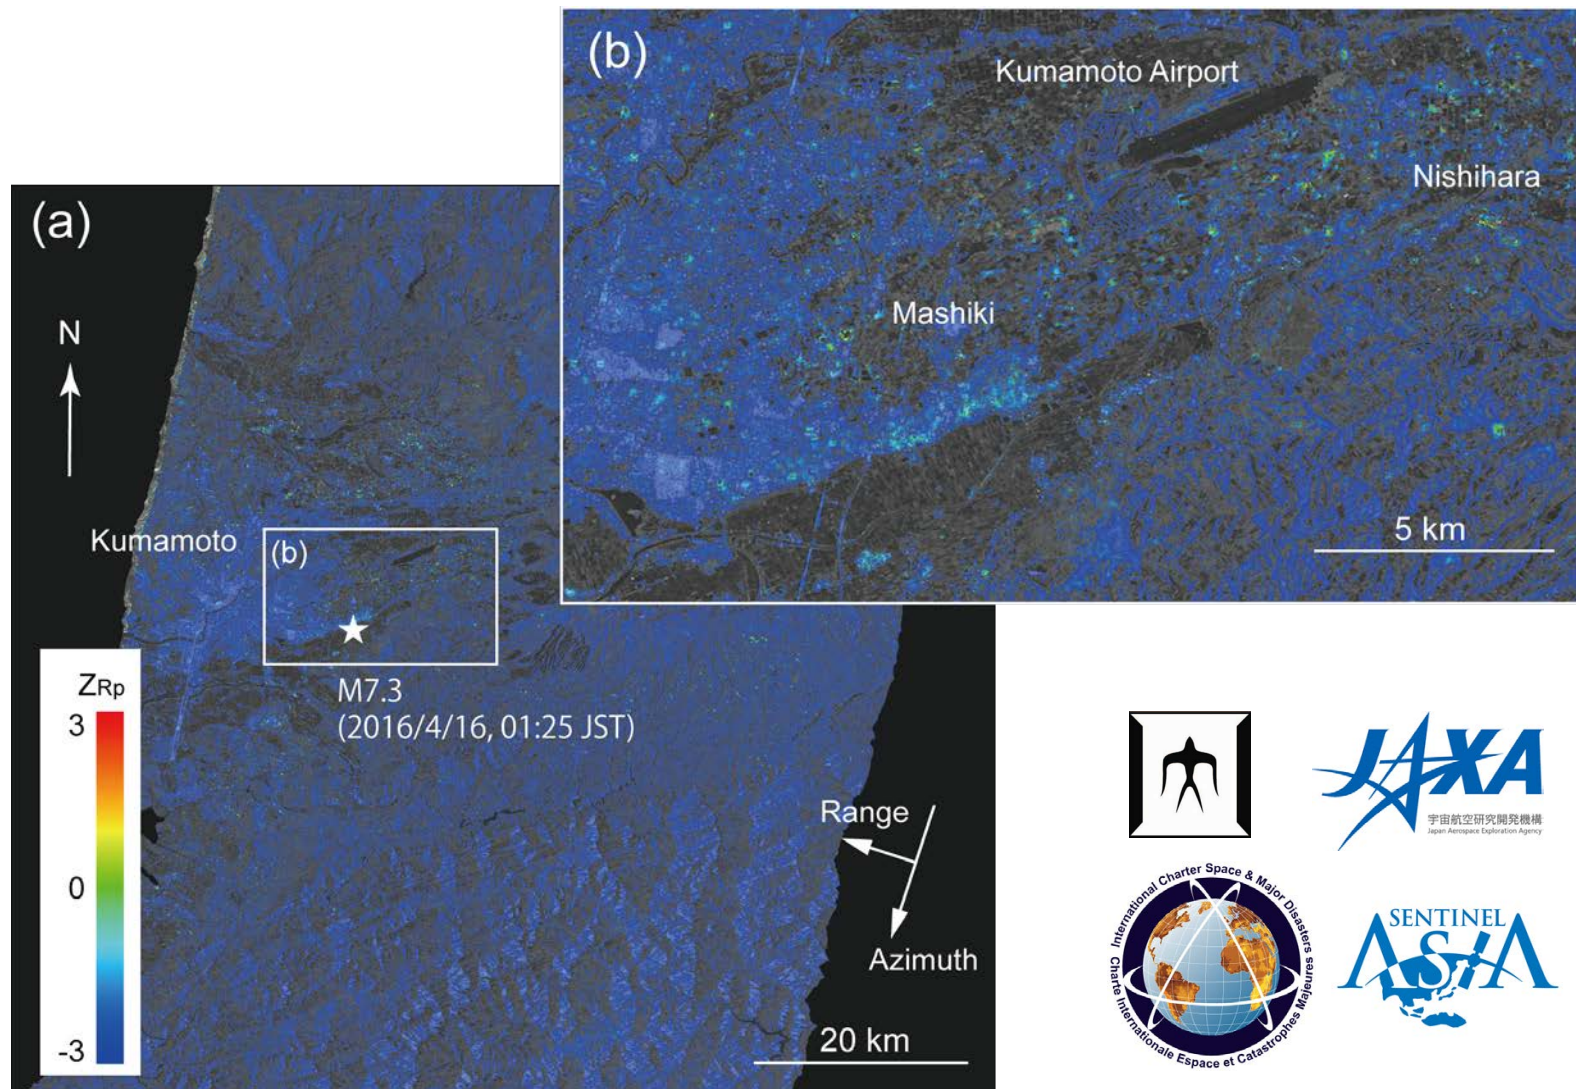
Distribution of discriminant score (Z_{rp}) calculated from d and r . There are large values of southwest to northeast direction from Mashiki to Nishihara.

益城町から西原村にかけて南西から北東方向に値が大きい地域が分布

- Co-registered SAR multi-look intensity images are prepared (two taken before the earthquake and one taken after). Each image is filtered using a Lee filter (Lee 1980) with a 21 x 21 pixel window.
- The difference in backscattering coefficient d and correlation coefficient r within a local window (13 x 13 pixels) are calculated from the two filtered images. Then, combined index (discriminant score, Z_{Rp}) which is corresponding to severe damage ratio of buildings using ALOS PALSAR imagery of the 2017 Pisco, Peru earthquake, is calculated by d and r .
- Finally, the building damage ratio is estimated by the normalized likelihood function based on the discriminant score, Z_{Rp} .

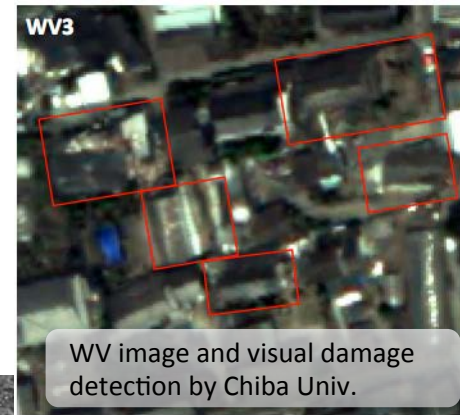
Severely damaged areas are located in Mashiki town and show relatively good agreement with ground photos and WorldView satellite images.

益城町の被害率が高い地域と地上写真, WorldView衛星画像との比較。
