# Damage Assessment for Kumamoto Earthquake Event Using FORMOSAT-2 Images

Center for Space and Remote Sensing Research  
National Central University

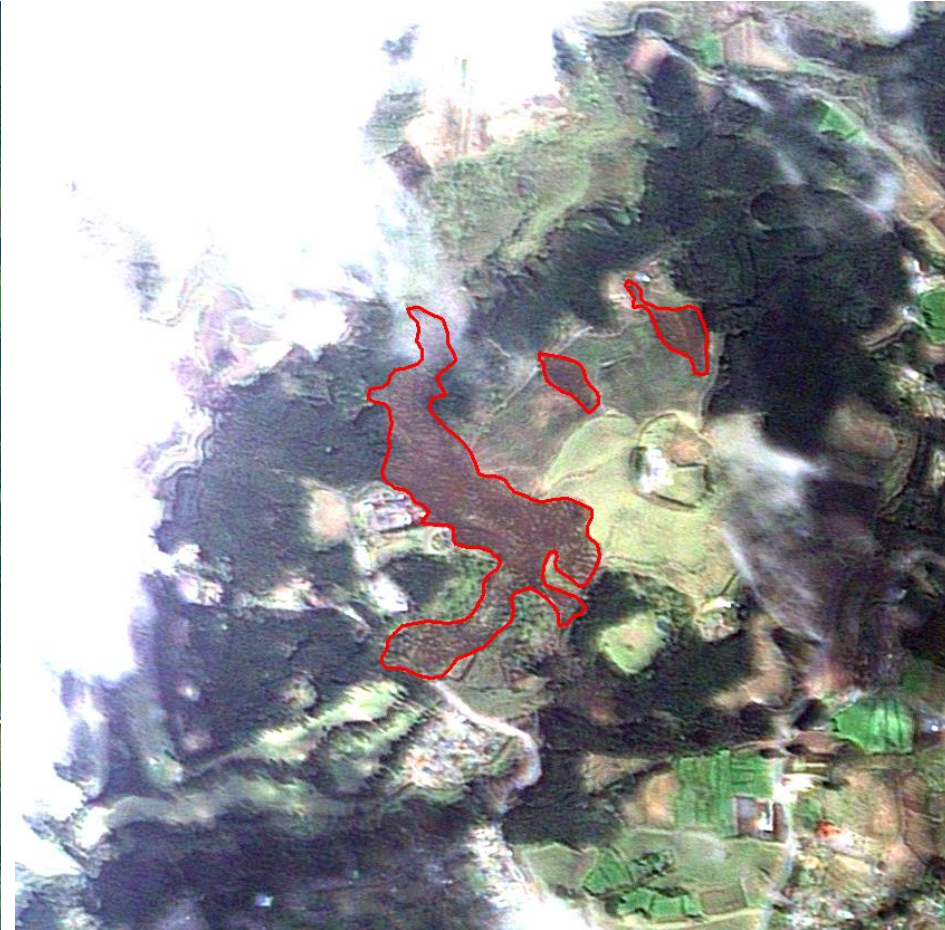
# Suspected Landslides in Location #1

Image Date : 2015-12-18

Image Date : 2016-04-17

Landslide area in this location :  
10.60 hectares

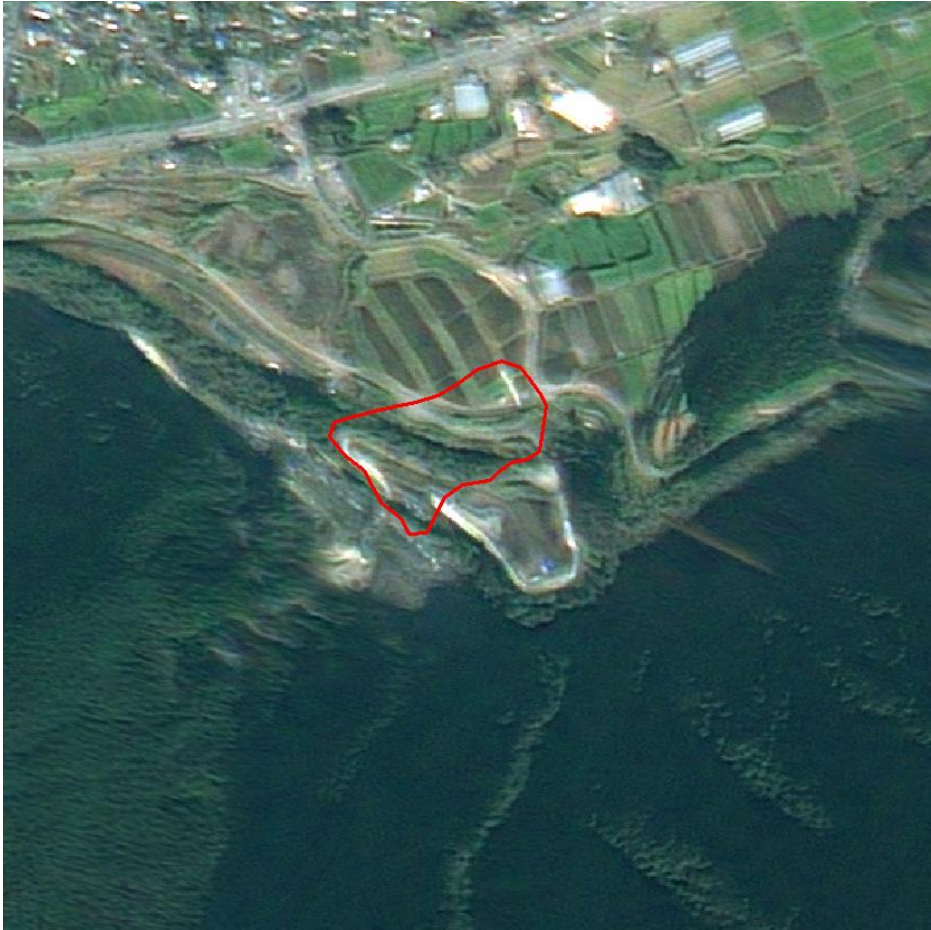
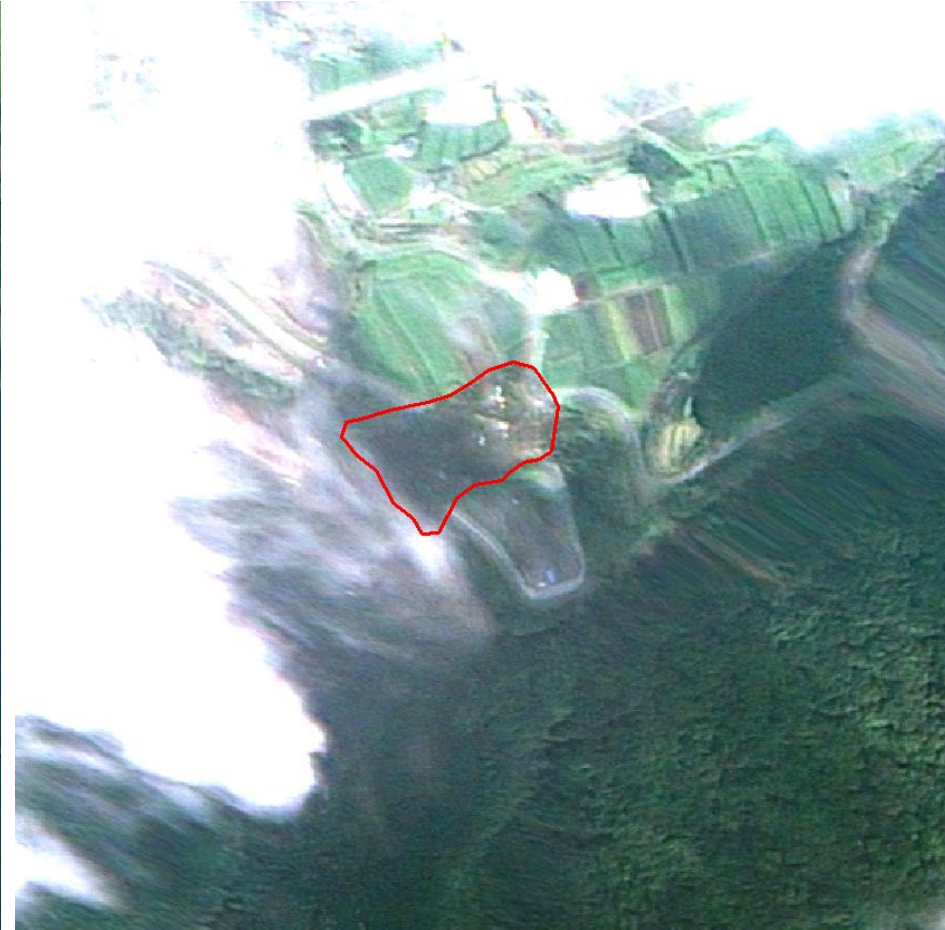
# Suspected Landslides in Location #2

Image Date : 2015-12-18

Image Date : 2016-04-17

Landslide area in this location :  
3.37 hectares

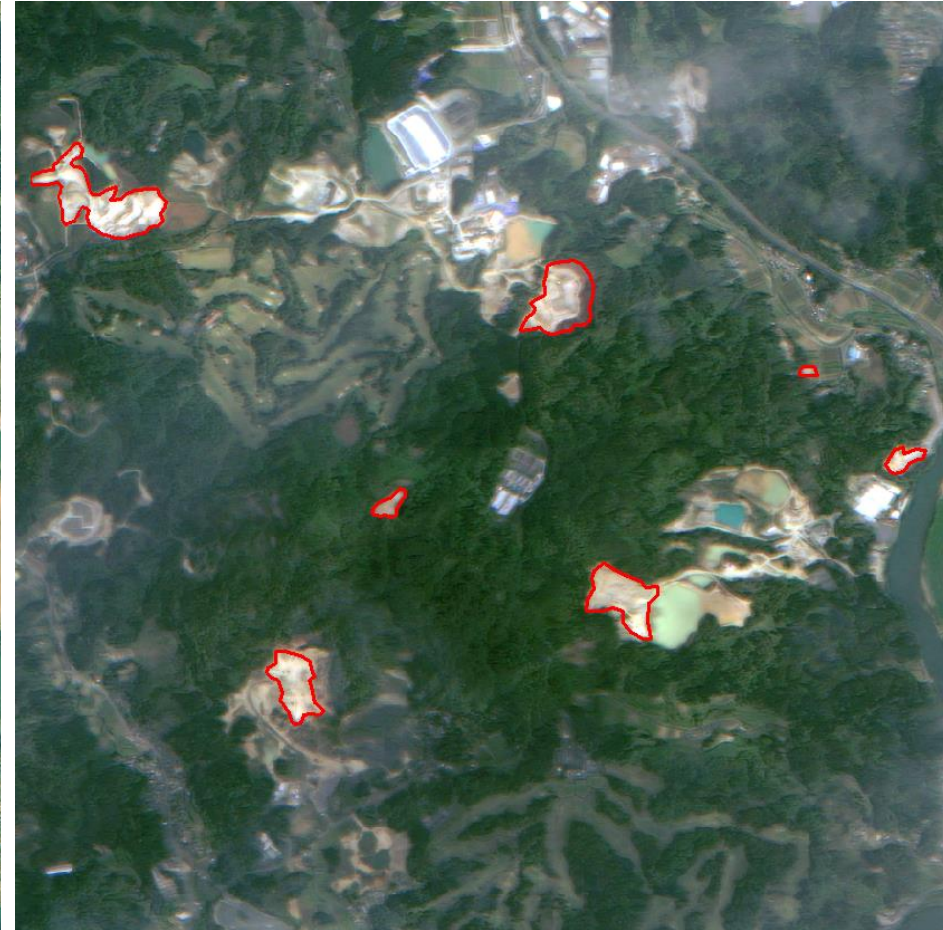
# Suspected Landslides in Location #3

Image Date : 2014-12-19

Image Date : 2016-04-16

Landslide area in this location :  
20.95 hectares

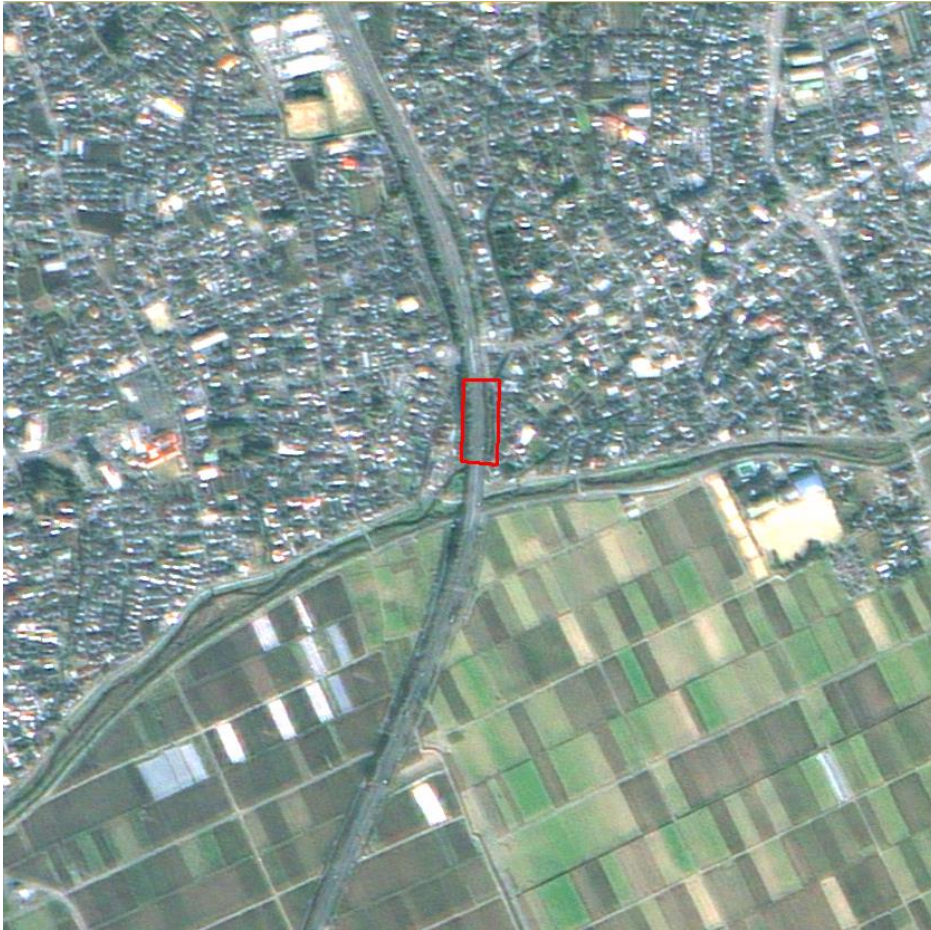
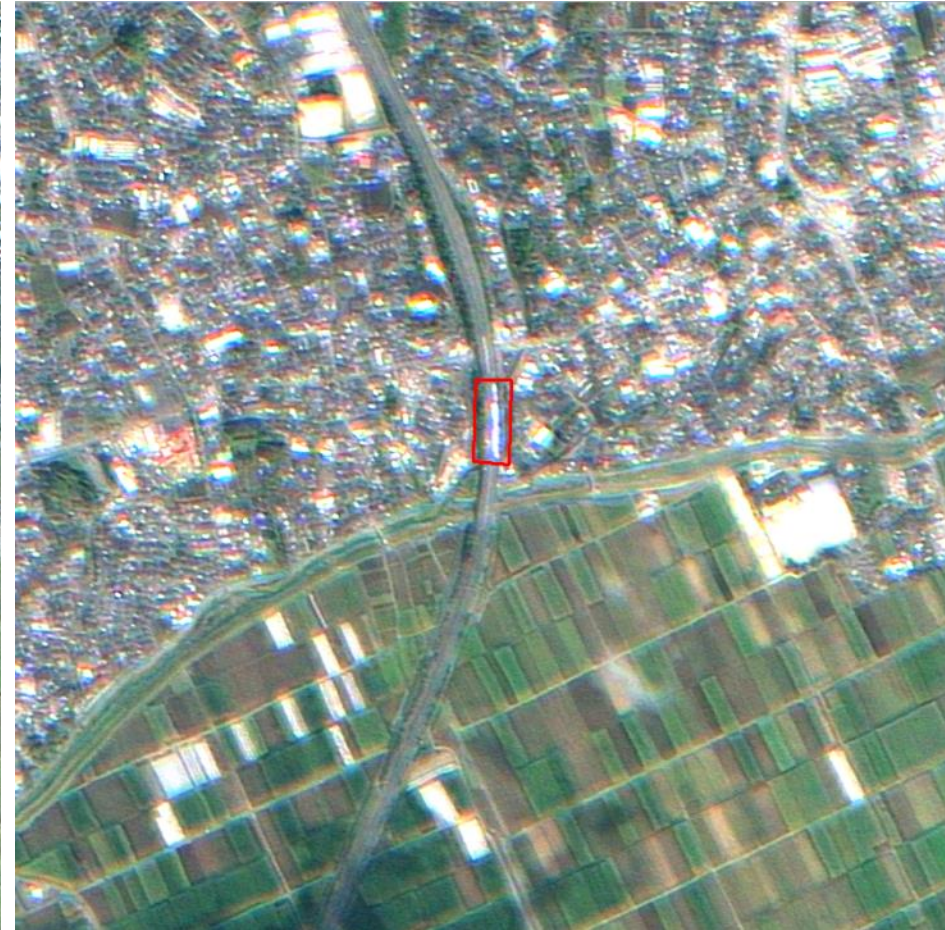
# Suspected Damage in Location #4

Image Date : 2015-12-18

Image Date : 2016-04-17
