Sri Lanka

Flood Monitoring Bulletin

19th May 2016

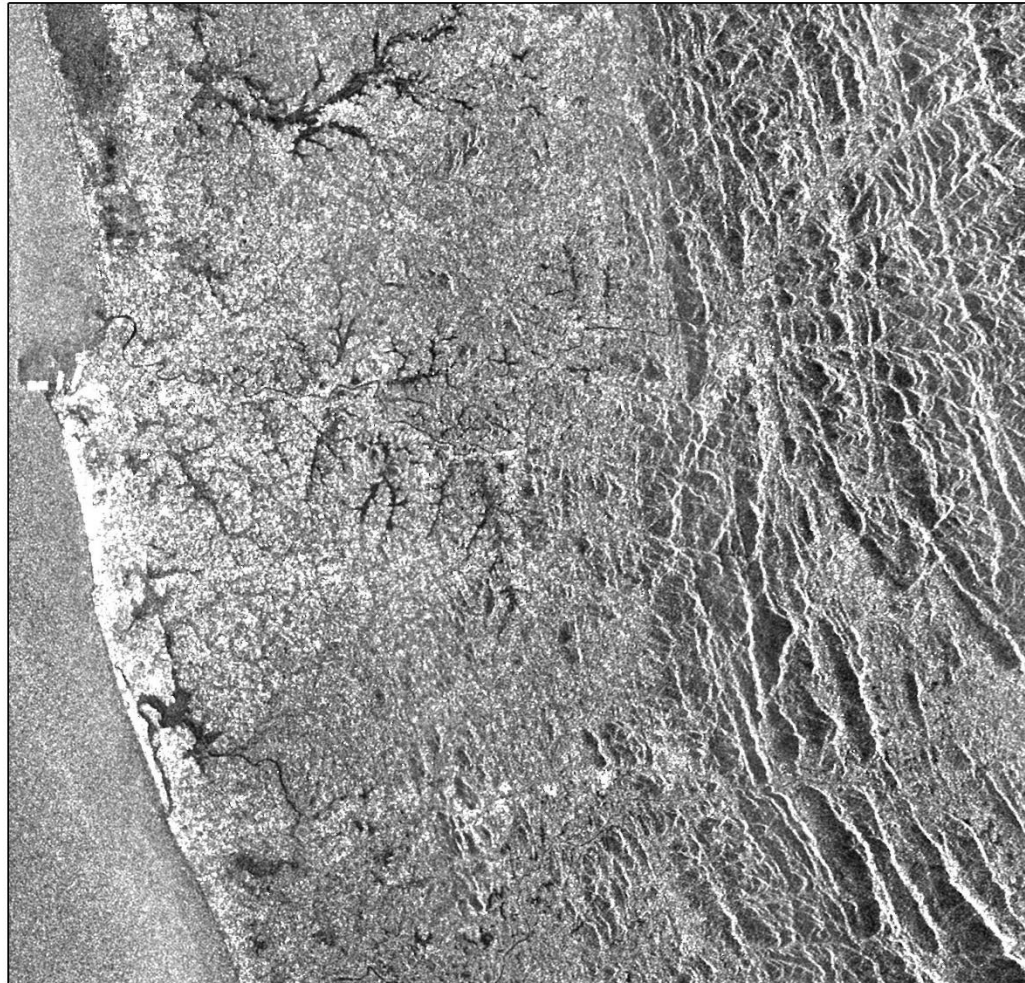
Disaster Image : RISAT - 1 (ISRO)
Date : 18 May, 2016

IWMI received satellite imagery from RISAT-1 dated 18 May 2016 through International Disaster Charter (IDC) provide by Indian Space Research Organization (ISRO). It is estimated that the maximum inundation observed for 18 May 2016 is approximately 2,343 sq. km. As mentioned earlier, most of this standing water are noticed in abandoned croplands, banana cultivations and large scale devastation in household area as well as several roads have been disconnected restricting the movement of general population.

The analysis excluded permanent water bodies including reservoir, tanks and ponds and this reflects only the inundation extent. Please note the surface water extent mapped has not yet been validated

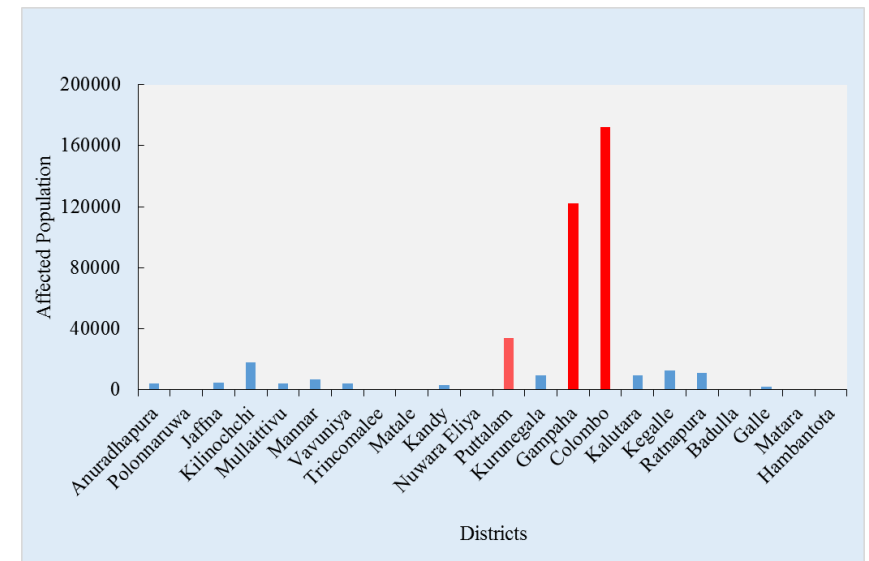
Flood affected population for 19th May 2016

The current flooding event affected 172,000 people in and around Colombo, 122,000 in Gampaha and 12,757 in Kegalle mainly from landslide reported on 18 May 2016. Six to ten feet of flood waters were observed in some household localities causing untold damage to rural households and gardens/croplands. Area under banana cultivation and rubber plantations are also currently under standing water. The flood affected Grama Niladhari (GN) divisions includes: Kolonnawa GND – Wellampitiya, Kelanimulla, Gotatuwa, Udumulla North, and Kaduwela_GND – Walpola, Kaduwela, Mahadeniya, Rangala, Welivita, Malabe West, Pahala Bomiriya, Ihala Bomiriya) and for the Gampaha GN divisions - Gampaha, Biyagama, Dompe, Jaela, Diulapitiya based on the reports from Disaster Management Center (DMC).

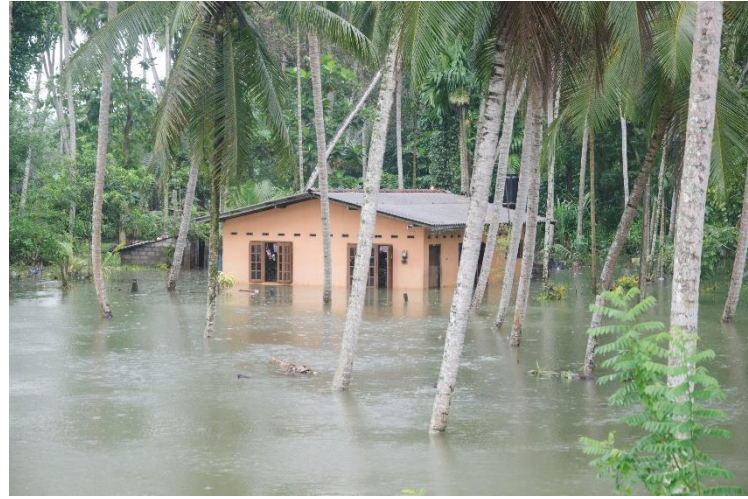
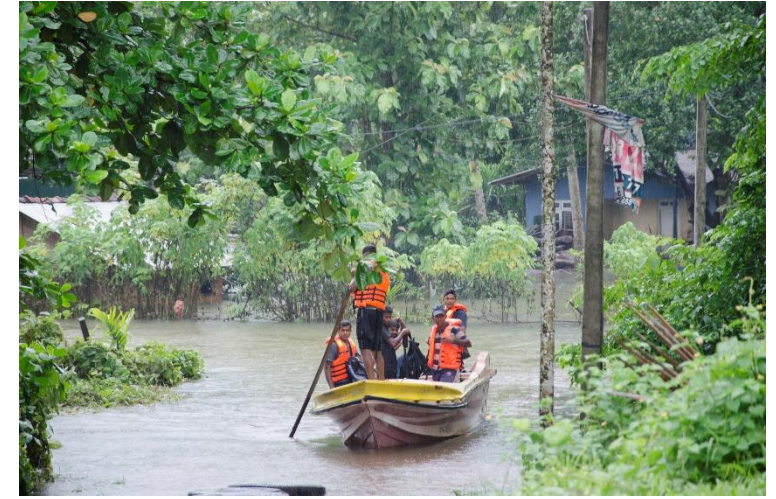
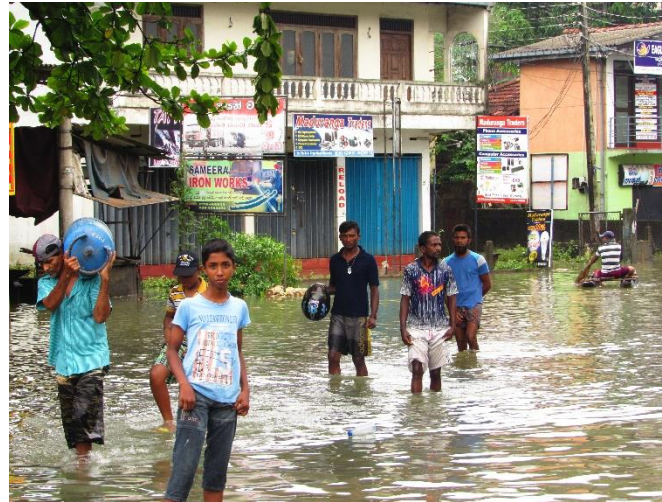
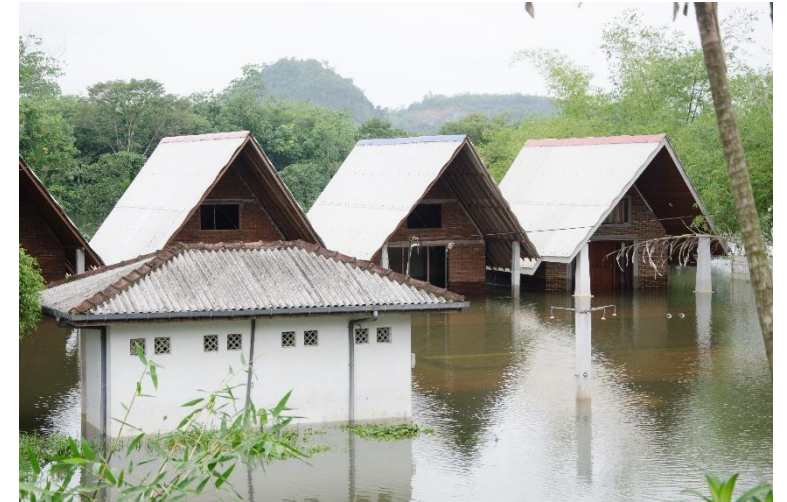
Field Observations in Kelani Ganga River Basin

- Images from flood affected areas in Colombo district and parts of Gampaha;
- Key locations includes Hanwella, Pugoda, Pahathagama, Suduwella, Thiththapaththara, Galagedara are severely affected by flooding with closer to 5 to 6 feet of standing water
- Most of the low land flooding are partially the abandoned paddy fields, banana cultivation
- Flood has caused several damages to rural houses with as many as 6 to 8 feet of standing water;
- In all these GN divisions, the flood affected communities are staying in flood shelters and government are provided food through local administration and DMC coordination to address the problems faced by major flooding
