Mapping Inundation extent for Colombo District in Western Province(Sri Lanka) using ALOS 2 PALSAR 2 Satellite Data (23 May 2018)

24 May 2018 | FL-2018-0003-SL |
Version 1

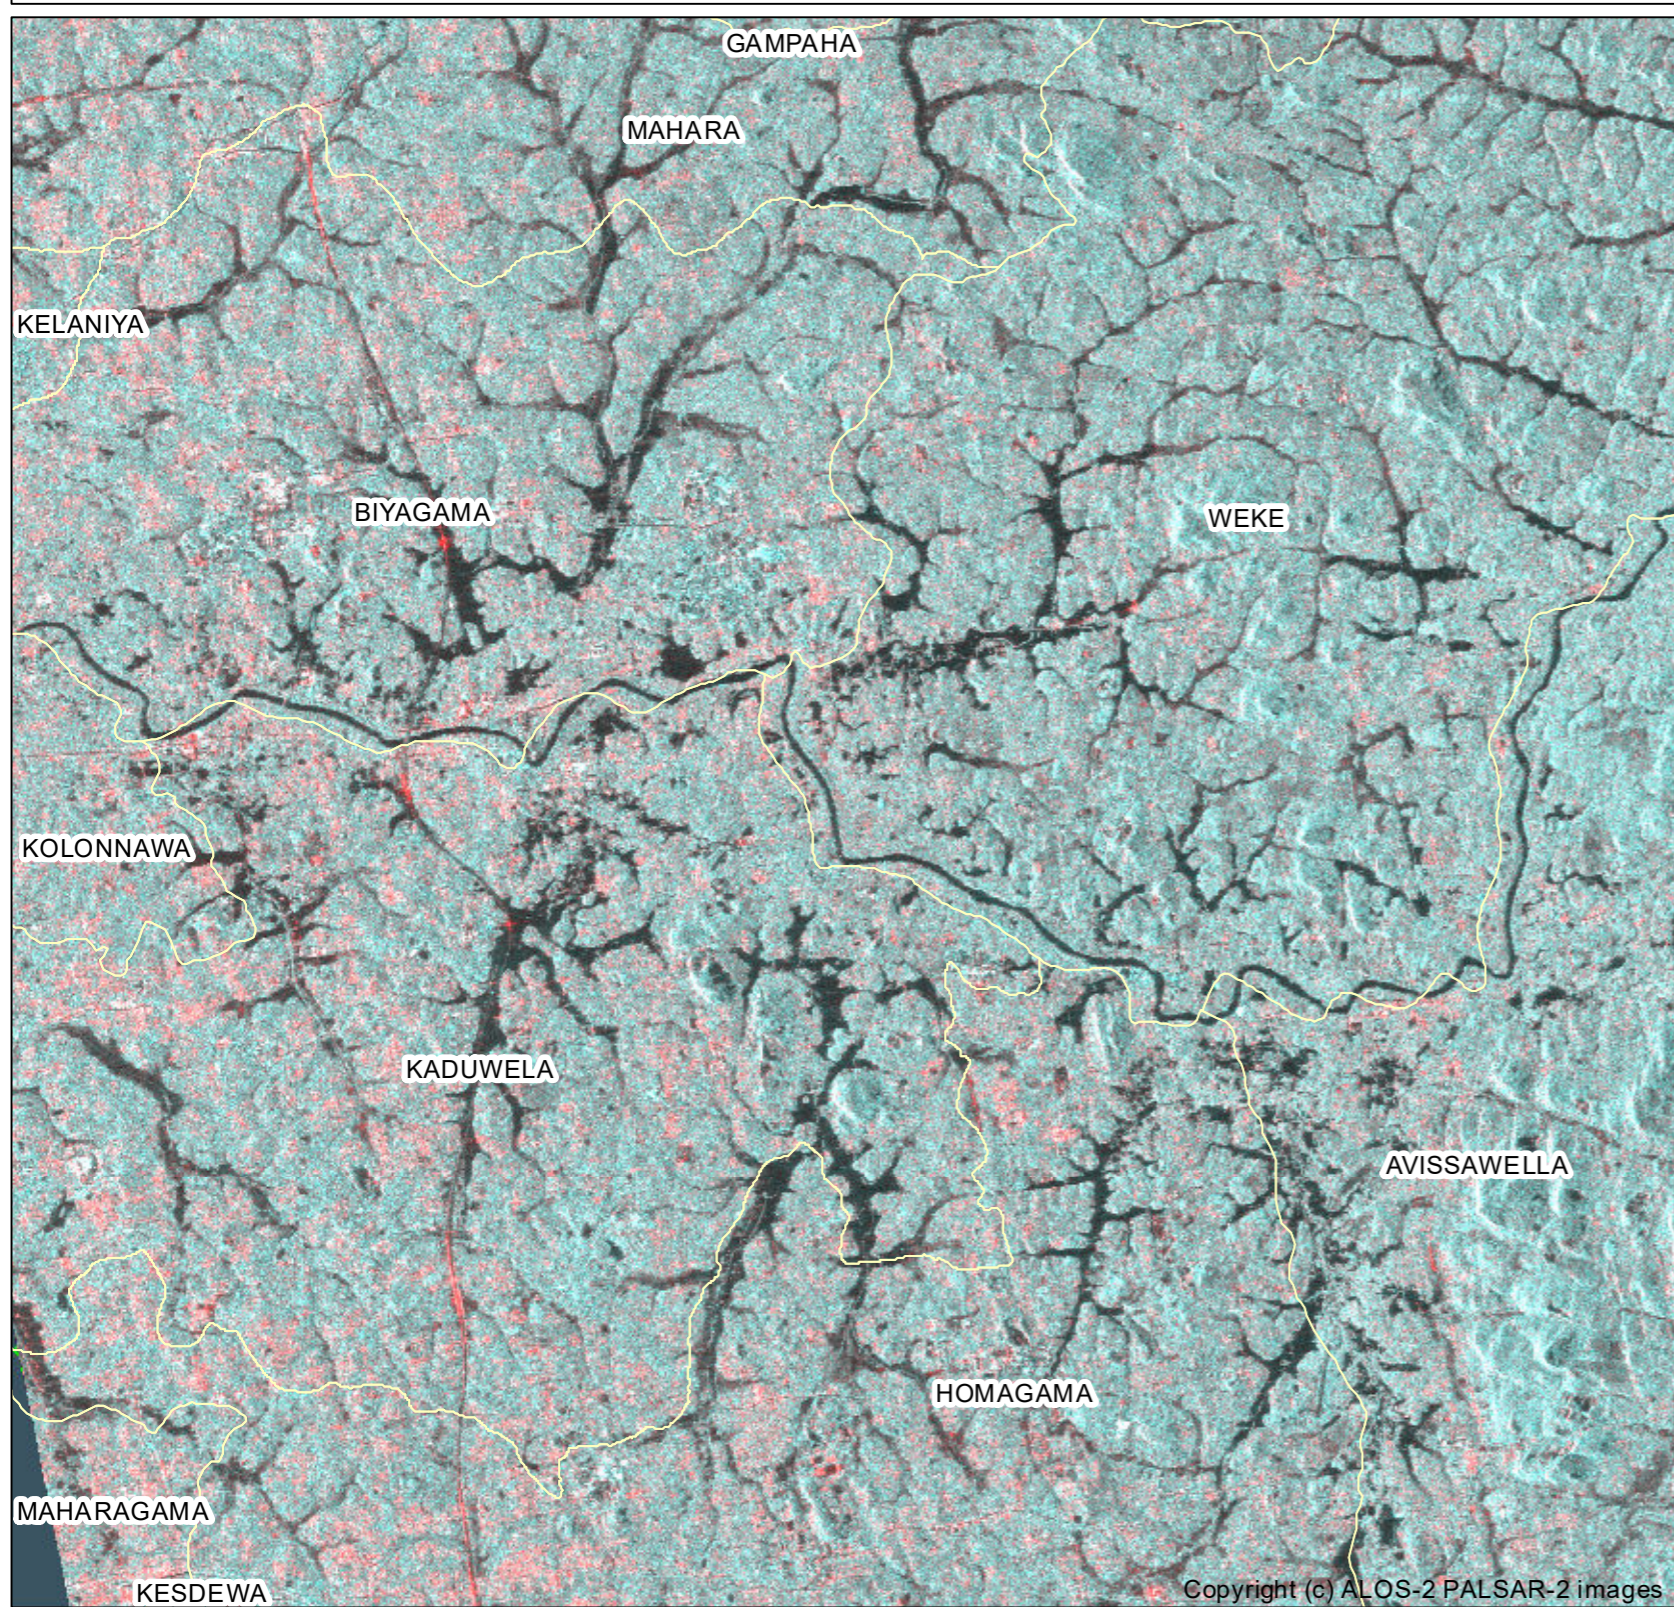
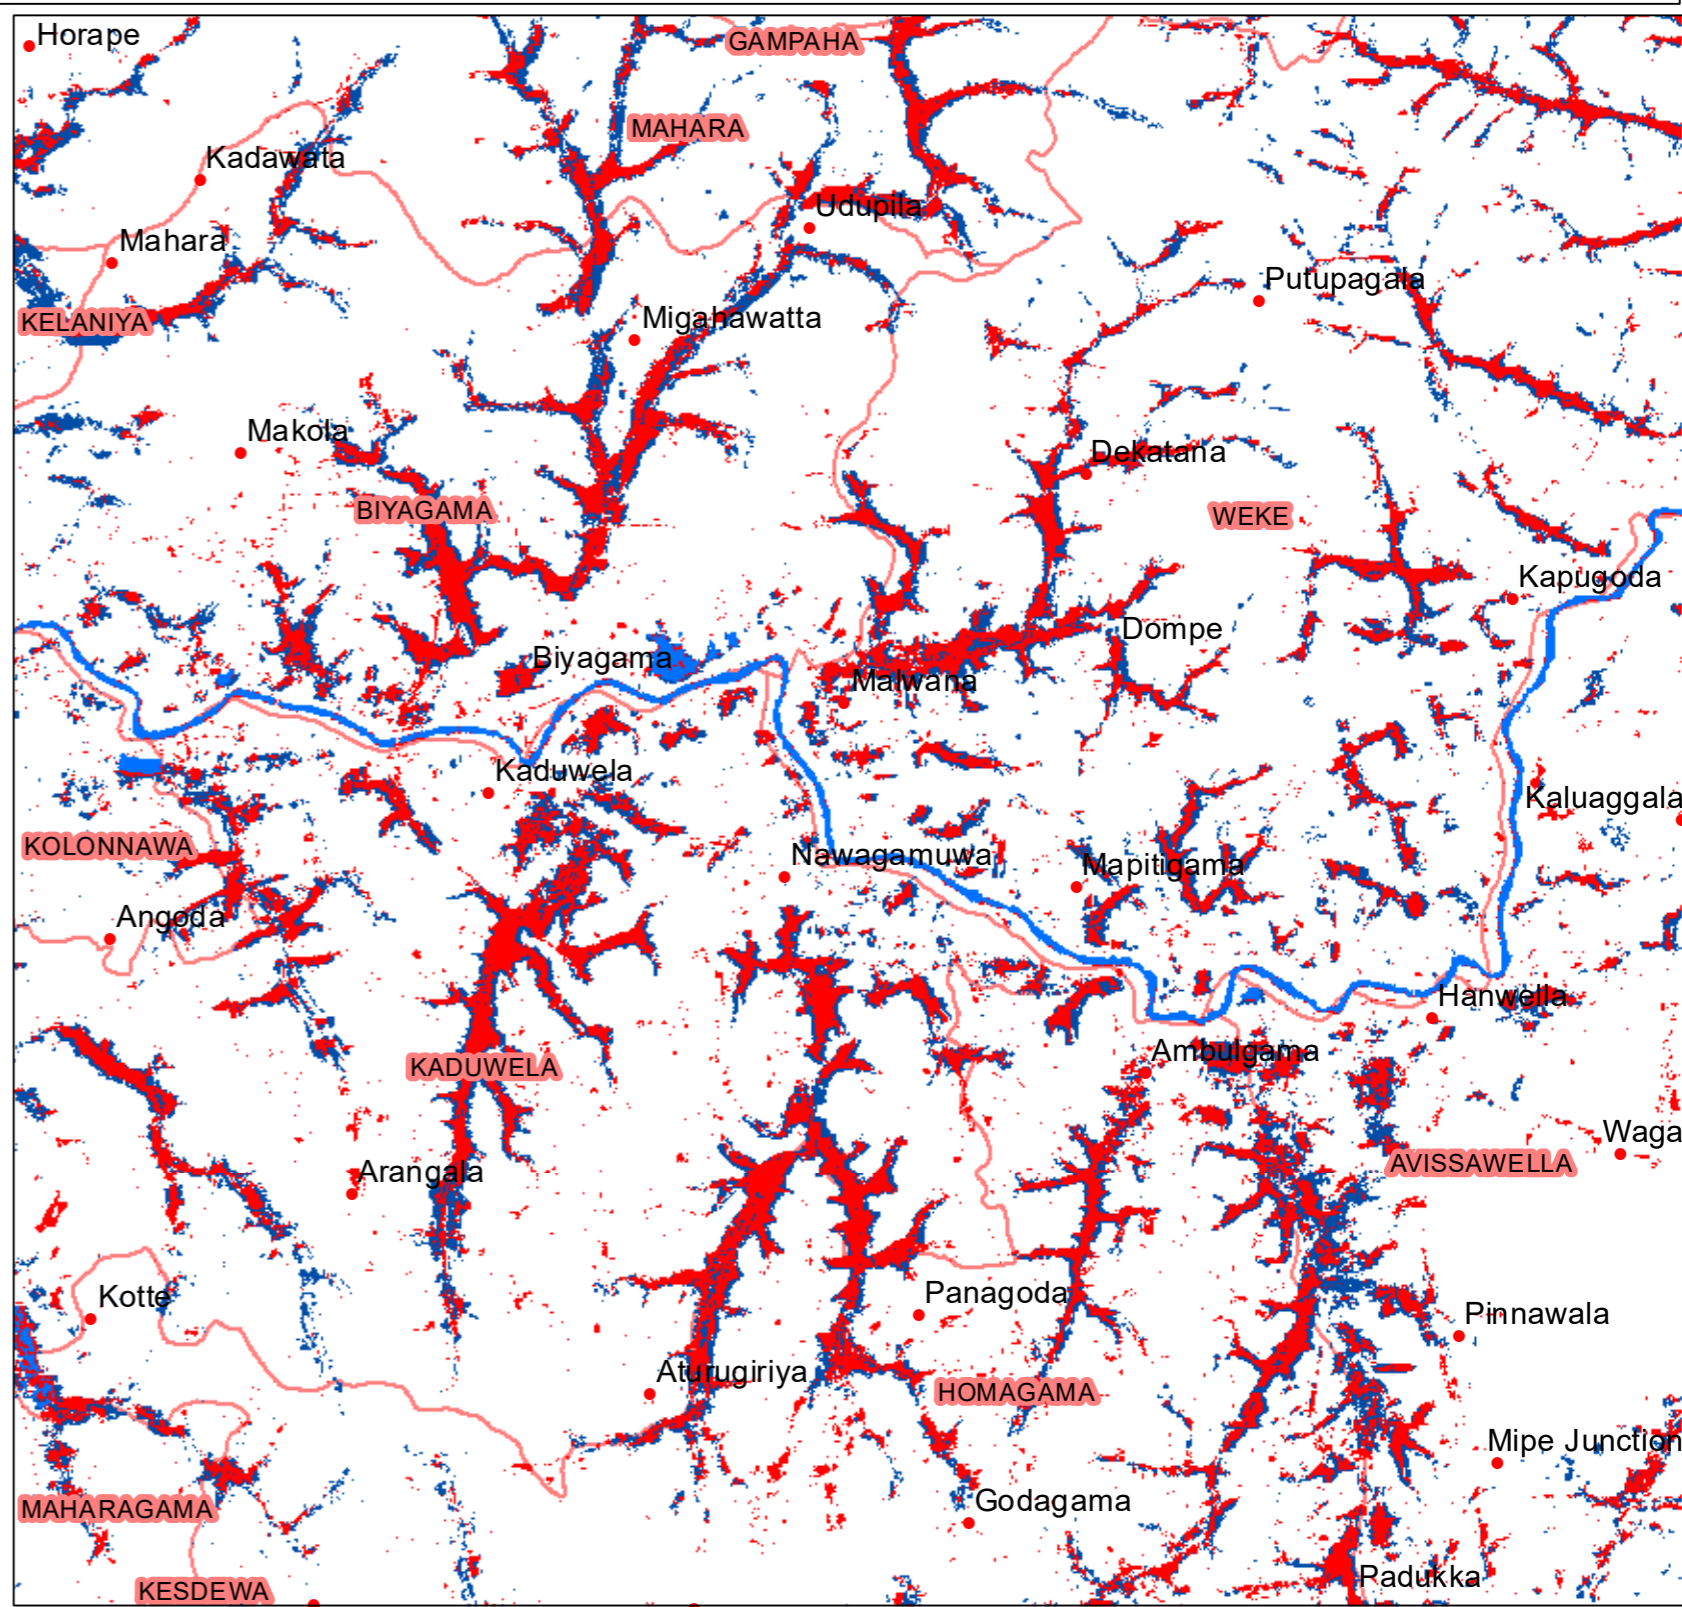
Satellite Image : ALOS-2 PALSAR-2
23 May 2018

The initial satellite observations from ALOS-2 PALSAR-2 (23 May 2018) showed vast areas of standing flood waters along the North Western, Western and Southern Provinces. Initial estimates from satellite images indicate that Puttalam (96.1 sq.km), Kurunagala (198.6.sq.km), Gampaha (82.46 sq.km) Galle (25.5 sq.km), Kaluthara (22.1 sq.km), Rathnapura (10.4 km.sq), Colombo (4.2 sq.km). Most of the district flood is reducing but rivers are still under minor flood level.

The satellite image from ALOS-2 PALSAR-2 taken on 23 May 2018 showing considerable inundation for Galle and reference to dark with deep water and dark grey color in the agriculture fields with water.

The analysis excluded permanent water bodies including reservoir, tanks and ponds and this reflects only the inundation extent. Please note the surface water extent mapped has not yet been validated in the field.
