Mapping Inundation extent for Kurunegala District in North Western Province (Sri Lanka) using ALOS 2 PALSAR 2 Satellite Data (23 May 2018)

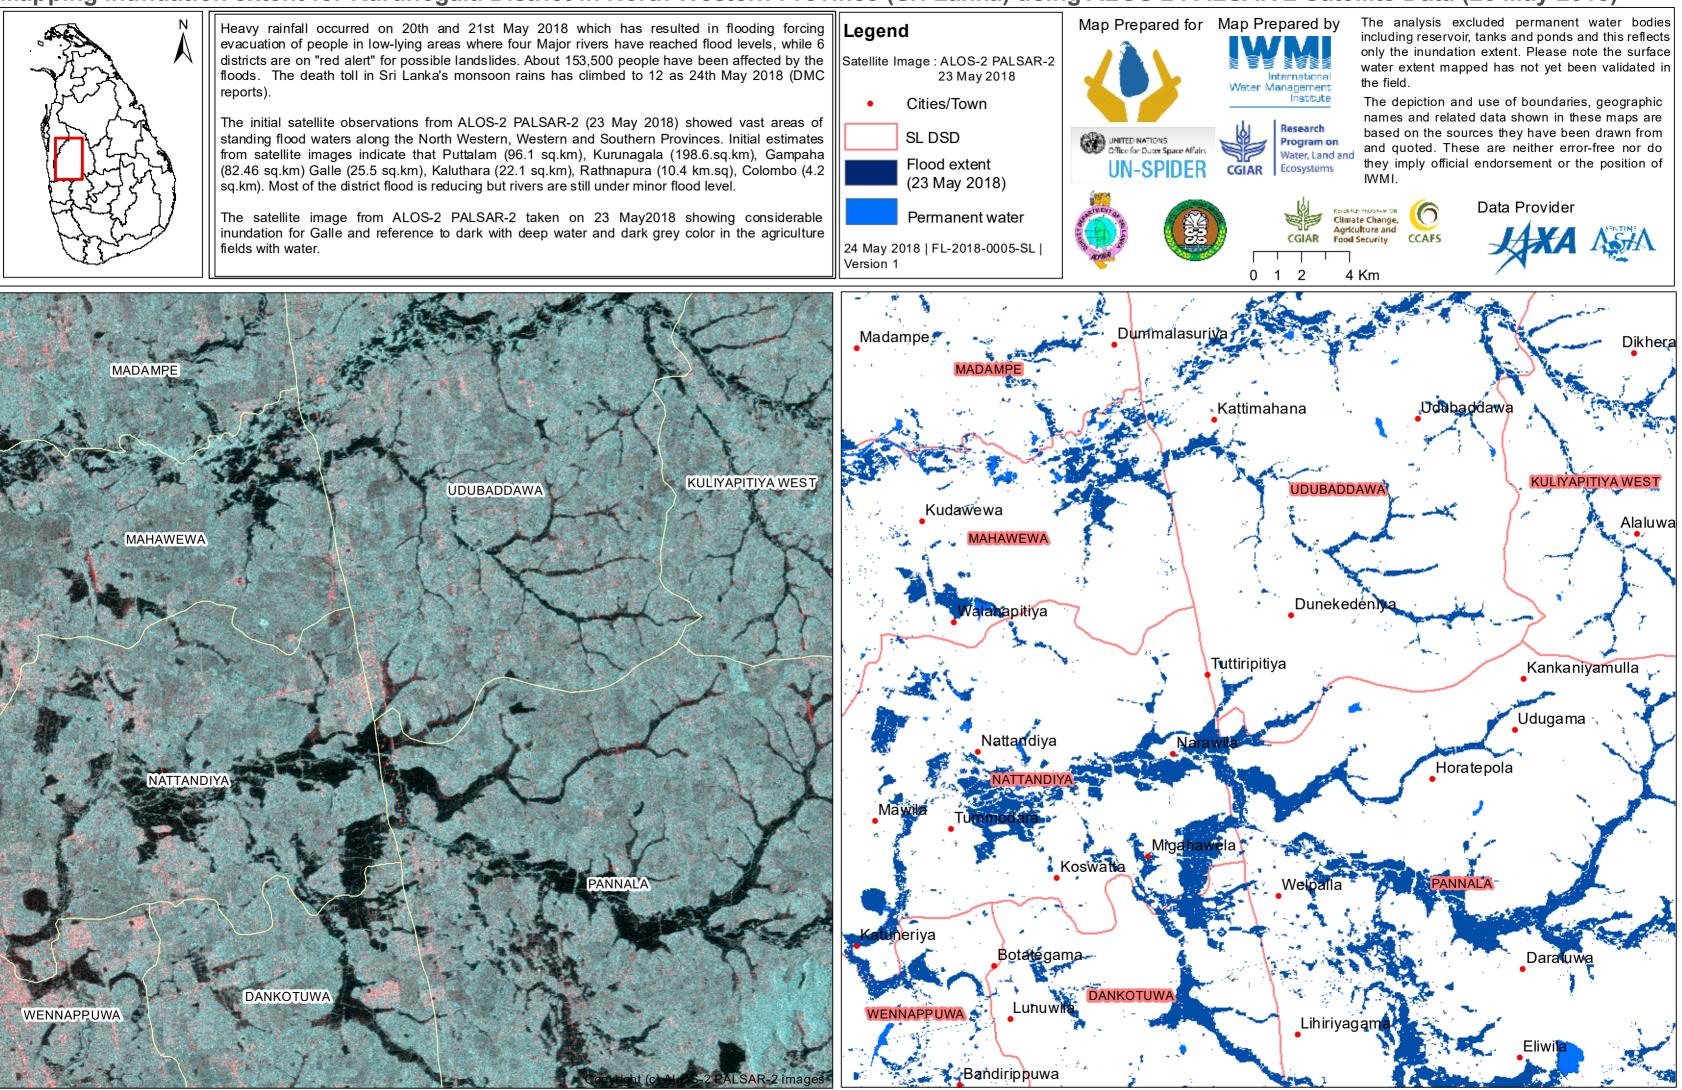
sq.km). Most of the district flood is reducing but rivers are still under minor flood level.

The satellite image from ALOS-2 PALSAR-2 taken on 23 May2018 showing considerable
