Mapping Inundation extent for Gampaha District in Western Province (Sri Lanka) using Satellite Data (23,25 and 26 May 2018)

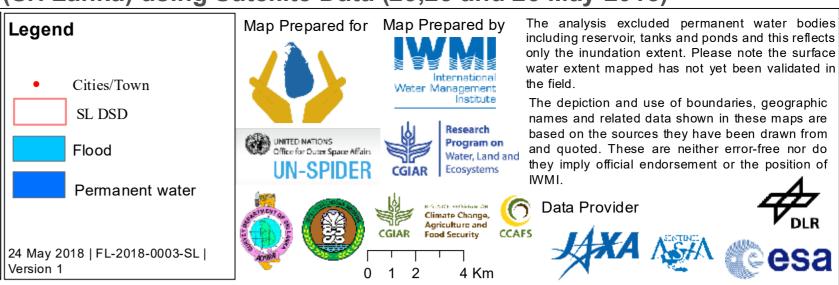
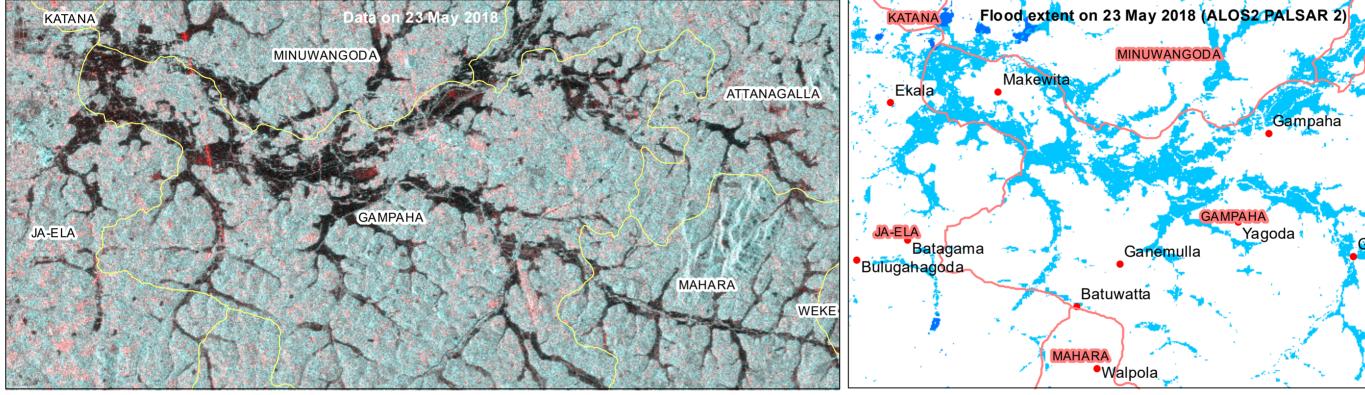
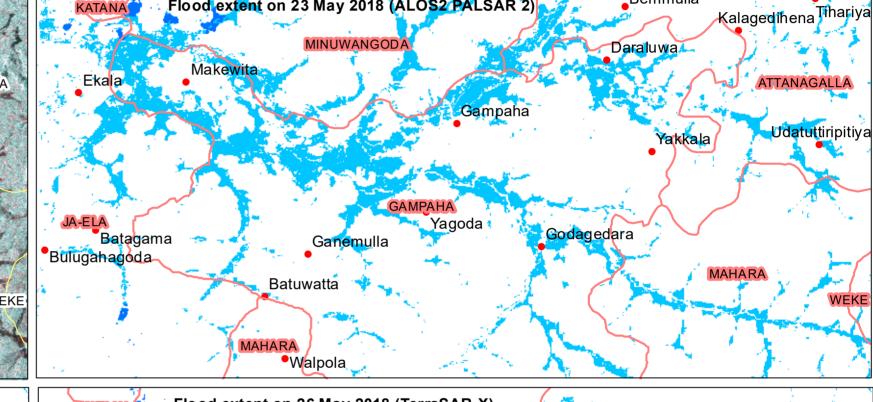
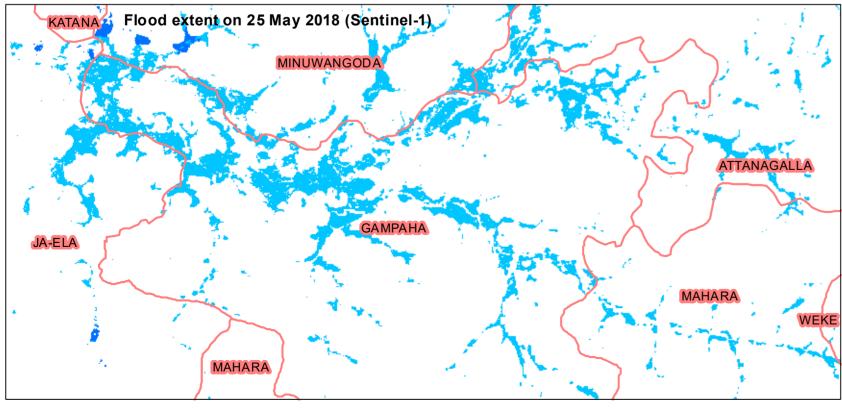
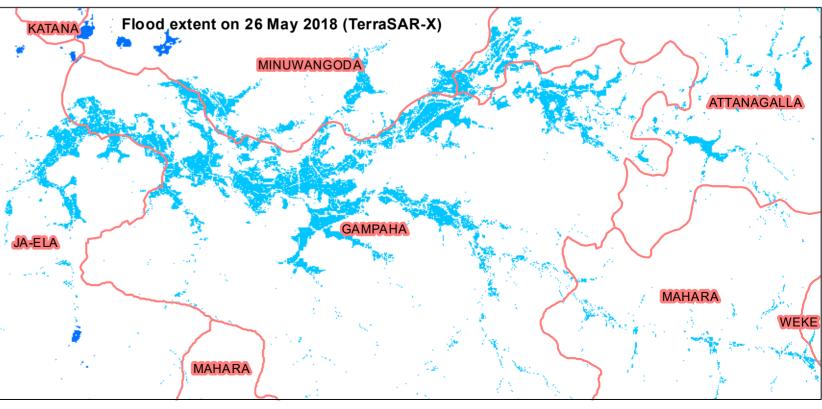
The satellite image from ALOS-2 PALSAR-2 taken on 23 May2018 showing considerable inundation for Gampaha and reference to dark with deep water and dark grey color in the agriculture fields with water. Most of the areas are still water logged due to the second rainfall event on 25th May 2018 in Gampaha district.

The initial satellite observations from ALOS-2 PALSAR-2 (23 May 2018) showed vast areas of standing flood waters along the North Western, Western and Southern Provinces. Initial estimates from satellite images indicate that Puttalam (68.4 sq.km), Kurunagala (135.5.sq.km), Gampaha (37.7 sq.km) Galle (9.2 sq.km), Kaluthara (8.1 sq.km), Rathnapura (4.6 km.sq), Colombo (2.1 sq.km). Most of the district flood is reducing but rivers are still under minor flood level.
