DETECTED FLOOD WATER THANH HOA PROVINCE

As Observed by Sentinel-1 image on 30 September 2023

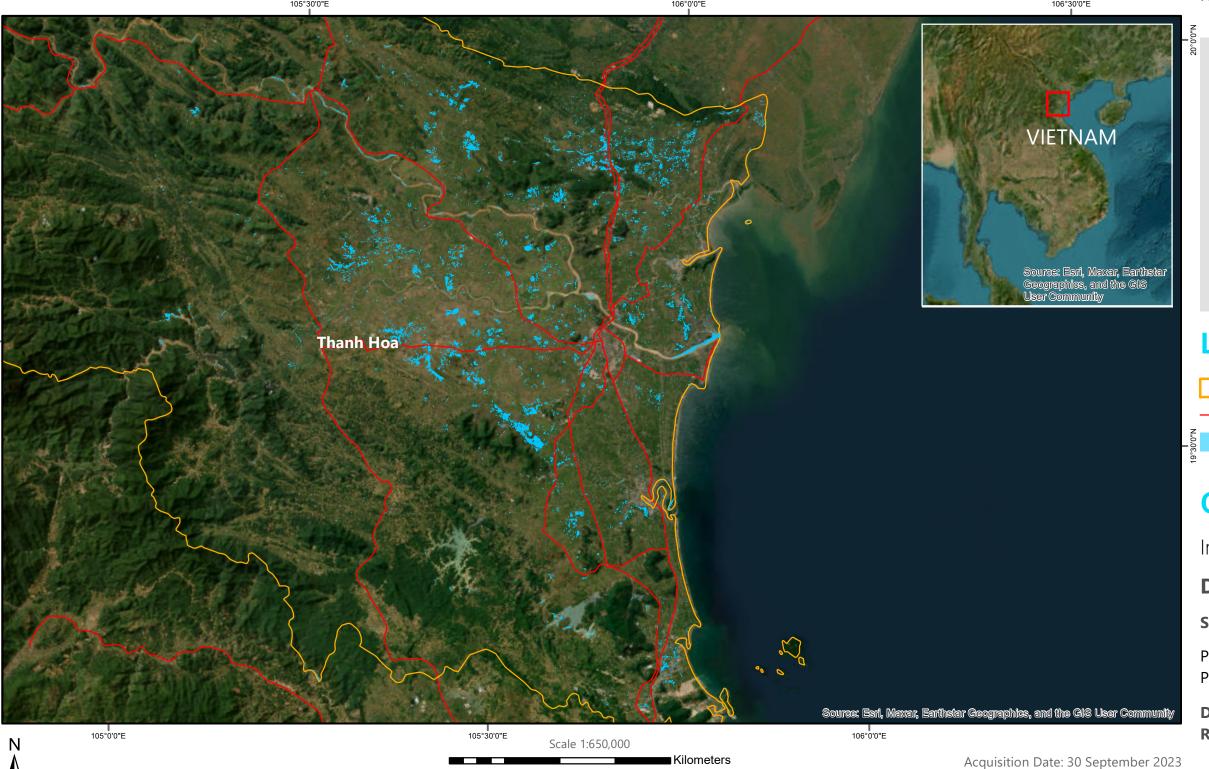
"This map shows flooded area and standing water in the North central provinces of Vietnam on 26 September 2023 after the heavy rainfall. Flood water detected in "Nong Cong, Dong Son, Trieu Son, Hoang Hoa, Ha Trung, Nga Son, Hau Loc Districts of Thanh Hoa province".
