# Eskisehir Technical University, Institute of Earth and Space Sciences (ESTU-IESS), New Member of Sentinel Asia

# Sentinel Asia Capacity Building WS in Ankara, Türkiye'' Workshop on January 7 and 8, 2025

# Selected Case Study: 20251128-Indonesia-Flood-Landslide-00628

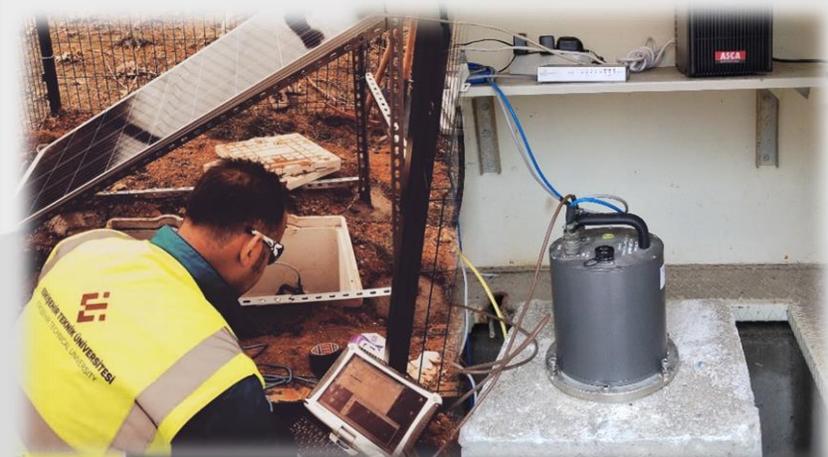
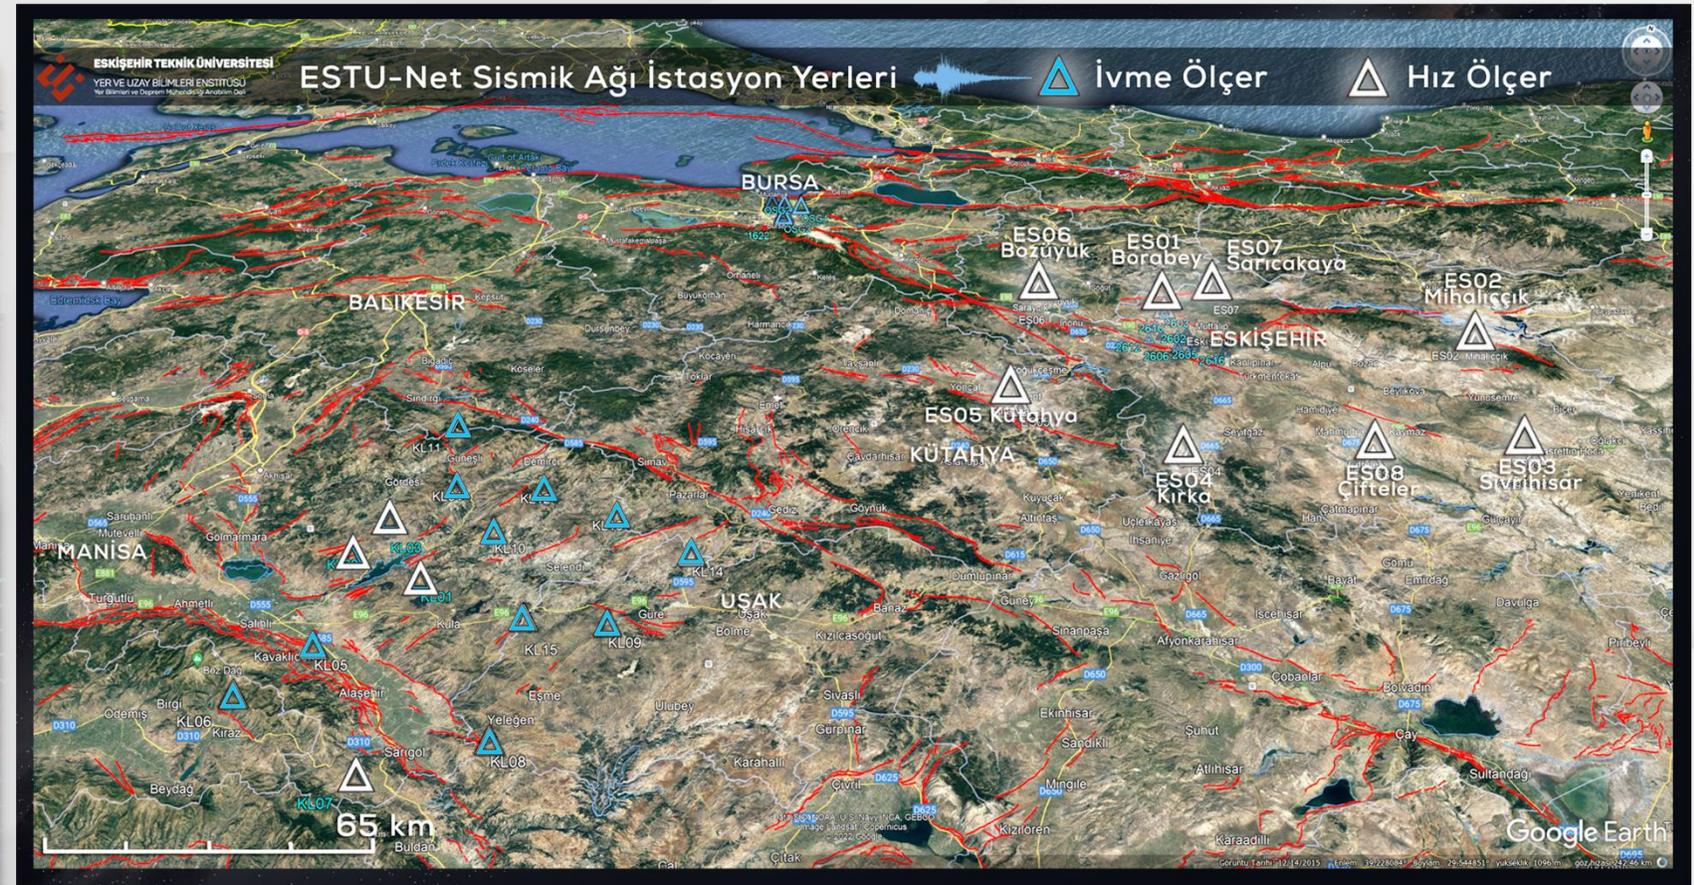
## Estu-Net Seismic Network

41 Stations

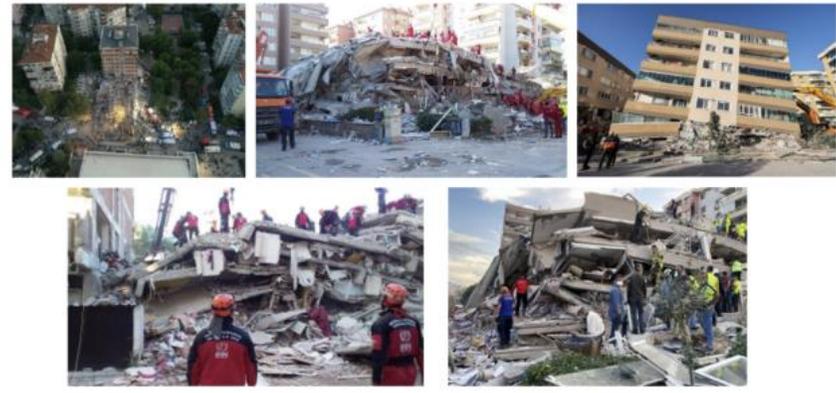
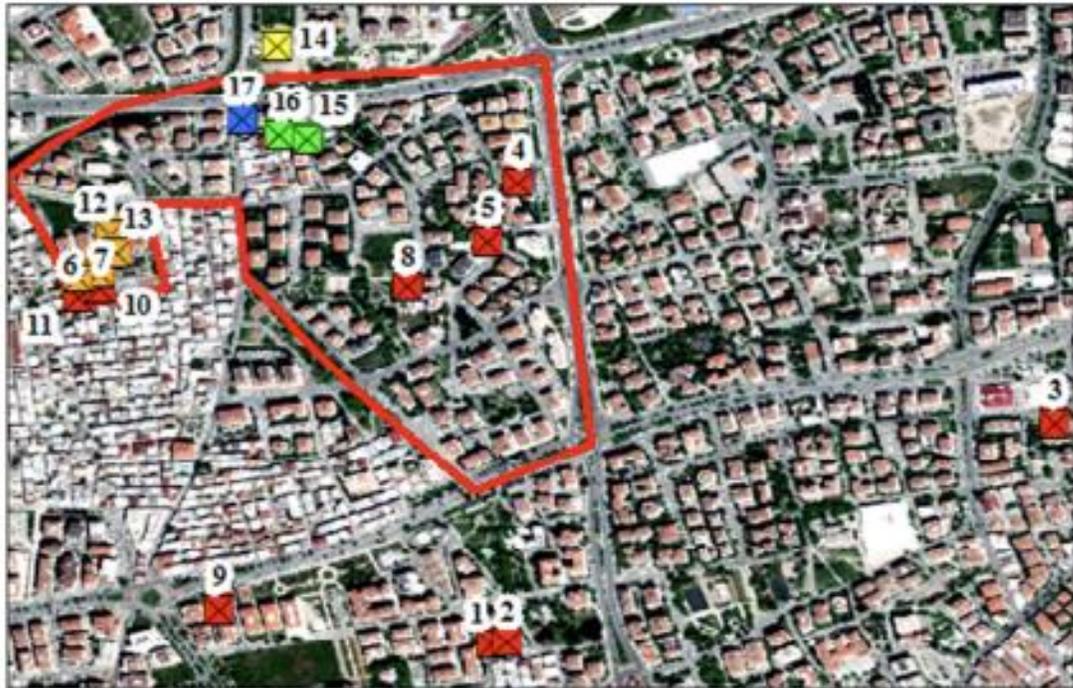
- Mid-rise collapsed buildings
- Mid-rise heavy damaged buildings
- High-rise buildings
- Low-rise buildings
- Mid-rise buildings

Figure 10. Structural damage estimation in the study area.
