**Government of Nepal**  
**Ministry of Energy, Water Resources and Irrigation**  
**Department of Hydrology and Meteorology**

# Feedback on GLOF monitoring training including GLOF events in Nepal, 2025

*12 February 2026*

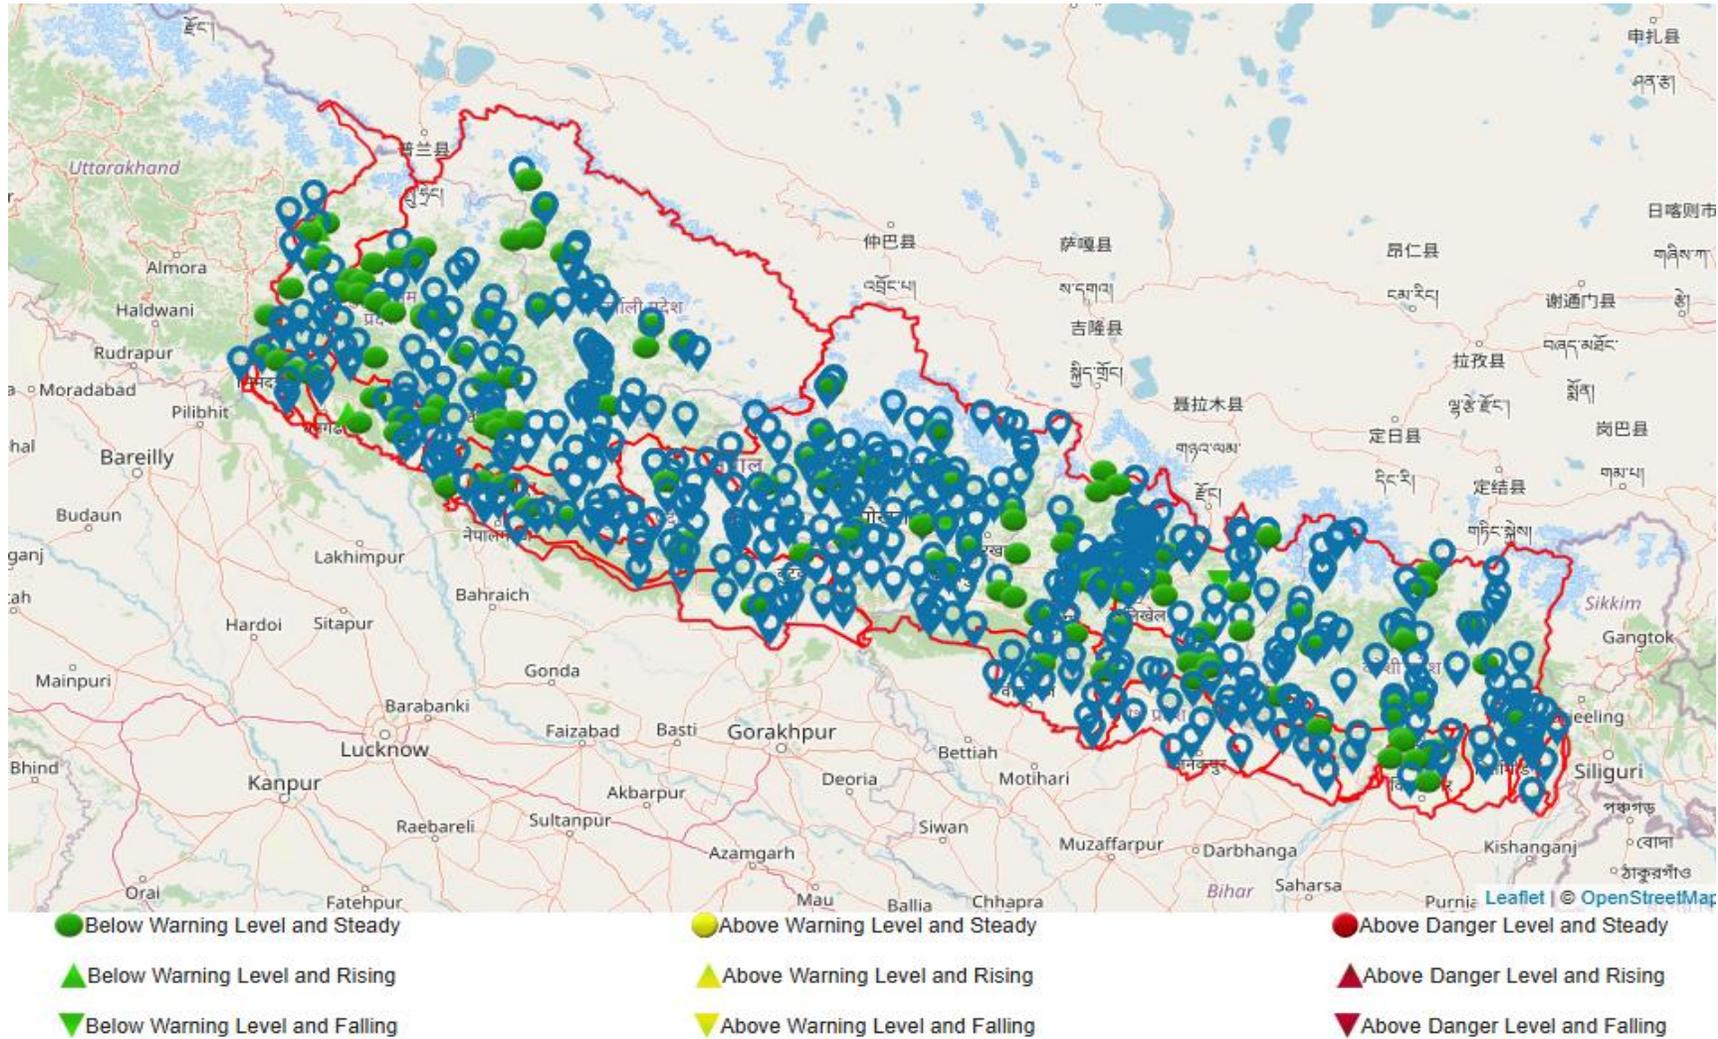
## Hydro- meteorological Observation Network

More than 325 Rainfall monitoring stations

More than 200 Water level monitoring stations

More than 10 snow stations (both meteorological and hydrological stations)

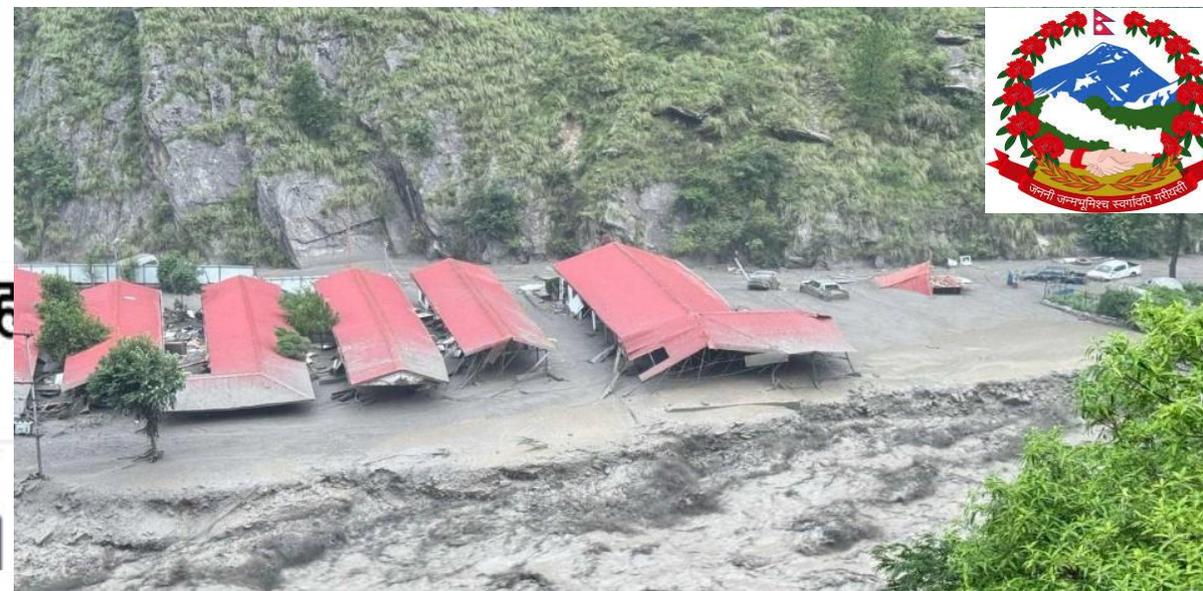
रसुवामा बाढीले नेपाल-चीन मितेरी पुल बगायो, सुक्खा बन्दरगाह

- On July 8, 2025 early morning, a massive flash flood originating from China caused an unprecedented surge into the Bhotekoshi River
  - The Miteri (Friendship) Bridge near the Rasuwagadhi border crossing was washed away.
  - significant damage at the dry port, customs office, hydropower projects
  - vehicles and goods swept away
  - reports confirmed fatalities and missing persons
- caused by GLOF from a supraglacial lake on the Purepu Galcier- approx. 36 km u/s of Nepal-China border
- Lake area decreased from approx. 0.75 km<sup>2</sup> to 0.6 km<sup>2</sup>

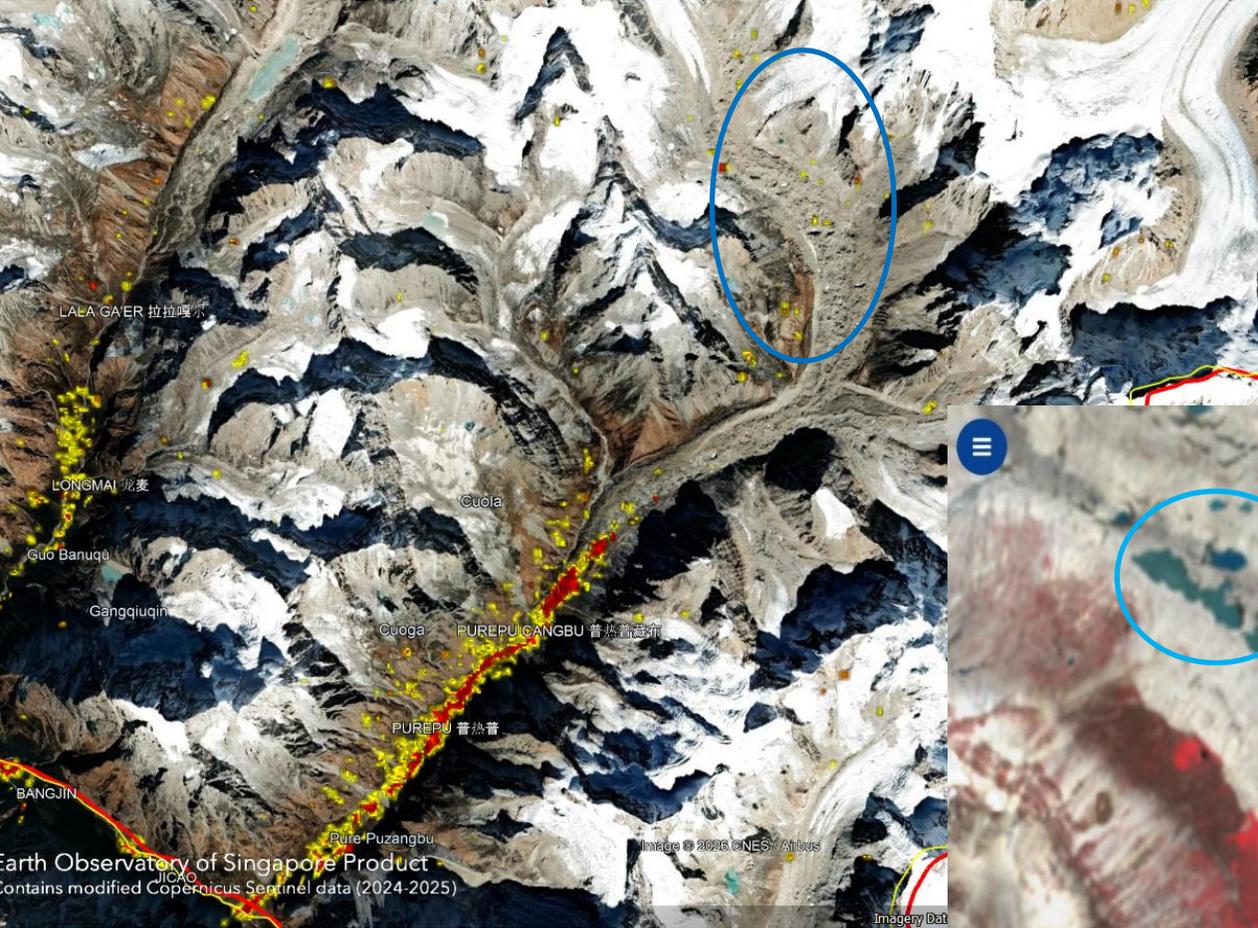
**Damage proxy map overlaid over google earth image from 2021 (no lake visible. Possibly originated in 2024)**

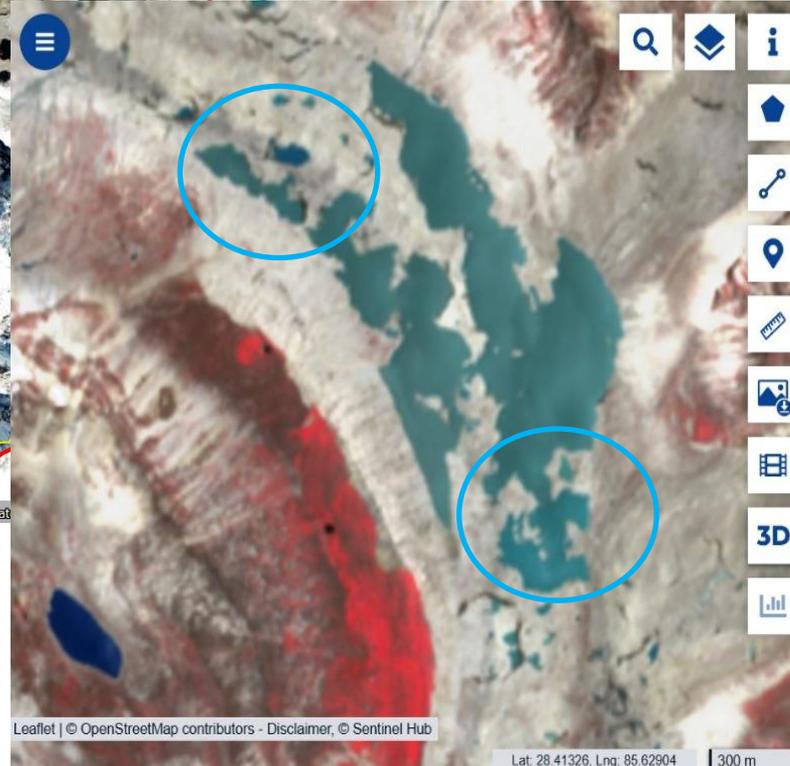
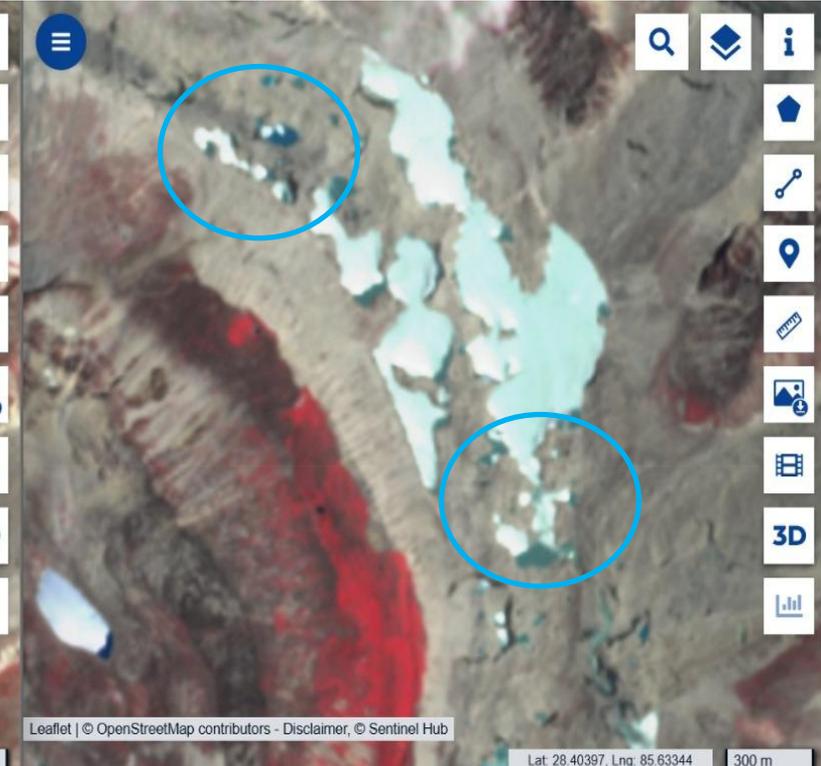
**Left Pre-event (July 5, 2025) and Right Post-event (July 8, 2025) Sentinel 2 images**

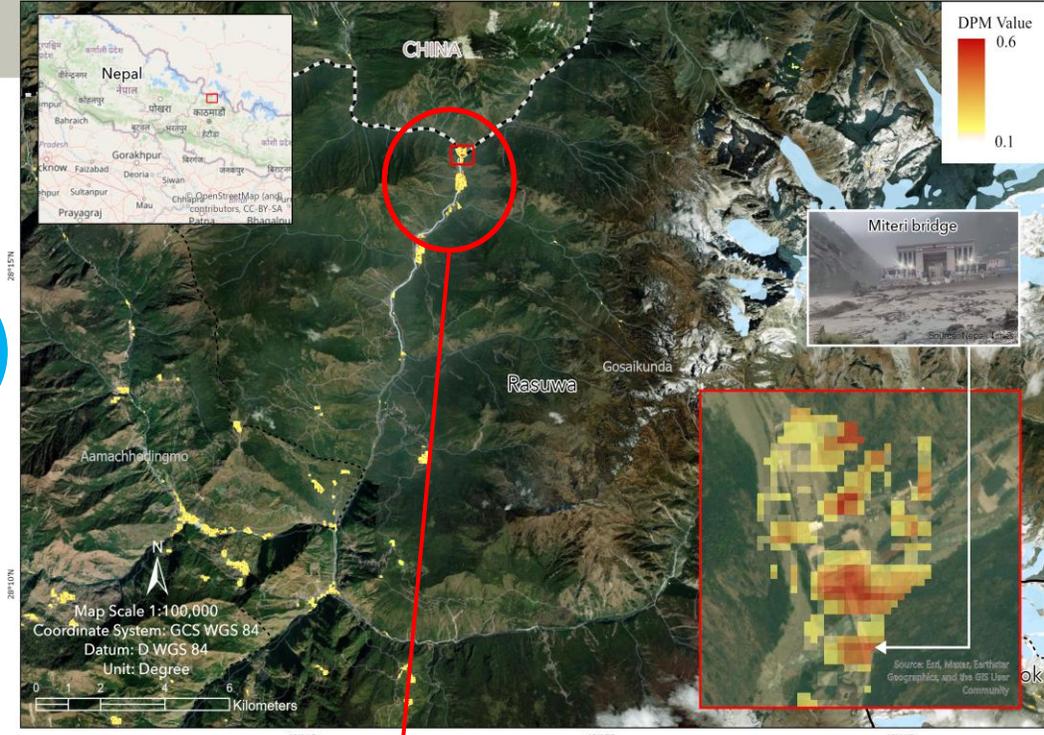
## DAMAGE PROXY MAP IN RASUWA DISTRICT, BAGMATI PROVINCE

As observed by Sentinel-1 images on 9 July 2025

This map serves as a guideline for potentially damaged areas within human settlements. However, accuracy may be limited, especially in over vegetated or mountainous terrain where some damage might not be detected by satellite imagery.

Satellite Image:  
 Pre-disaster : Sentinel-1, 15 and 27 June 2025  
 Post-disaster : Sentinel-1, 9 July 2025

**Sentinel 1 Damage Proxy Map Pre event: 15 & 27 June 2025 and Post: July 09 2025 (Source: GIC-AIT)**

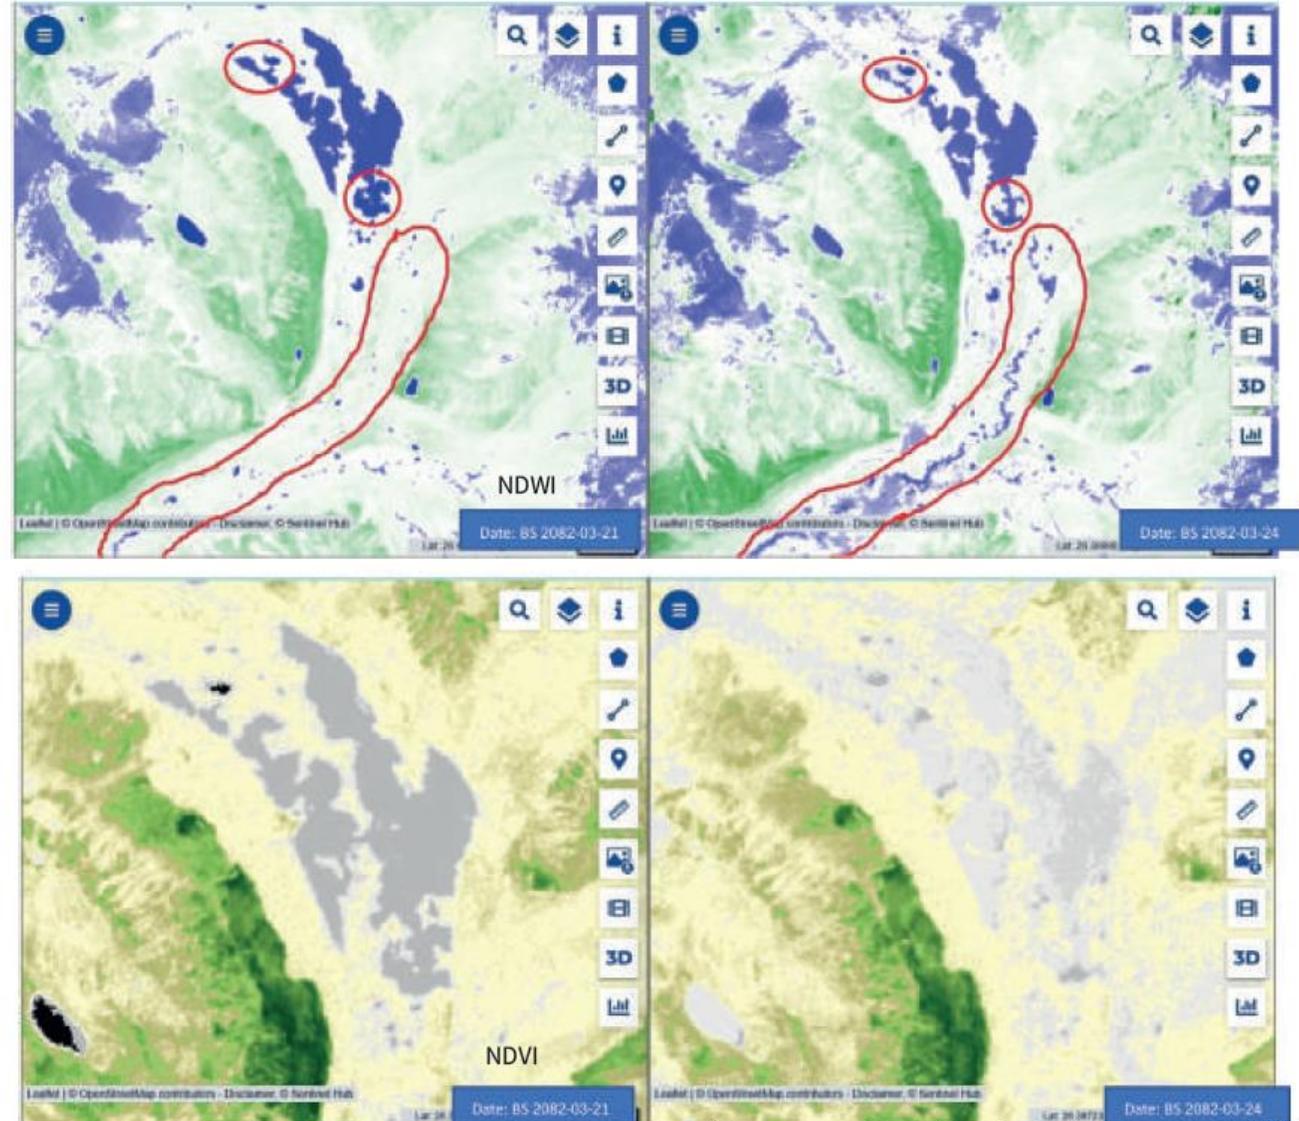
Sentinel-2 imagery reveals the rapid development and subsequent discharge of a supraglacial lake on the Purepu Glacier, located approximately 35 km upstream from the Nepal–China border post.

Beginning in March 2025, supraglacial ponds started to form and gradually expanded through mid-May. From that point onward, a sharp increase in surface water was observed, culminating in a lake area of approximately **0.525 km<sup>2</sup>** by 28 June (source:ICIMOD). Continued coalescence and expansion led to the formation of supraglacial lake measuring around **0.75 km<sup>2</sup>** by 07 July (source :DHM).

On 08 July, the lake had undergone a rapid decline in area, shrinking to approximately **0.6 km<sup>2</sup>** (source :DHM). Drainage features visible on the glacier surface that day indicate that at least part of the outburst occurred supraglacially, suggesting a complex drainage pathway contributing to the downstream flash flood.

(Source : Sentinel - 2 Imagery, DHM)

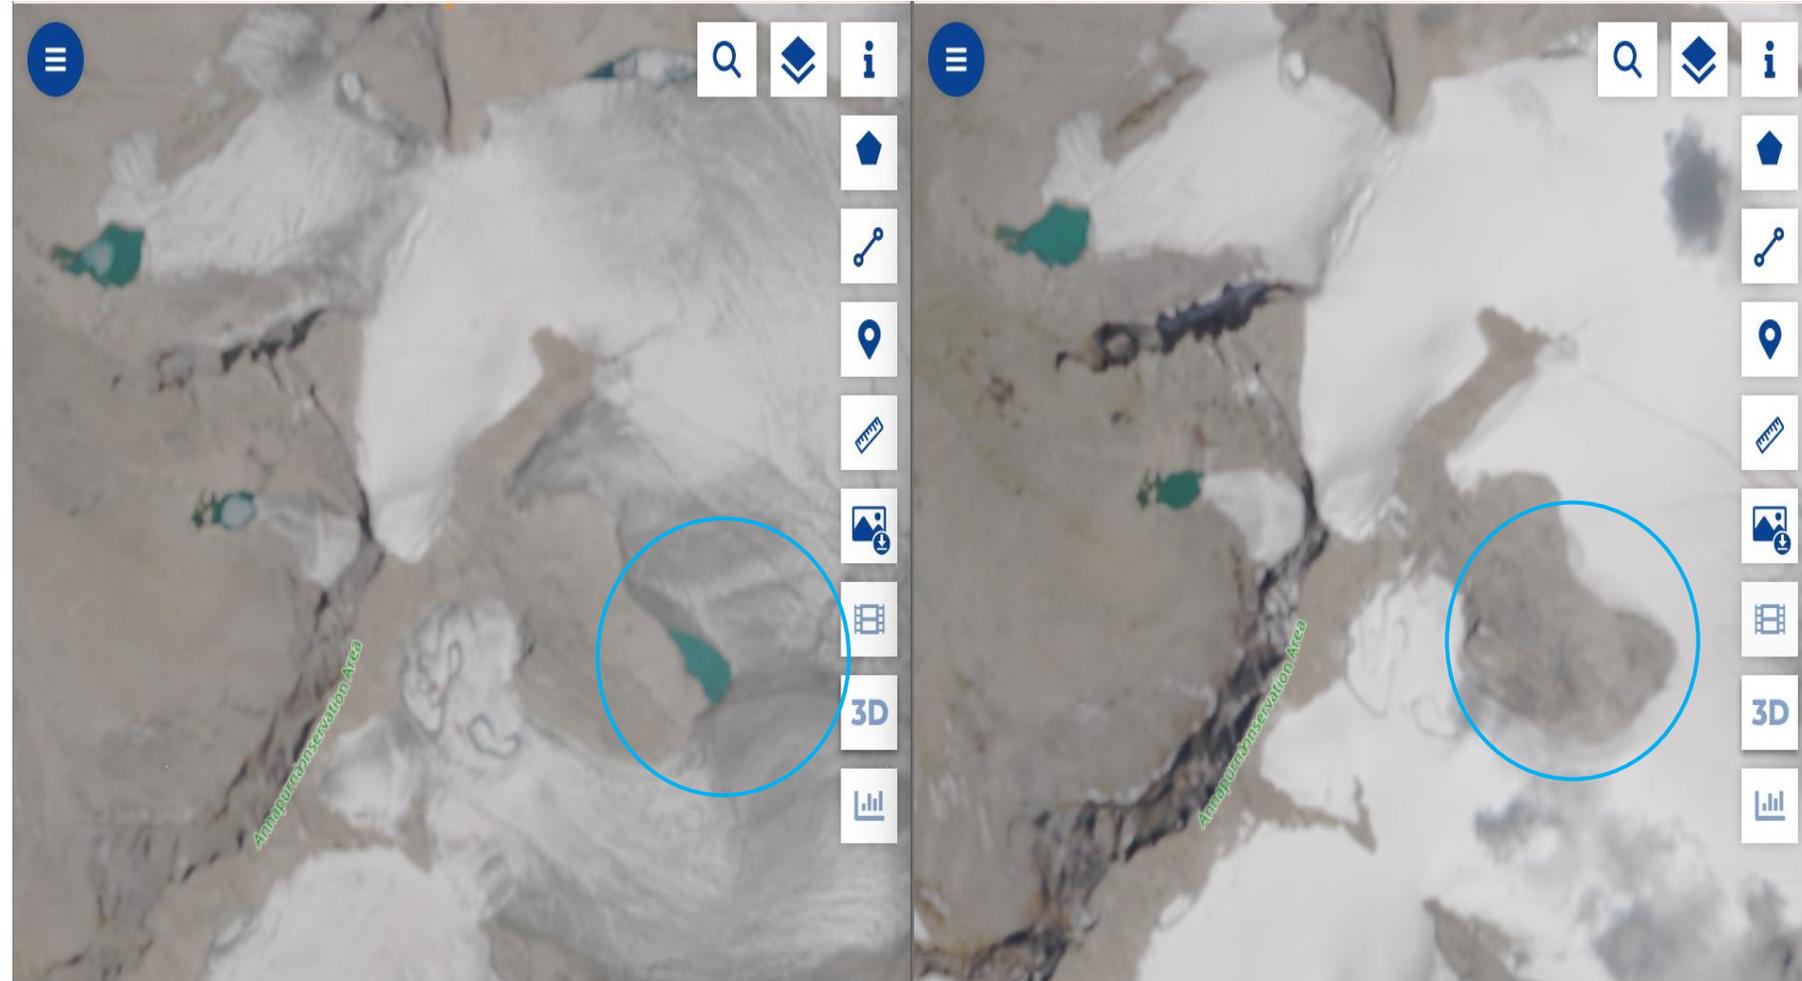
**Left Pre-event (July 8, 2025) and Right Post-event (August 7, 2025)  
Sentinel 2 images**

- Same afternoon of Rasuwa GLOF
- Date: July 8, 2025
- Location: Lomanthang, Mustang
- Damage: No casualties recorded

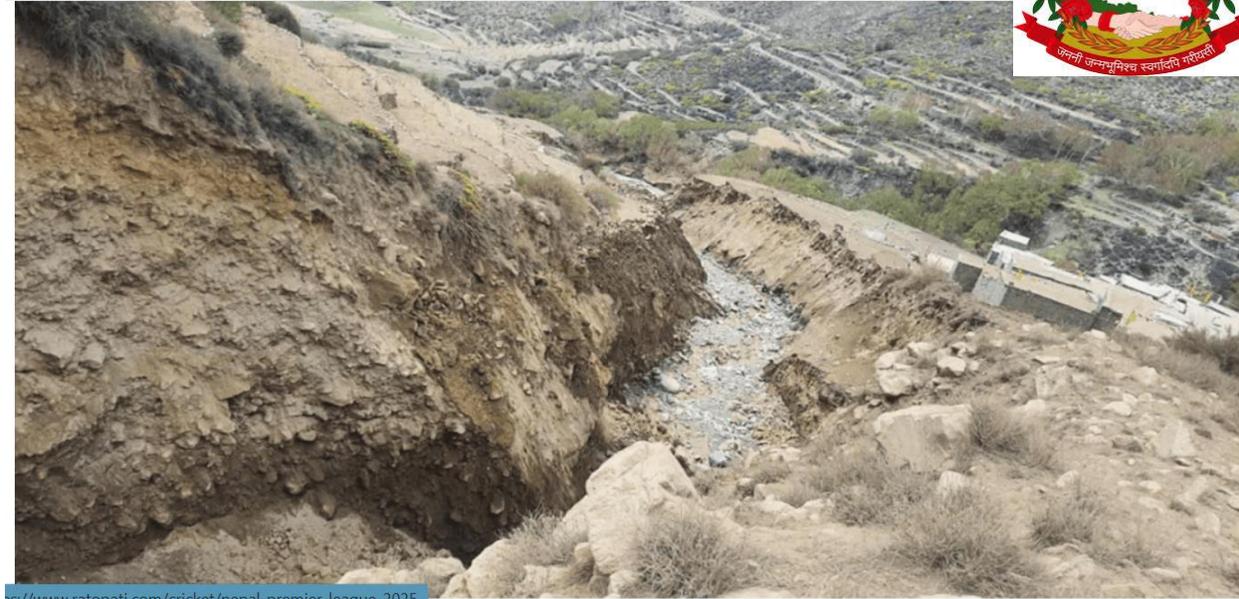
उत्तरी हुम्लाको तिलगाउँ पहिरोले क्षतविक्षत, नागरिक राहत र उद्धारको पर

- First recorded GLOF of 2025
- Date: May 14, 2025
- Location: Tilgaon, Namkha–6, Humla
- Damage: Bridge, hydropower station, and irrigation canal
- Displacement: 32–33 people from 18–19 households
- Casualties: No casualties

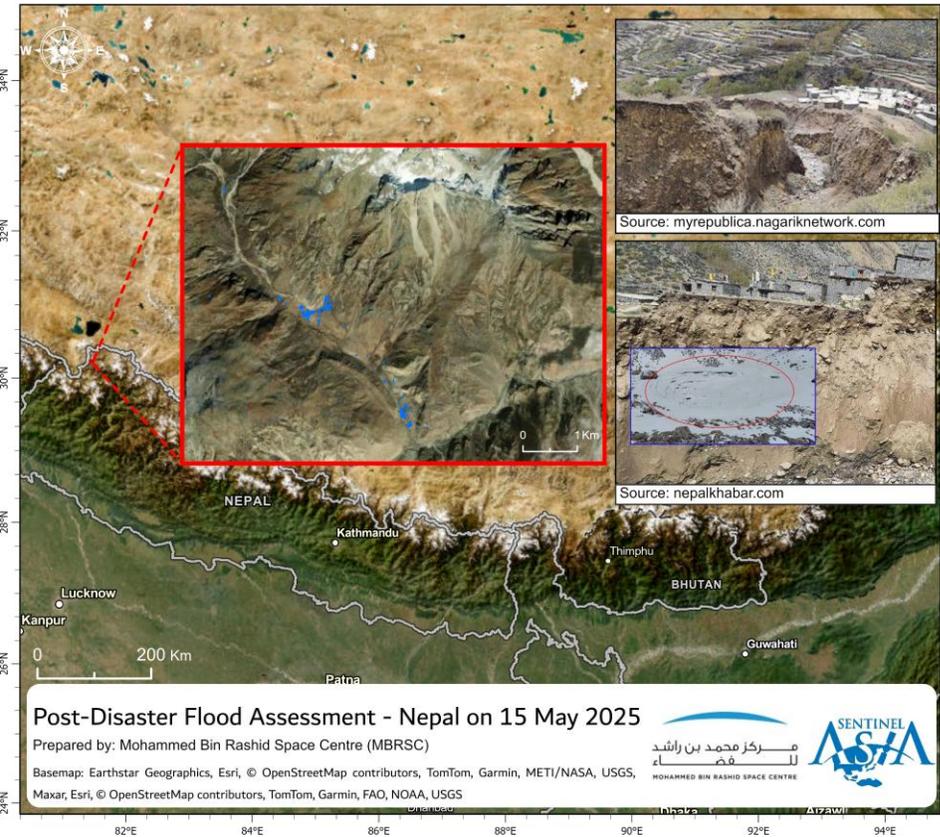
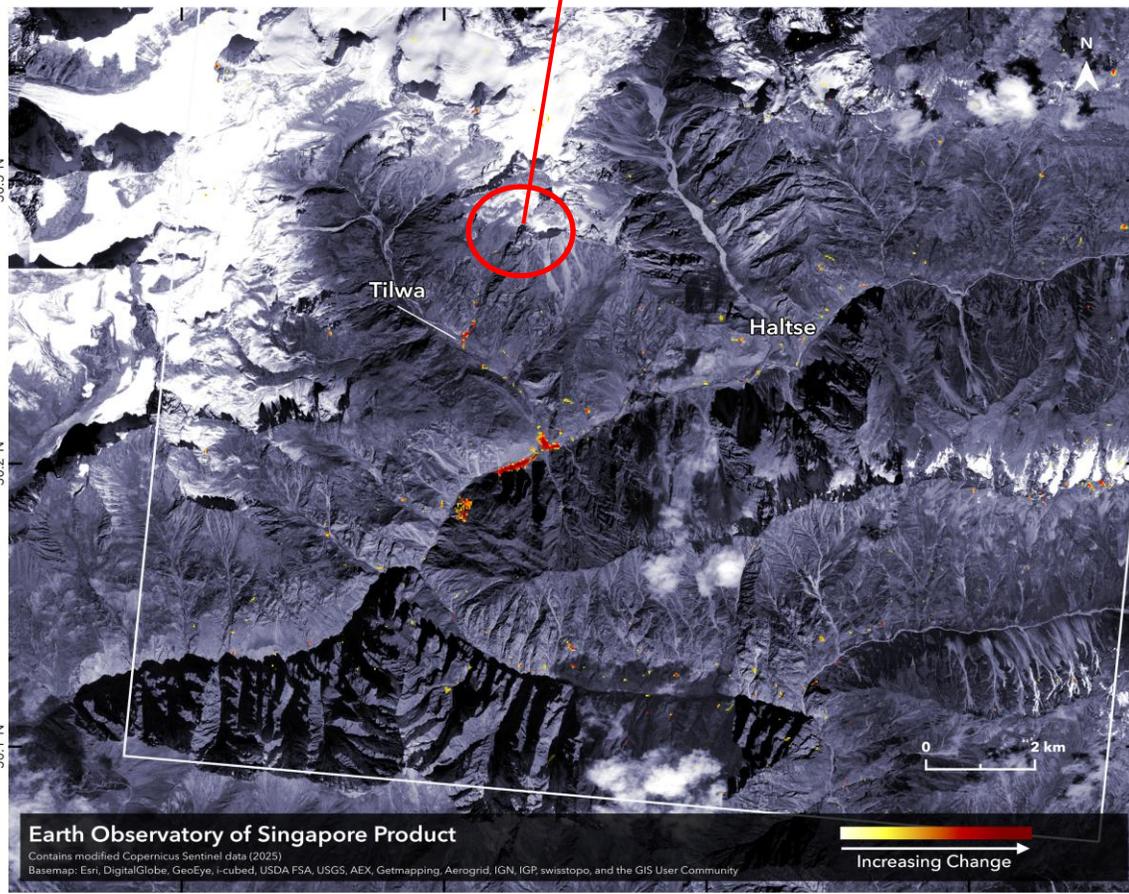
## EOS-RS Damage Proxy Map: Tilwa, Nepal, Glacial Lake Outburst Flood, 16 May 2025, v0.7

The Earth Observatory of Singapore - Remote Sensing Lab (EOS-RS) created this preliminary Damage Proxy Map (DPM) depicting areas that are likely damaged in Tilwa, Namkha Rural Municipality-6 of Humla, Nepal following a glacial lake outburst flood on 15 May 2025. This map was derived from synthetic aperture radar (SAR) images acquired by the Copernicus Sentinel-1 satellite operated by the European Space Agency (ESA) before (16 Jan 2025 to 4 May 2025) and after (16 May 2025) the event.

The map covers an area indicated by the white polygon. Damage is shown by colored pixels of 30m in size, where yellow to red indicates increasingly significant ground surface change before and after the event. Preliminary validation was conducted using news reports, with the cluster of red pixels validated using optical imagery to confirm the extent of the glacial lake outburst flood. This map should be used as a guidance to identify damaged areas, and may be less reliable over vegetated or mountainous areas. Scattered pixels over vegetated or mountainous areas may be false positives, and a lack of colored pixels over such areas may not mean no damage.

**Sentinel 1 image showing Deformation change between May 4, 2025 and May 16 2025 (Source: Earth Observatory of Singapore)**

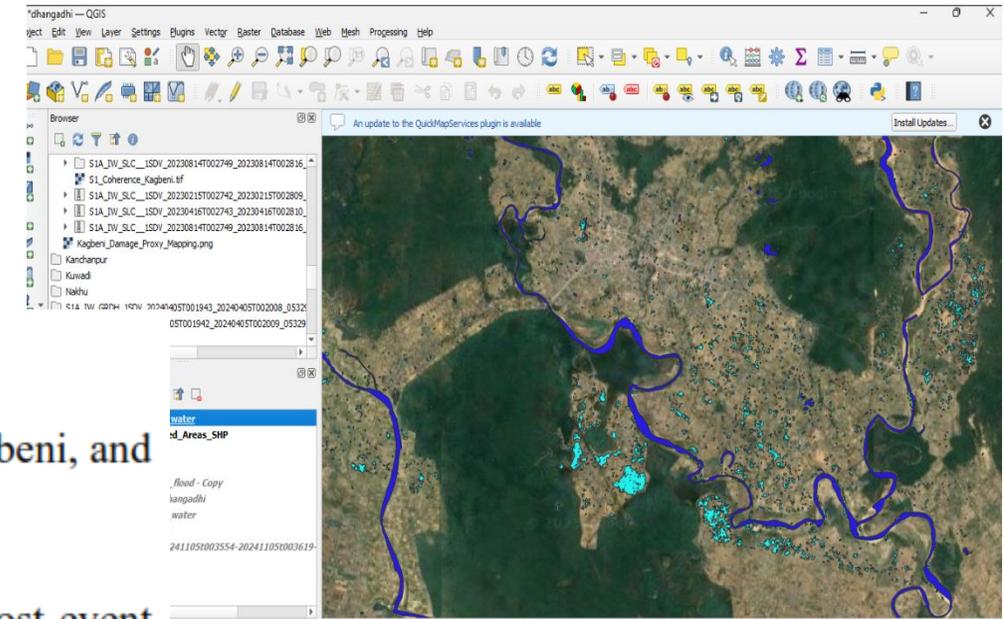
Showing the post-processing in QGIS for the Flood Inundation of Dhangadhi.

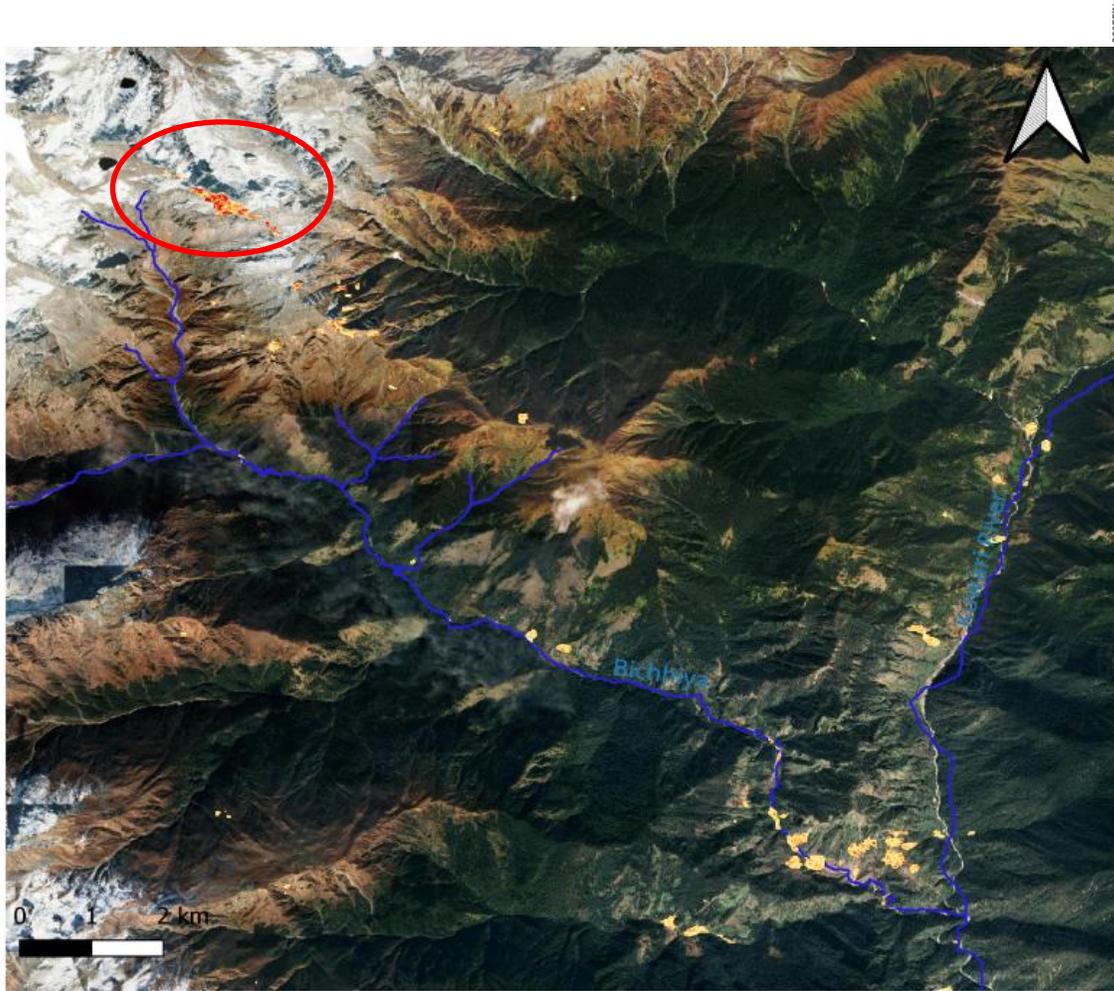
Damage proxy map from Sentinel 1 image showing Deformation change between July 15, 2025 and August 15 2025 (Source: DHM)

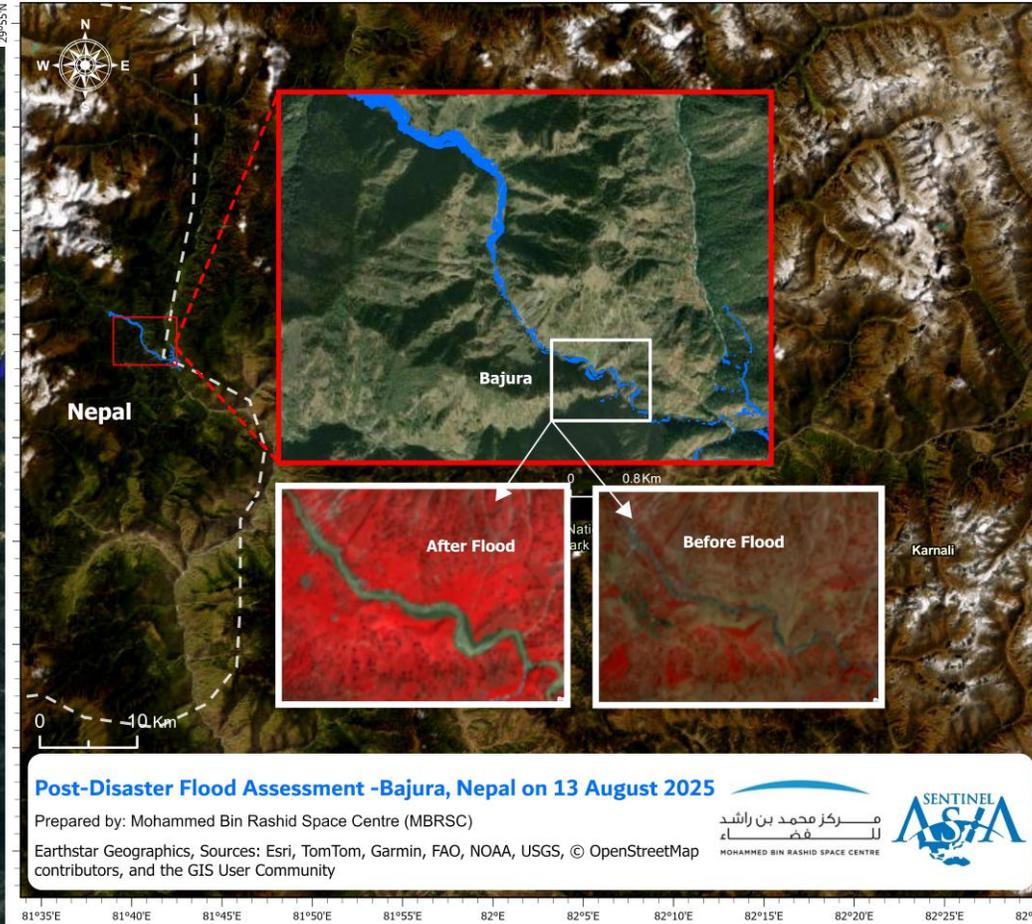
Post disaster assessment- Bajura (Source: MBRSC)

<b>Description</b>	The Mohammed Bin Rashid Space Centre (MBRSC) created this map to support post-disaster assessment efforts following the flood in Bajura District, Nepal, on 13 August 2025.
<b>Area of Interest (AOI)</b>	<b>Longitude:</b> 81.6469°E to 81.7089°E <b>Latitude:</b> 29.6838°N to 29.6380°N
<b>Methodology</b>	<b>Satellite Sensor Used:</b> Sentinel-2 (Multispectral imagery) <b>Methodology:</b> <ul style="list-style-type: none"> <li>• Comparison of pre- and post-disaster Sentinel 2 images</li> <li>• Change detection tool utilized based on NMDWI indices over both before and after image.</li> <li>• Flooded area extraction</li> </ul>
<b>Imagery Dates</b>	<b>Pre-Disaster:</b> 27-05-2025 <b>Post-Disaster:</b> 15-08-2025
<b>Impact Statistics</b>	Reference:

<b>11</b> Houses Swept Away
<b>Legend</b>	Flooded Areas

<b>Remark(s)</b>	The accuracy of this product has not been validated
