IWMI DAN Activities – 2015

Giriraj Amarnath, IWMI

2015 Floods in Sri Lanka

Mapping Floods in Southern Provinces - Sri Lanka using ALOS-2 PALSAR-2 Satellite Images

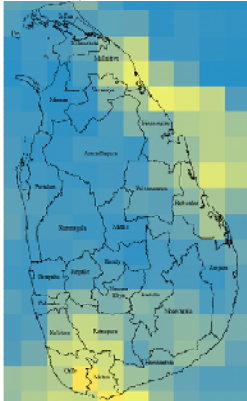
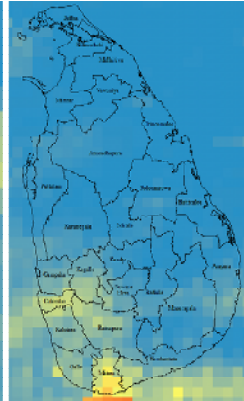
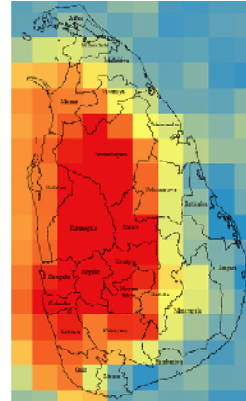
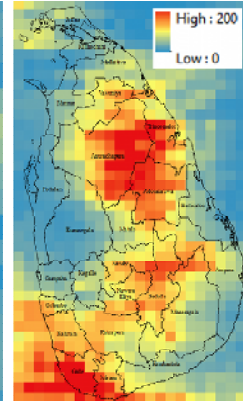
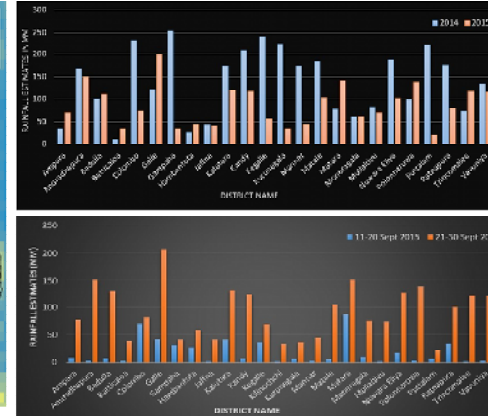
Accumulated rainfall Sept. (2014 and 2015) & Rainfall events from 11 - 30 Sept.

Satellite rainfall estimates from Global Precipitation Mission (GPM) and Tropical Rainfall Measuring Mission (TRMM) revealed extraordinary flooding in Sri Lanka caused by unusually strong monsoonal rainfall over the period 10 September - 30 September 2014.

The exceptional rainfall occurred mainly in the Southern, Northcentral and Uva Province of Sri Lanka. Massive flooding was reported in the districts of Kalutara, Ratnapura and in parts of Colombo, Galle and Matara. The accumulated rainfall was about 2 to 3 times as high as compared to the rainfall in the same period in 2014. For example, the southern provinces districts received an average accumulated rainfall of more than 100mm from 24 to 30 Sept. 2015 - compared to 75mm in 2014. At district level (Galle 198mm in 2015 vs. 121mm in 2014; Matara 142mm in 2015 vs. 78mm in 2014; Polonnaruwa 136mm in 2015 vs. 98mm in 2014).

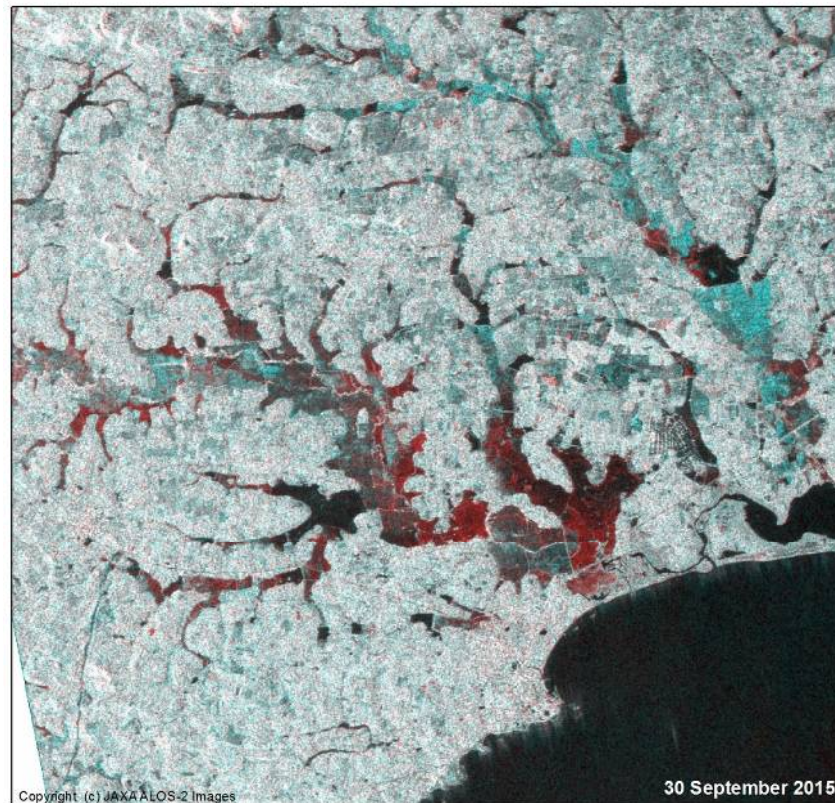
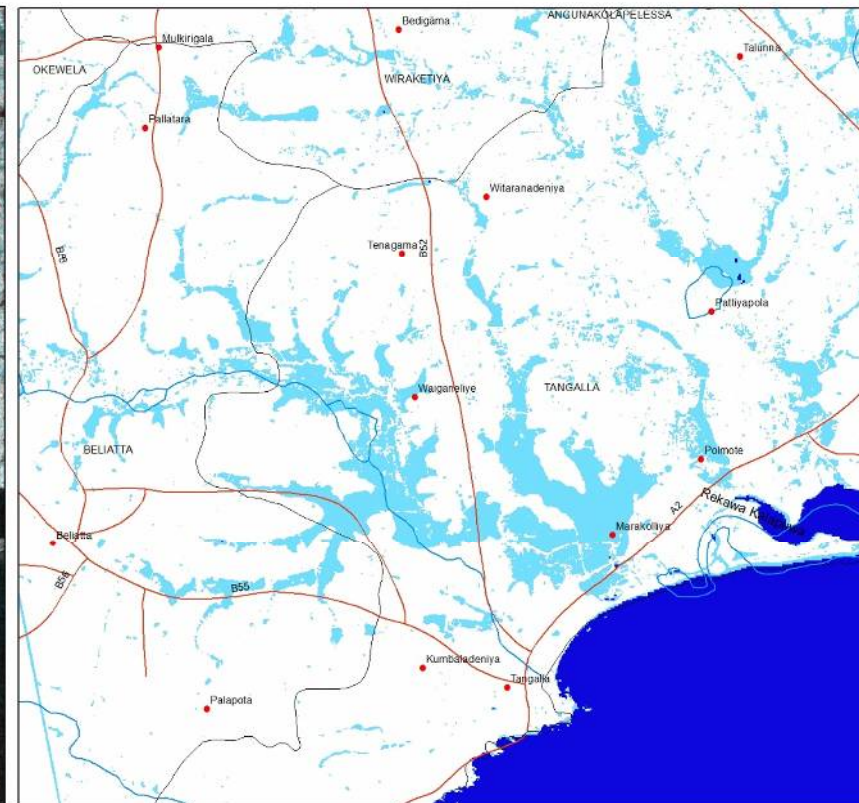
In total an area of 365 sq.km were inundated as viewed by ALOS PALSAR Satellite images taken on 30 September 2015. Approximately 150sq.km of paddy fields were flooded. The data sources from Survey Department of Sri Lanka was used for this analysis purpose. Major flooded affected divisions are Hambantota, Tanamalwila, Lunugamwehara, Tissamaharama, Wellawaya and Embilipitiya. In terms of major paddy field affected division's area Hambantota, Tanamalwila, Tissamaharama, Lunugamwehara and Tangalla. For the ALOS PALSAR-2 images taken on 1st October 2015, the affected districts are mainly the Matara and Galle. The divisions that includes Thihagoda, Kamburupitiya, Malimbada, Akuressa, Mulatiyana. In total 15 divisions were affected with a maximum inundation of 89sq.km of which paddy fields affected area is 47sq.km. The division with paddy field affected areas are Thihagoda, Malimbada, Kamburupitiya.

Before Disaster Image : ALOS-2 PALSAR 2
 Date : 18 Feb. 2015
 After Disaster Image : ALOS-2 PALSAR 2
 Date : 30 Sept.2015

The analysis excluded permanent water bodies including reservoir, tanks and ponds and this reflects only the inundation extent. Please note the surface water extent mapped has not yet been validated in the field.

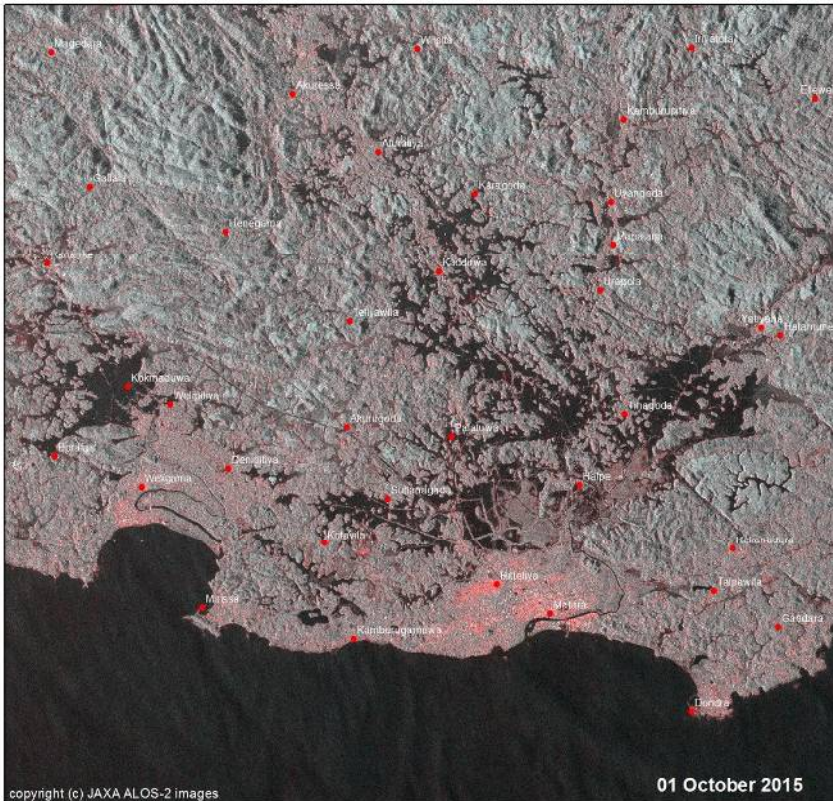
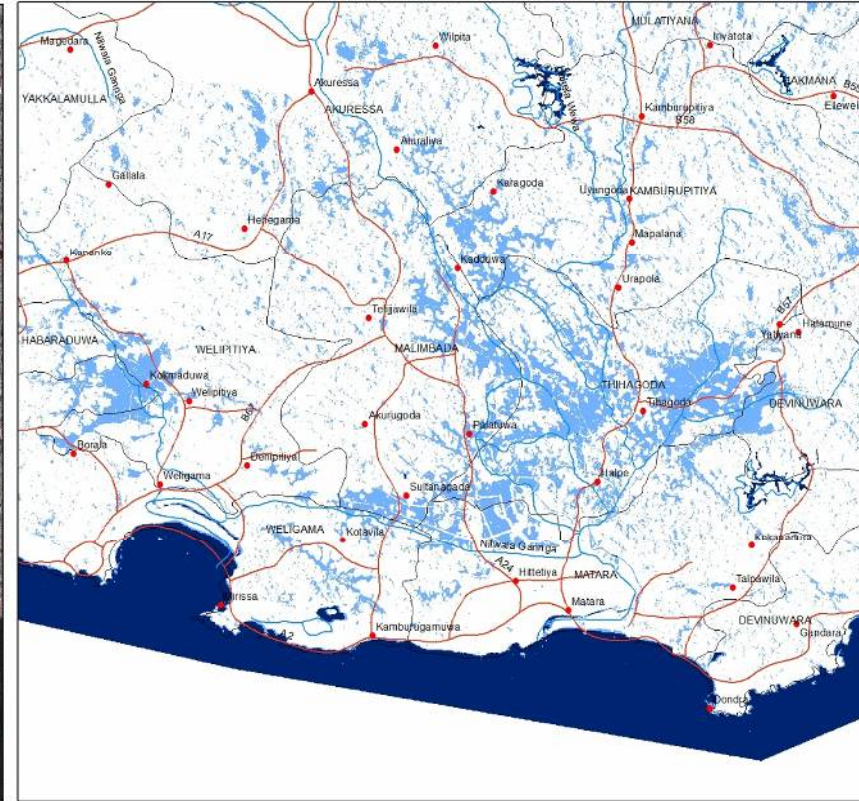
Mapping Floods in Southern Provinces - Sri Lanka using ALOS-2 PALSAR-2 Satellite Images

In total an area of 365 sq.km were inundated as viewed by ALOS PALSAR Satellite images taken on 30 September 2015. Approximately 150sq.km of paddy fields were flooded. The data sources from Survey Department of Sri Lanka was used for this analysis purpose. Major flooded affected divisions are Hambantota, Tanamalwila, Lunugamwehara, Tissamaharama, Wellawaya and Embilipitiya. In terms of major paddy field affected division's area Hambantota, Tanamalwila, Tissamaharama, Lunugamwehara and Tangalla. For the ALOS PALSAR-2 images taken on 1st October 2015, the affected districts are mainly the Matara and Galle. The divisions that includes Thihagoda, Kamburupitiya, Malimbada, Akuressa, Mulatiyana. In total 15 divisions were affected with a maximum inundation of 89sq.km of which paddy fields affected area is 47sq.km. The division with paddy field affected areas are Thihagoda, Malimbada, Kamburupitiya.

Before Disaster Image: ALOS-2 PALSAR 2
Date : 18 Feb. 2015
After Disaster Image : ALOS-2 PALSAR 2
Date : 01 October 2015

The analysis excluded permanent water bodies including reservoir, tanks and ponds and this reflects only the inundation extent. Please note the surface water extent mapped has not yet been validated in the field.

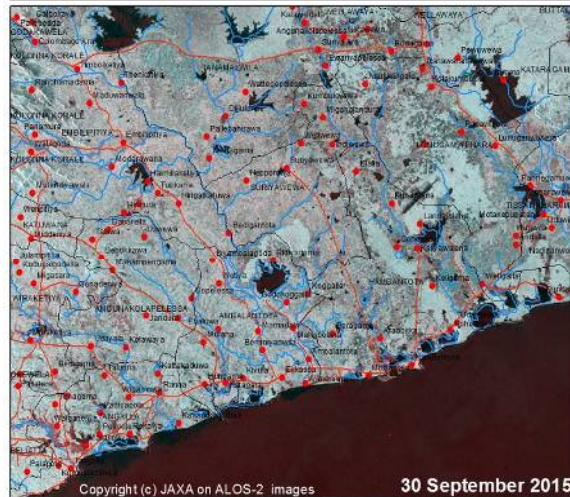
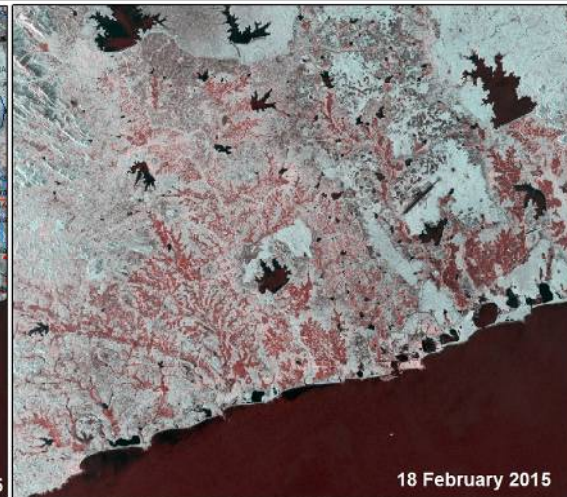
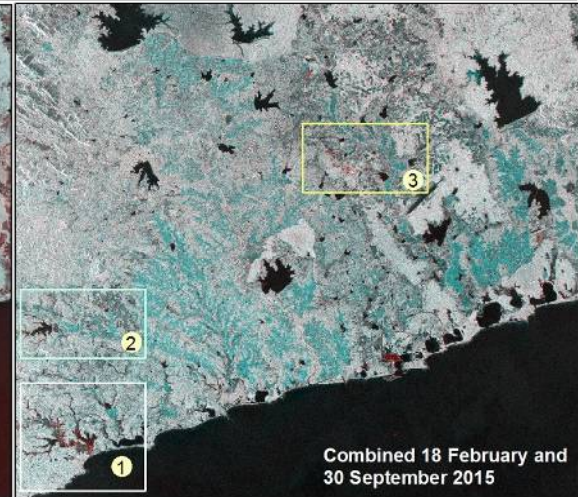
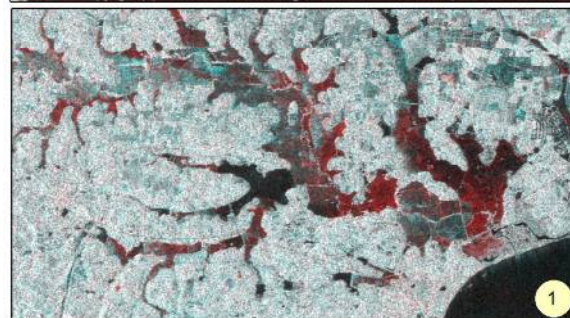
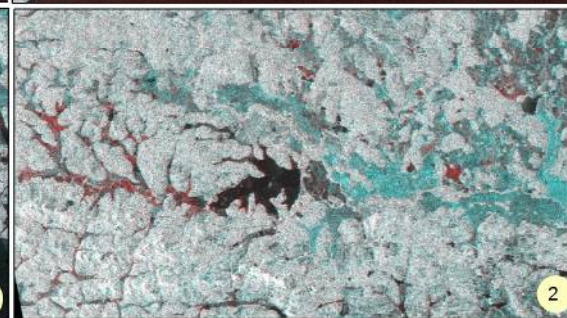
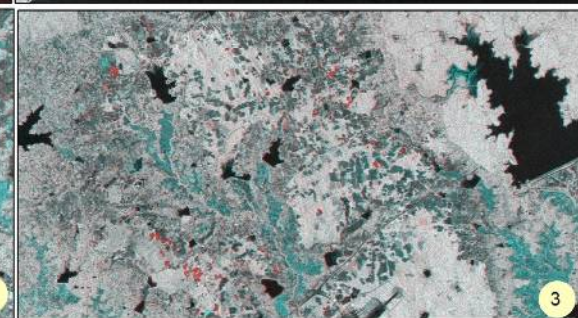
Mapping Floods in Southern Provinces - Sri Lanka using ALOS-2 PALSAR-2 Satellite Images

In total an area of 365 sq.km were inundated as viewed by ALOS PALSAR Satellite images taken on 30 September 2015. Approximately 150sq.km of paddy fields were flooded. The data sources from Survey Department of Sri Lanka was used for this analysis purpose. Major flooded affected divisions are Hambantota, Tanamalwila, Lunugamwehara, Tissamaharama, Wellawaya and Embilipitiya. In terms of major paddy field affected division's area Hambantota, Tanamalwila, Tissamaharama, Lunugamwehara and Tangalla. For the ALOS PALSAR-2 images taken on 1st October 2015, the affected districts are mainly the Matara and Galle. The divisions that includes Thihagoda, Kamburupitiya, Malimbada, Akussa, Mulatiyana. In total 15 divisions were affected with a maximum inundation of 89sq.km of which paddy fields affected area is 47sq.km. The division with paddy field affected areas are Thihagoda, Malimbada, Kamburupitiya.

Before Disaster Image : ALOS-2 PALSAR 2
Date : 18 Feb. 2015
After Disaster Image : ALOS-2 PALSAR 2
Date : 30 Sept 2015
Date : 01 Oct 2015

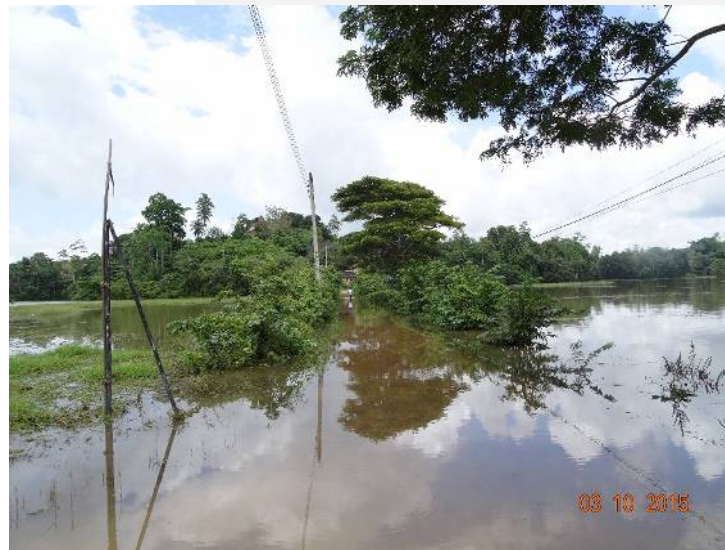
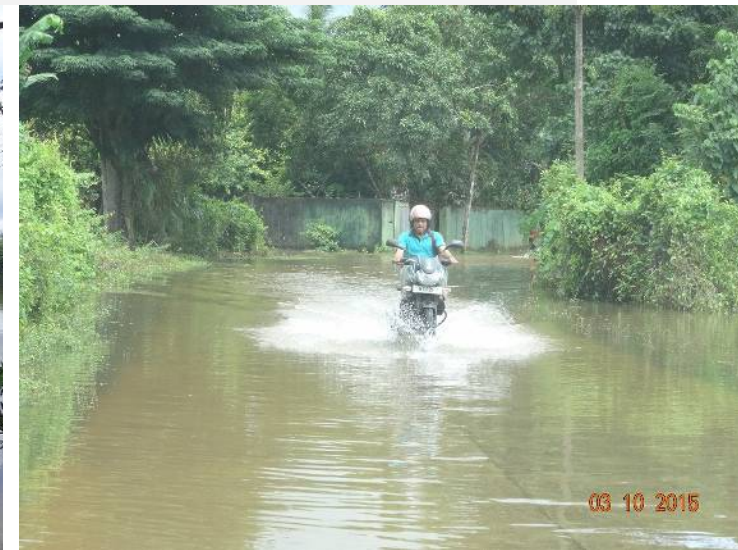
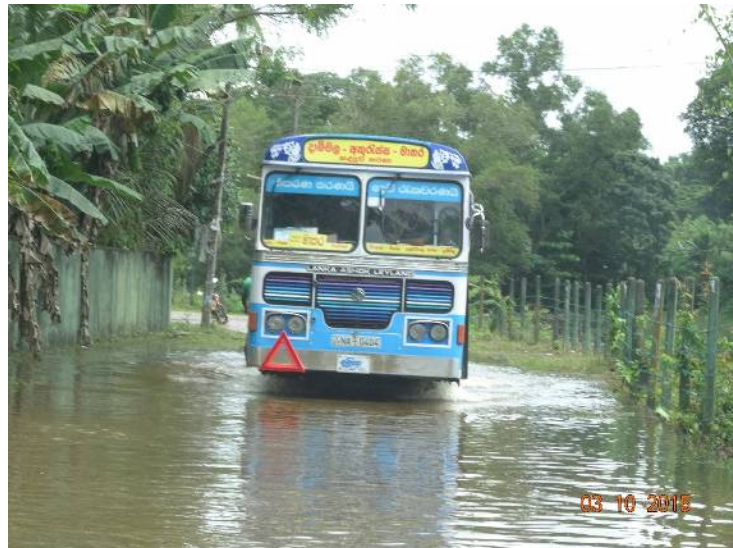
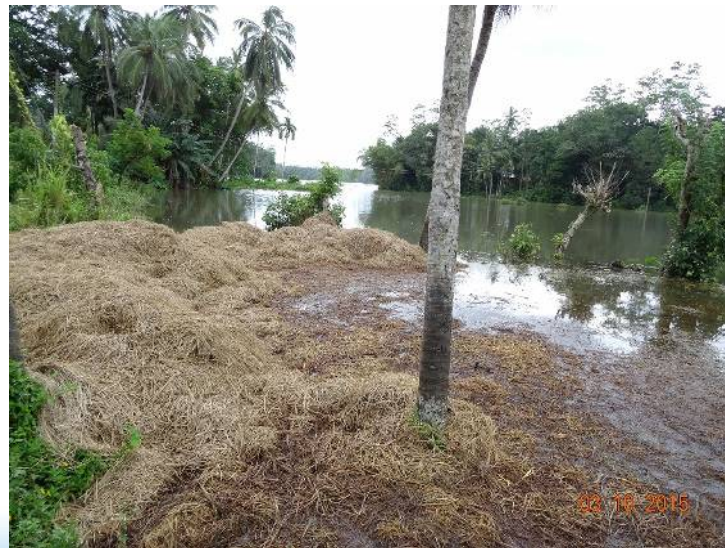
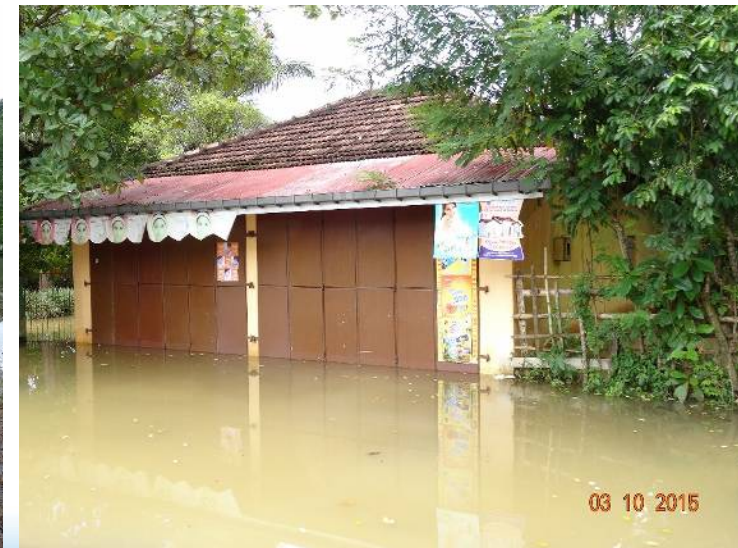
2015 Floods in southern province of Sri Lanka (Nilwala River)

District	2015 Sep 30 Image	Flood Area km ²	LU_Damage Area km ²
	DIVISEC		
Rathnapura	GODAKAWELA	1.57	0.63
Rathnapura	WELIGEPOLA	1.16	0.39
Rathnapura	KOLONNA KORALE	4.81	2.36
Rathnapura	EMBILIPITIYA	19.84	14.01
Monaragala	BUTTALA	14.95	0.34
Monaragala	WELLAWAYA	26.04	7.22
Monaragala	TANAMALWILA	60.50	17.50
Hambantota	KATUWANA	1.80	0.33
Hambantota	WIRAKETIYA	10.02	4.84
Hambantota	ANGUNAKOLAPELESSA	9.37	6.24
Hambantota	AMBALANTOTA	13.56	6.52
Hambantota	HAMBANTOTA	73.74	23.80
Hambantota	SURIYAWEWA	22.04	4.18
Hambantota	LUNUGAMWEHARA	49.36	12.35
Hambantota	TISSAMAHARAMA	31.52	15.80
Hambantota	TANGALLA	19.90	12.47
Hambantota	BELIATTA	4.19	2.87
Hambantota	OKEWELA	0.93	0.34

District	2015 Oct 01 Image	Flood Area km ²	LU_Damage Area km ²
	DIVISEC		
Galle	AKMEEMANA	0.65	0.32
Galle	BOPE-PODDALA	0.64	0.46
Galle	YAKKALAMULLA	1.67	0.37
Galle	HABARADUWA	4.41	1.87
Matara	MULATIYANA	6.89	1.71
Matara	AKURESSA	7.64	2.92
Matara	MALIMBADA	9.44	6.10
Matara	KAMBURUPITIYA	12.23	5.90
Matara	HAKMANA	2.51	0.63
Matara	DIKWELLA	2.26	0.92
Matara	THIHAGODA	17.96	13.20
Matara	WELIGAMA	6.42	4.15
Matara	MATARA	6.34	3.12
Matara	DEVINUWARA	3.90	2.06
Matara	WELIPITIYA	5.61	3.34

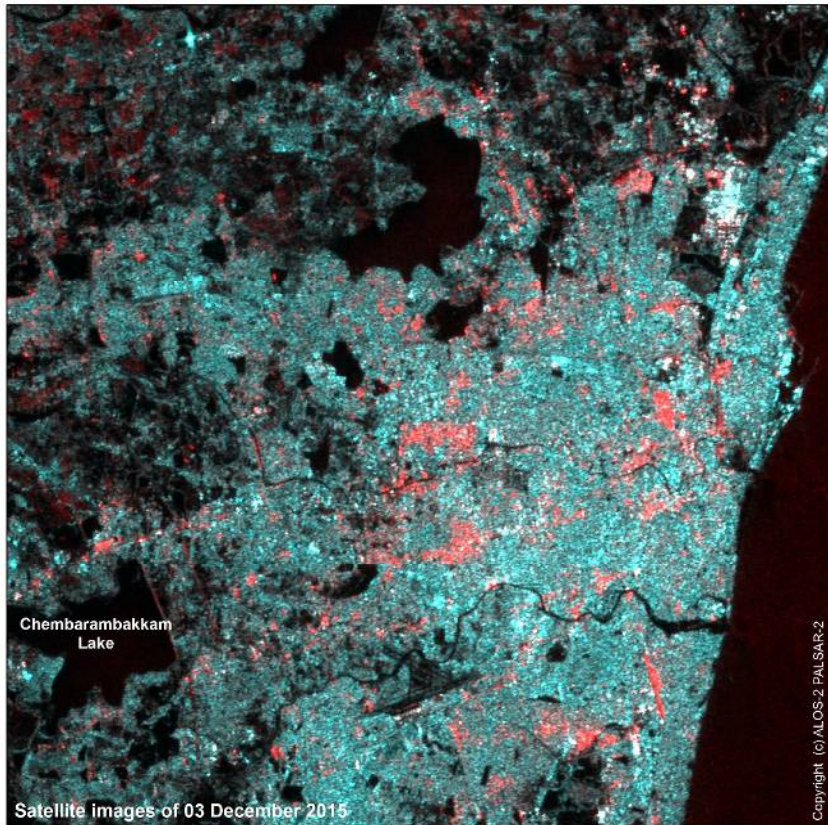
Second Wave of Catastrophic Flooding in Chennai (Tamil Nadu), India

IWMI in cooperation with Sentinel Asia In particular Japan Aerospace Exploration Agency (JAXA) activated disaster charter for December 03, 2014 at 16:43hours using ALOS-2 PALSAR-2 images. The images clearly highlight areas of standing water in and around Chennai city. Approximately 25km² is still inundated by extreme rainfall between Nov 30 and Dec 2, 2015.

The maps can be very well used by NDRF, Flood Control Room and aid agencies to understand the areas where floods are receding and standing water to prepare emergency response maps in support of relief and rescue operations.

Flood Date : 03 December 2015
Satellite Image : ALOS-2 PALSAR-2

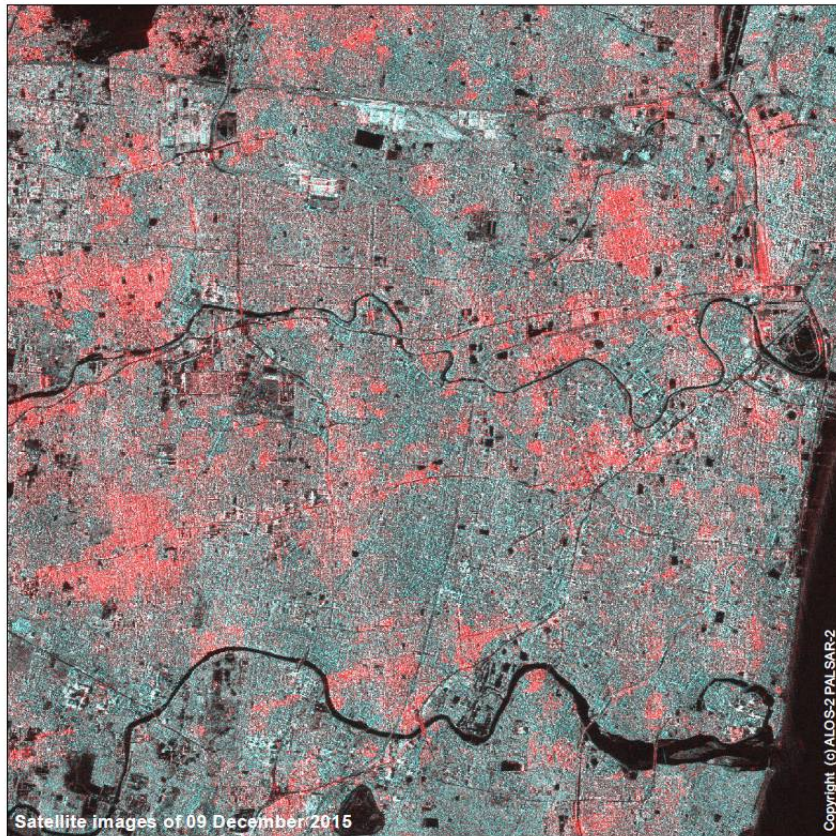
Second Wave of Catastrophic Flooding in Chennai (Tamil Nadu), India

IWMI in cooperation with Sentinel Asia in particular Japan Aerospace Exploration Agency (JAXA) activated disaster charter for December 03, 2014 at 16:43hours using ALOS-2 PALSAR-2 images. The images clearly highlight areas of standing water in and around Chennai city. Approximately 25sq.km is still inundated by extreme rainfall between Nov 30 and Dec 2, 2015. Further the JAXA made new satellite acquisition for December 09, 2015 to get update on the flood condition. The areas around Chennai namely Thiruvallur, Ponneri are still with flood water.

- Flood Date : 09 December 2015
Satellite Image : ALOS-2 PALSAR-2
- 09 Dec. 2015 (Post Disaster)
 - River/Permanent water
 - Roads
 - Railways
 - Waterways
 - Ocean
 - District boundary
 - Places

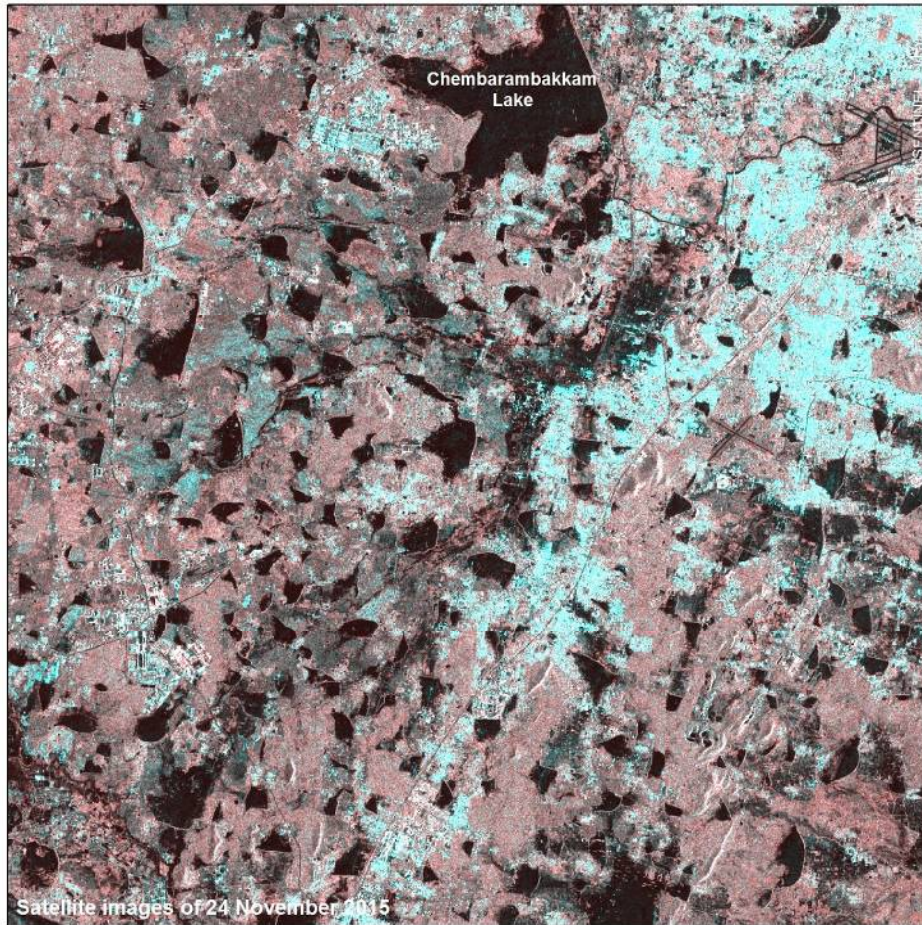
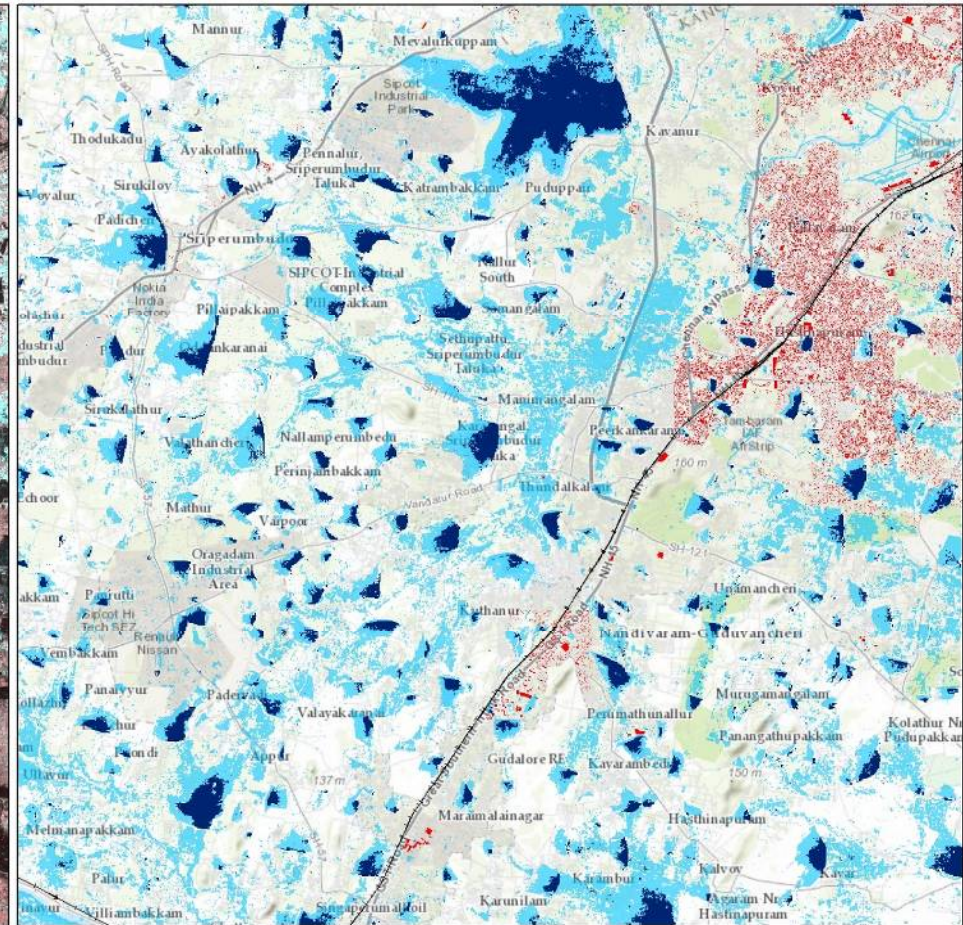
First Waves of Catastrophic Flooding in Chennai (Tamil Nadu), India

To determine the extent of severity in the flood affected districts in Tamil Nadu, Sentinel-1 satellite images referring to 24th November 2015 were obtained from European Space Agency to map the inundated areas. Dark areas in black referring to standing water. In total an estimated 567 sq.km were inundated of which the severely affected districts includes Cuddalore (360 sq.km), Nagapattinam (113 sq.km), Ariyalur (70 sq.km) and Perambalur (24 sq.km). Agriculture damage assessment at district level are Cuddalore (307 sq.km), Nagapattinam (82 sq.km), Ariyalur (50 sq.km) and Perambalur (16 sq.km).

- Flood Date : 24 November 2015
 Satellite Image : SENTINEL-1
- 24 Nov. 2015 (Post Disaster)
 - River/Permanent water
 - Roads
 - Railways
 - Waterways
 - Urban / Land Use
 - District boundary
 - Places

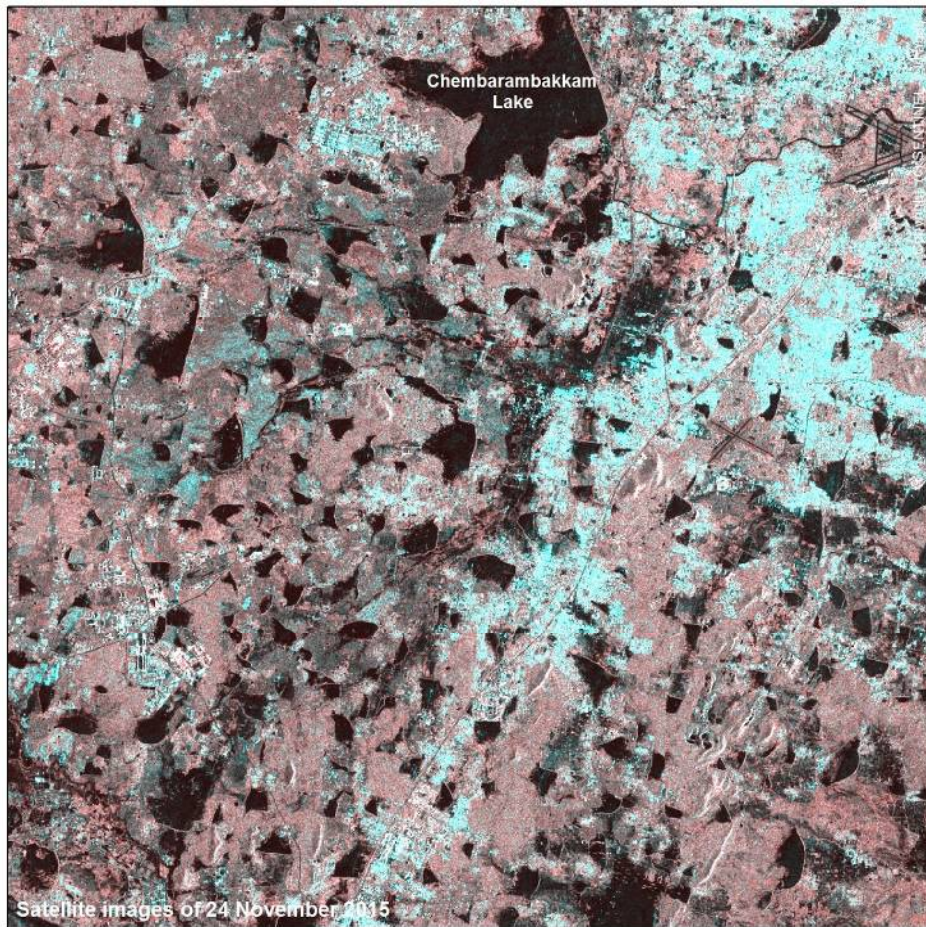
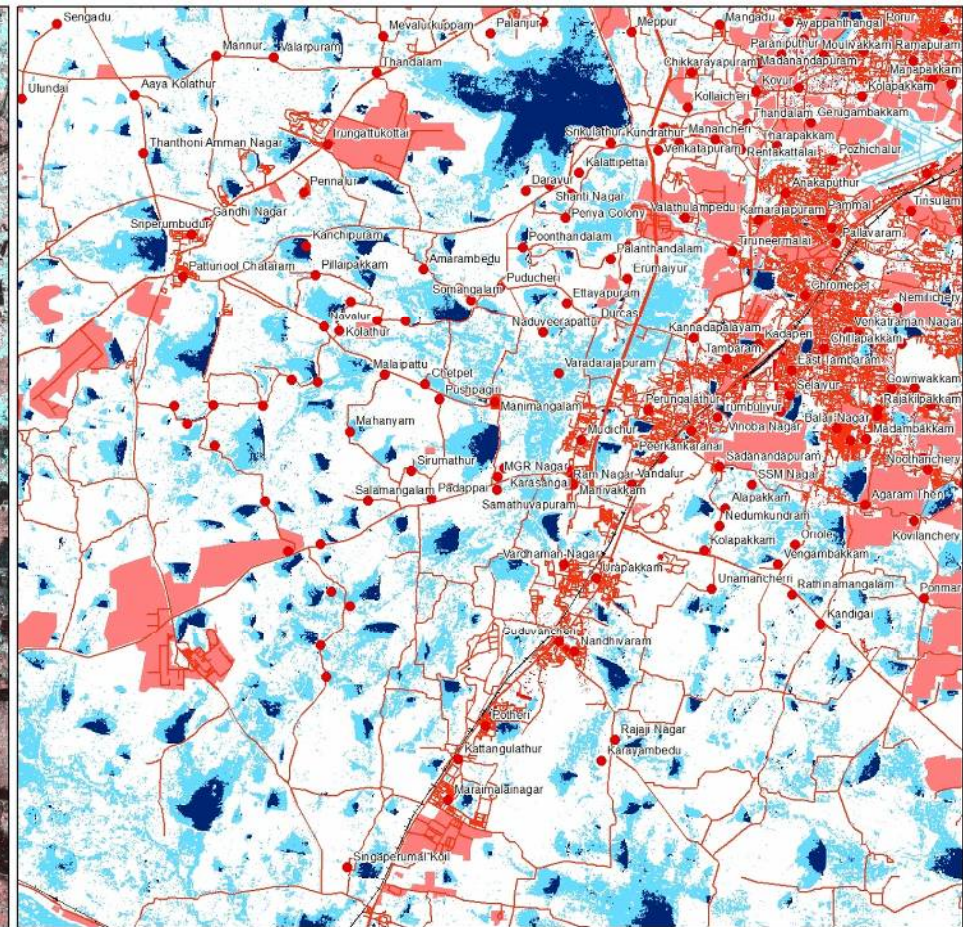
Satellite images of 24 November 2015

To determine the extent of severity in the flood affected districts in Tamil Nadu, Sentinel-1 satellite images referring to 24th November 2015 were obtained from European Space Agency to map the inundated areas. Dark areas in black referring to standing water. In total an estimated 567 sq.km were inundated of which the severely affected districts includes Cuddalore (360 sq.km), Nagapattinam (113 sq.km), Ariyalur (70 sq.km) and Perambalur (24 sq.km). Agriculture damage assessment at district level are Cuddalore (307 sq.km), Nagapattinam (82 sq.km), Ariyalur (50 sq.km) and Perambalur (16 sq.km).

- Flood Date : 24 November 2015
- Satellite Image : SENTINEL-1
- 24 Nov. 2015 (Post Disaster)
- River/Permanent water
- Roads
- Railways
- Waterways
- Urban / Land Use
- District boundary
- Places
