Ministry of Agriculture and Rural Development
VIETNAM DISASTER MANAGEMENT AUTHORITY

**APPLICATION OF REMOTE SENSING
AND SPACE TECHNOLOGY FOR
DISASTER MANAGEMENT IN VIETNAM**

Thailand, Nov 2019

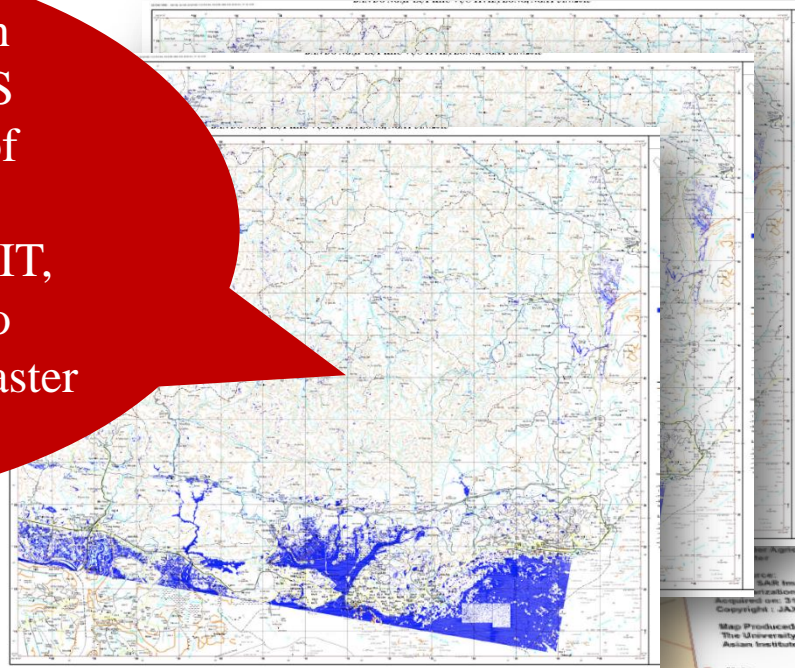
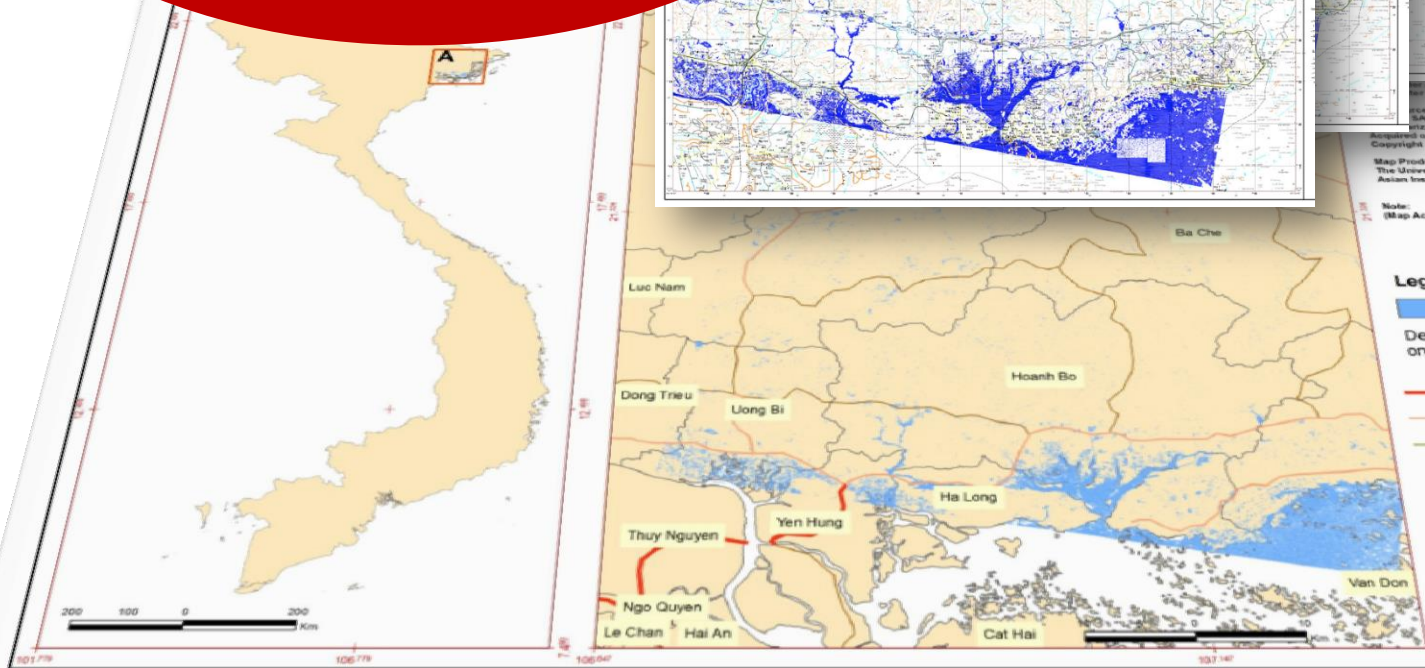
Inundation Map had been produced by National RS Department of Ministry of Natural Resources and Environment (MONRE), AIT, UNOSAT for reporting to National Committee for Disaster Prevention and Control

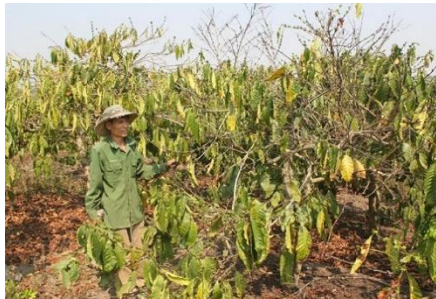
Mức độ cảnh báo khô hạn	Ngưỡng giá trị TVDI	Thang màu cảnh báo
Rất khô hạn	0,7 – 1	
Khô hạn	0,55 – 0,7	
Có nguy cơ khô hạn	0,4 – 0,55	
Chưa khô hạn	< 0,4

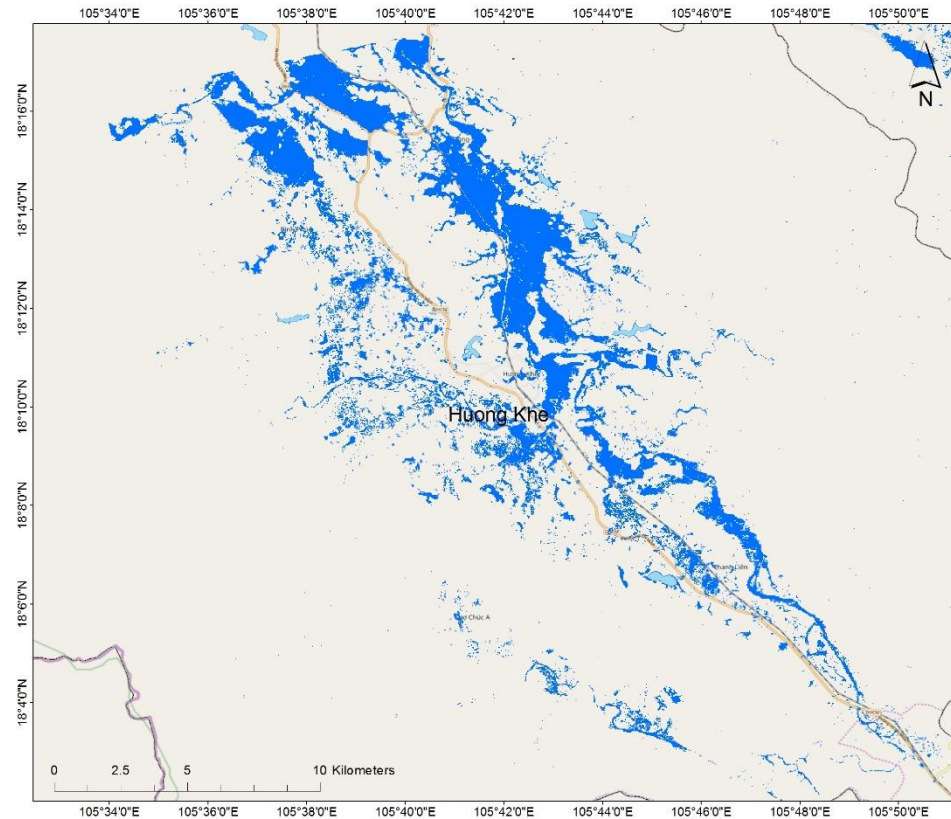
DETECTED WATER IN HUONG KHE DISTRICT, HA TINH PROVINCE, VIETNAM (16 OCT 2016)

Satellite/ Sensor: ALOS-2/ PALSAR-2
Date: 16 Oct 2016
© JAXA

This map shows detected water area in Huong Khe district, Quan Binh province, Vietnam as observed from ALOS-2 data on 16 October 2014. Image processing using thresholding technique was applied to extract the water area.

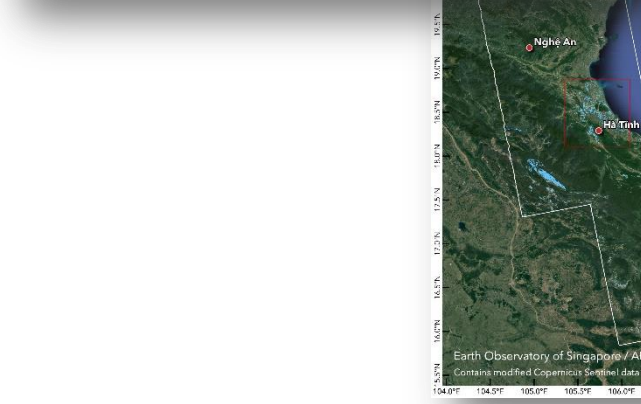
ARIA-SG Flood Proxy Map: Vietnam Floods, 6 Sep 2019, v0.1

This preliminary map shows areas that are likely flooded (shown by light blue pixels of 30 m in size) in central Vietnam due to heavy rains brought by Tropical Storm Poca, a week before, and Tropical Depression Kajiki. The map extents are indicated by the white polygon. This map should be used as a guidance to identify areas that are likely flooded, and is less reliable over urban and vegetated areas.

Derived from synthetic aperture radar data acquired by the Copernicus Sentinel-1 satellites operated by the European Space Agency (ESA) before (3 Sep) and during (6 Sep) the event. Analyzed by the ARIA-SG team at the Earth Observatory of Singapore (EOS) using the ARIA-SG system originally developed by NASA JPL and Caltech. Data processing used an AWS Open Dataset of Copernicus Sentinel-1 data for the Asia region (<https://registry.opendata.aws/sentinel-1-cosmos-pds/>).

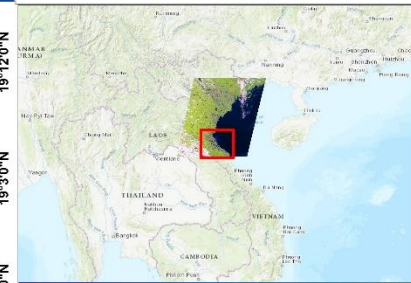
DETECTED WATER IN HA TINH AND NGHE AN, VIETNAM

Satellite image : Resourcesat-2A AWiFS, 07 Sep 2019
 Post-disaster : Resourcesat-2A AWiFS, 07 Sep 2019
 Copyright : © ISRO (2019) - All rights reserved.

This map shows detected water areas from heavy rain from 01 to 05 September, which has affected in Ha Tinh and Nghe An provinces, Vietnam. Note that detected water may also include water in paddy field areas.
