# Outburst of the Thorthormi Subsidiary Lake II on June 20, 2019

Wangchuk Namgay  
Geologist

Cryosphere Services Division ,NCHM  
Bhutan

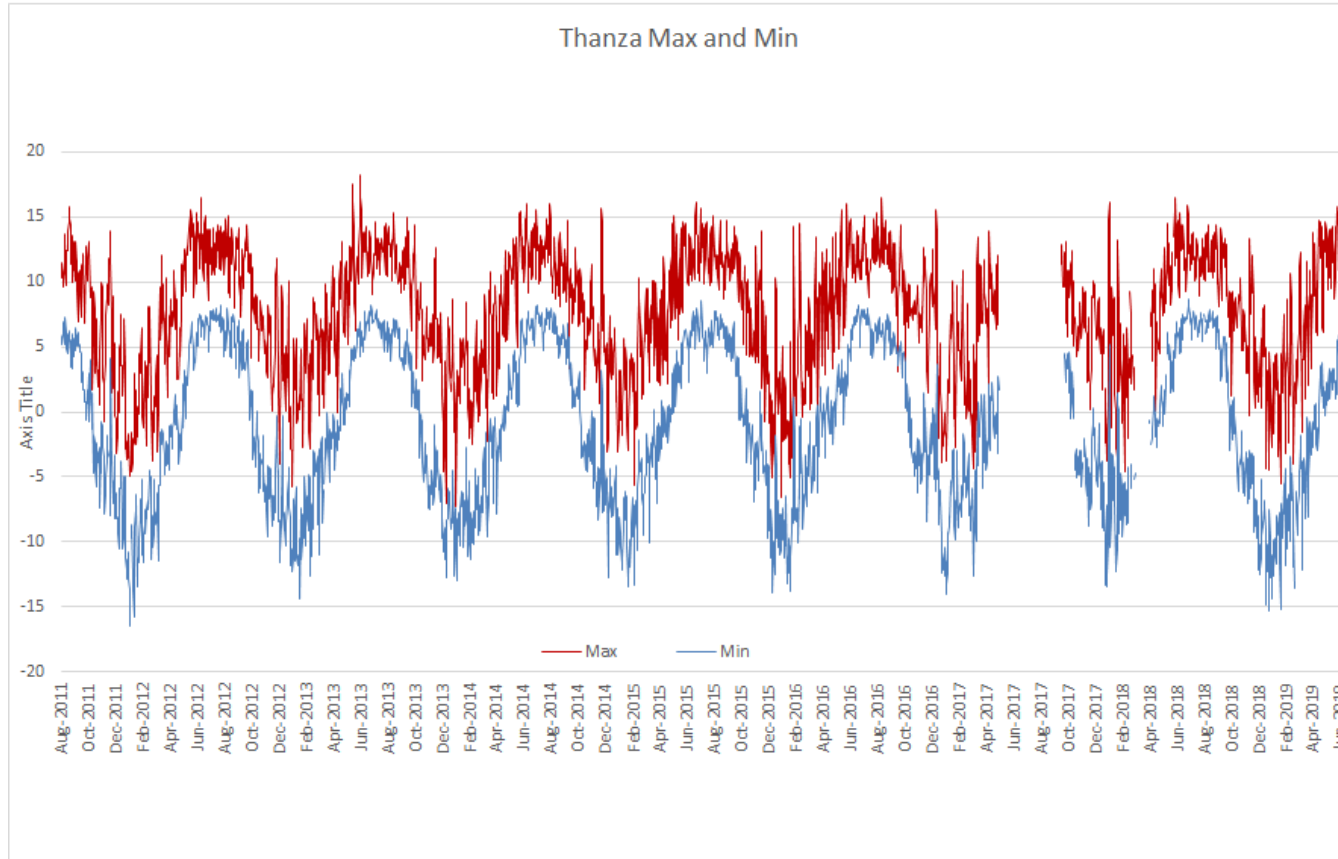
Figure 11. Daily Maximum and Minimum temperature of Thanza Station, Lunana.

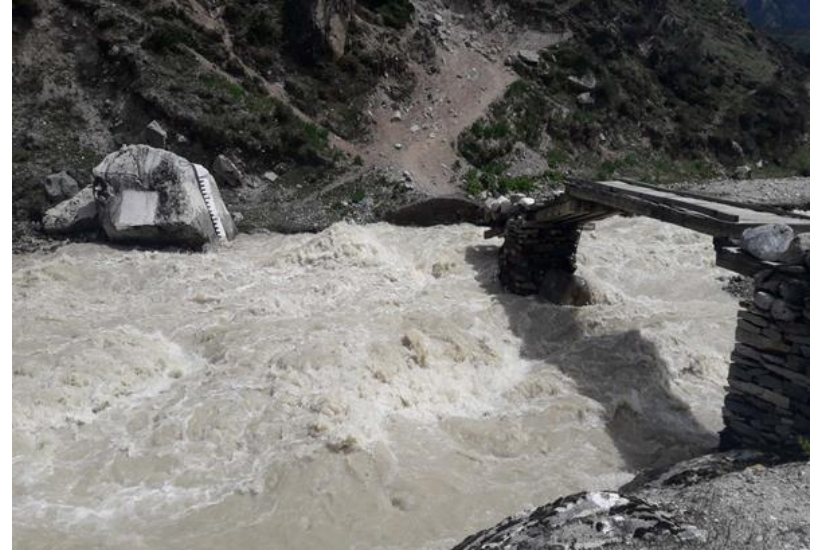
- NO MAJOR IMPACTS REPORTED.
- The wooden bridge connecting Thanza and Tenchey village damaged and access to the bridge is cut-off.
- Volume of water discharged was not significant enough to cause any downstream flooding.

*Figure 12. Bridge damaged by the Flood*
