# Lombok Indonesia

Damage Mapping

Date: 8/9/2018

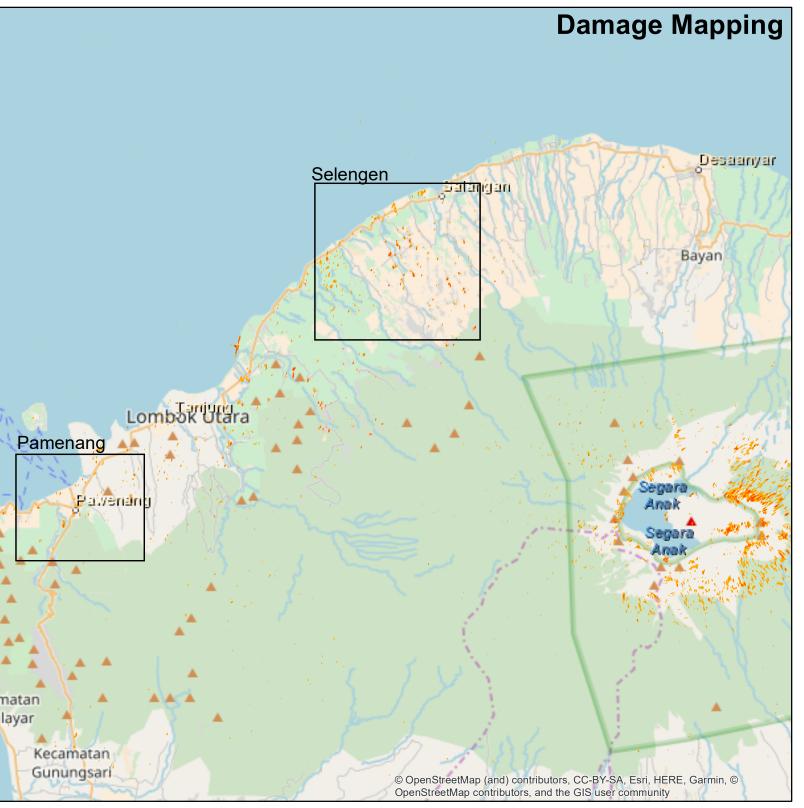
This preliminary damage mapping is based on the method in Wang et al. (2017). Red color reflects higher level of damage detected by using SAR coherence.
