# Mapping the Impacts of Typhoon Goni in Catanduanes

Geomatics for Environment and Development MANILA OBSERVATORY November 9, 2020

# Summary

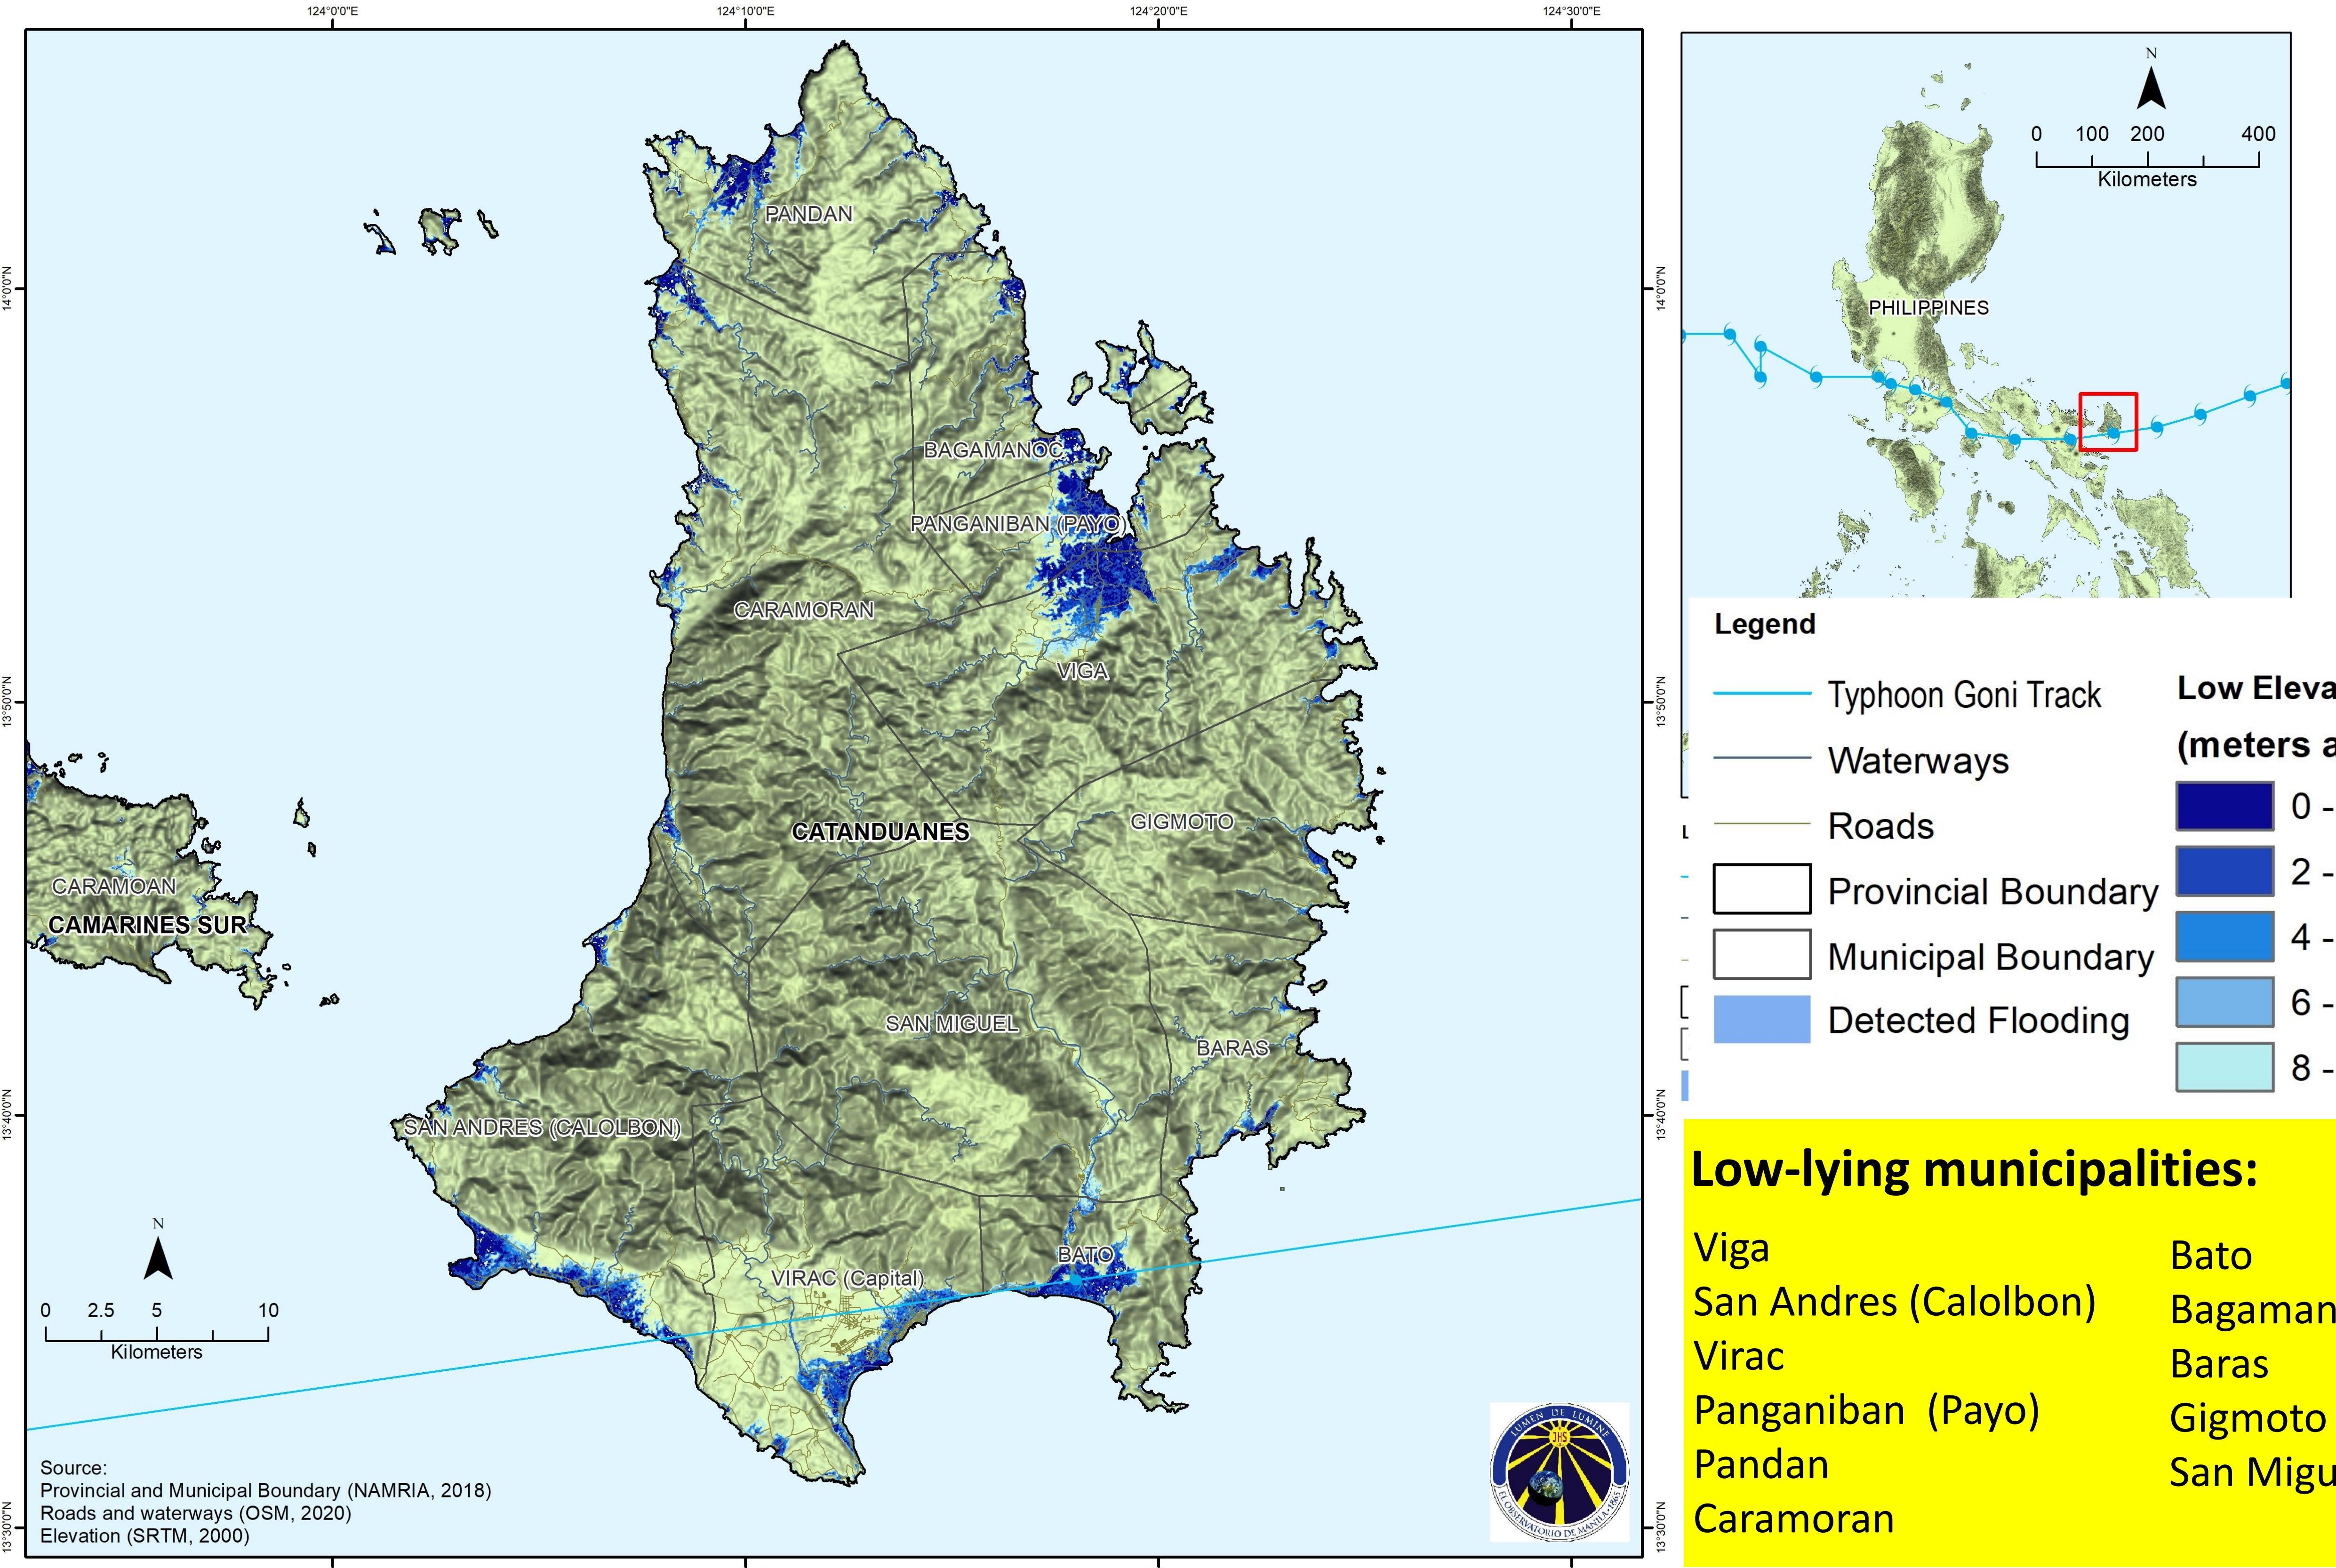
### **Low-lying Areas in Catanduanes**

Low-lying municipalities (with elevation less than 10 meters) above sea level) were flooded (flooded extent was estimated to be **4.3 km<sup>2</sup>**) due to rainfall exceeding 150 mm during the

- 0 2 2 - 4 4 - 6 6 - 8
- 8 10

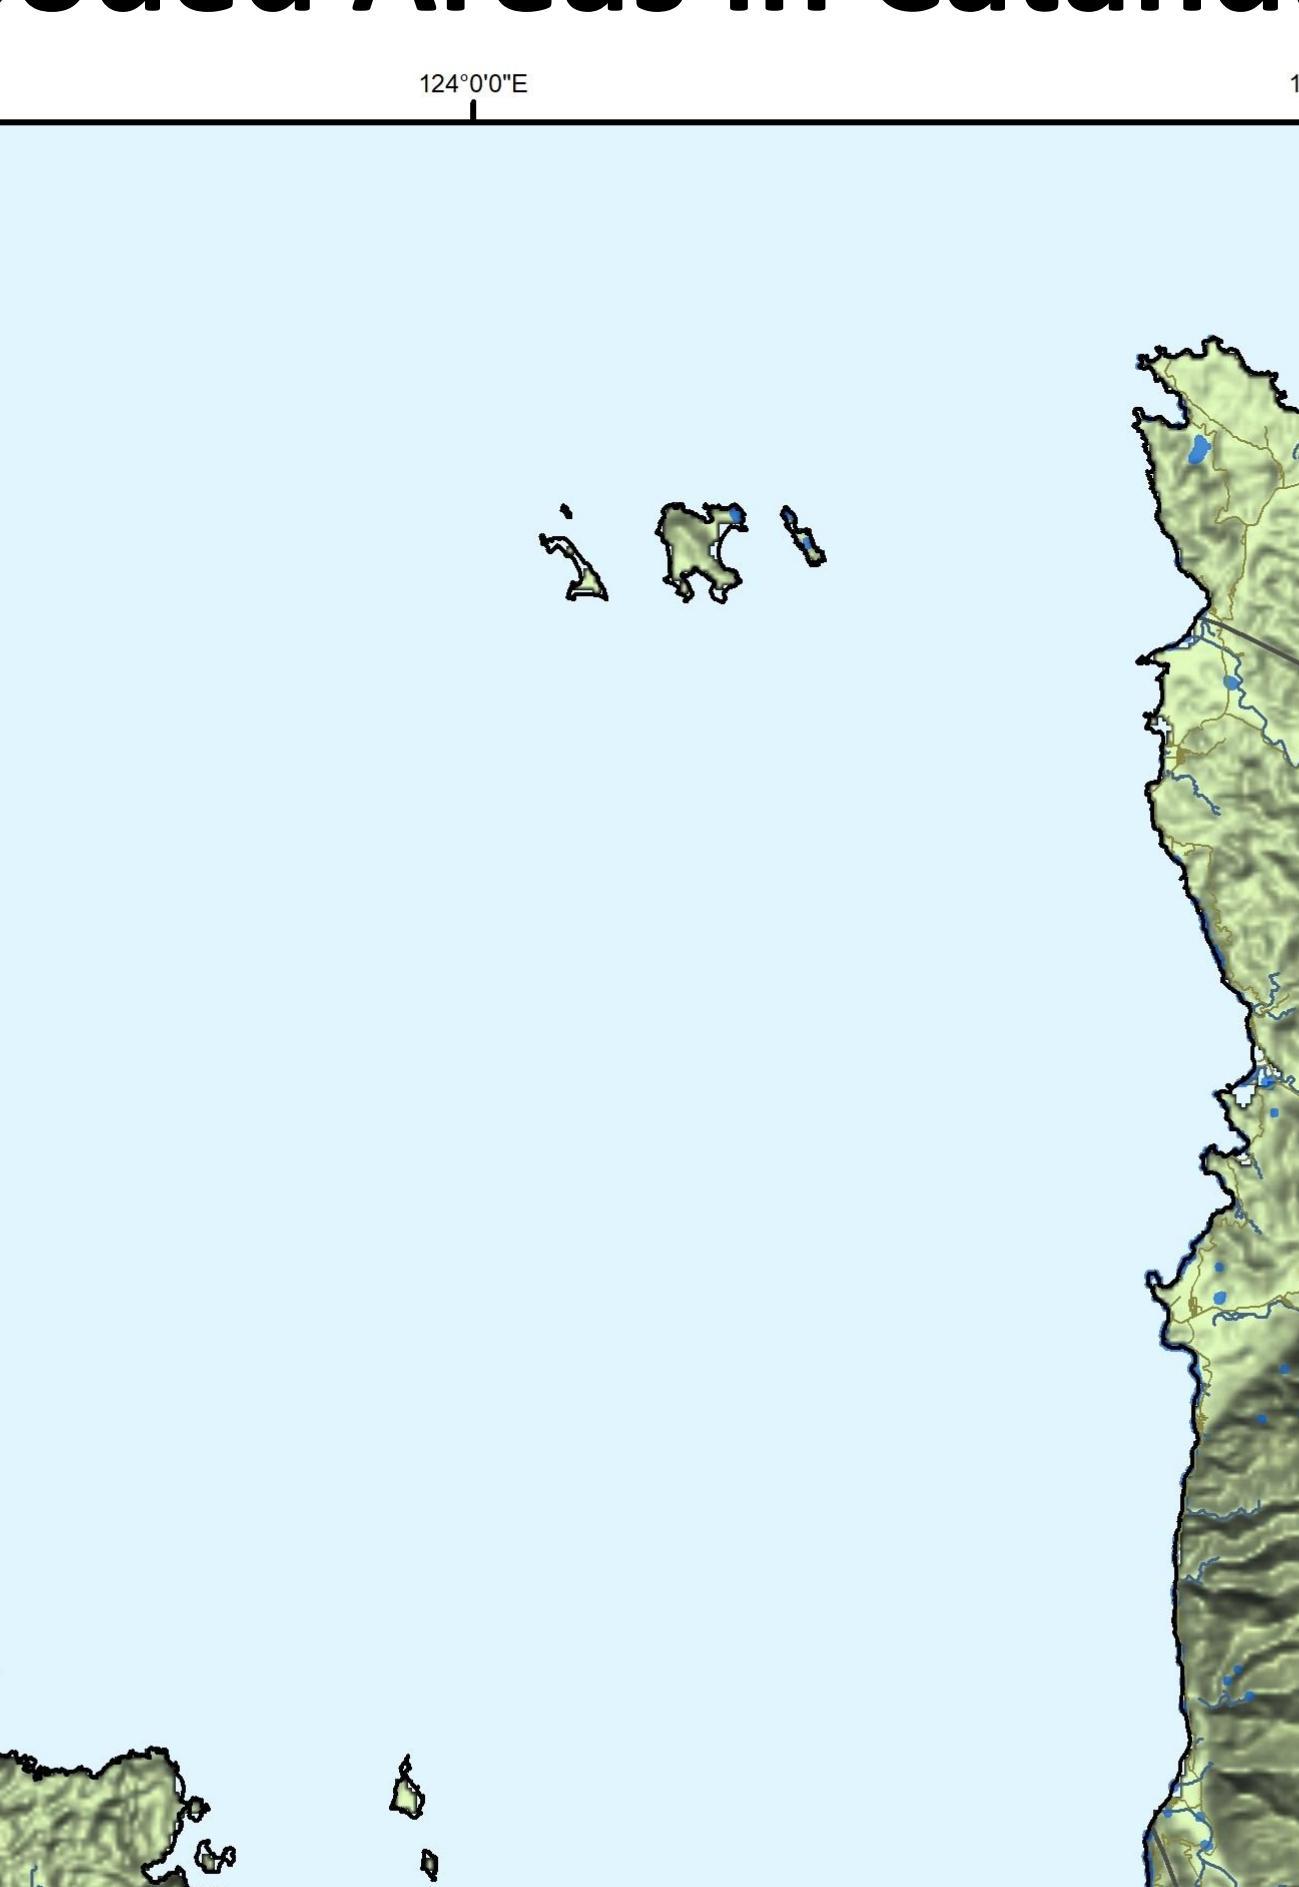
### **Flooded Areas in Catanduanes**

Detected Flood (Sentinel 1, Copernicus Sentinel data 2020, processed by ESA Oct. 2, 2020 - Nov. 1, 2020) Provincial and Municipal Boundary (NAMRIA, 2018) Roads and waterways (OSM, 2020) Elevation (SRTM, 2000)

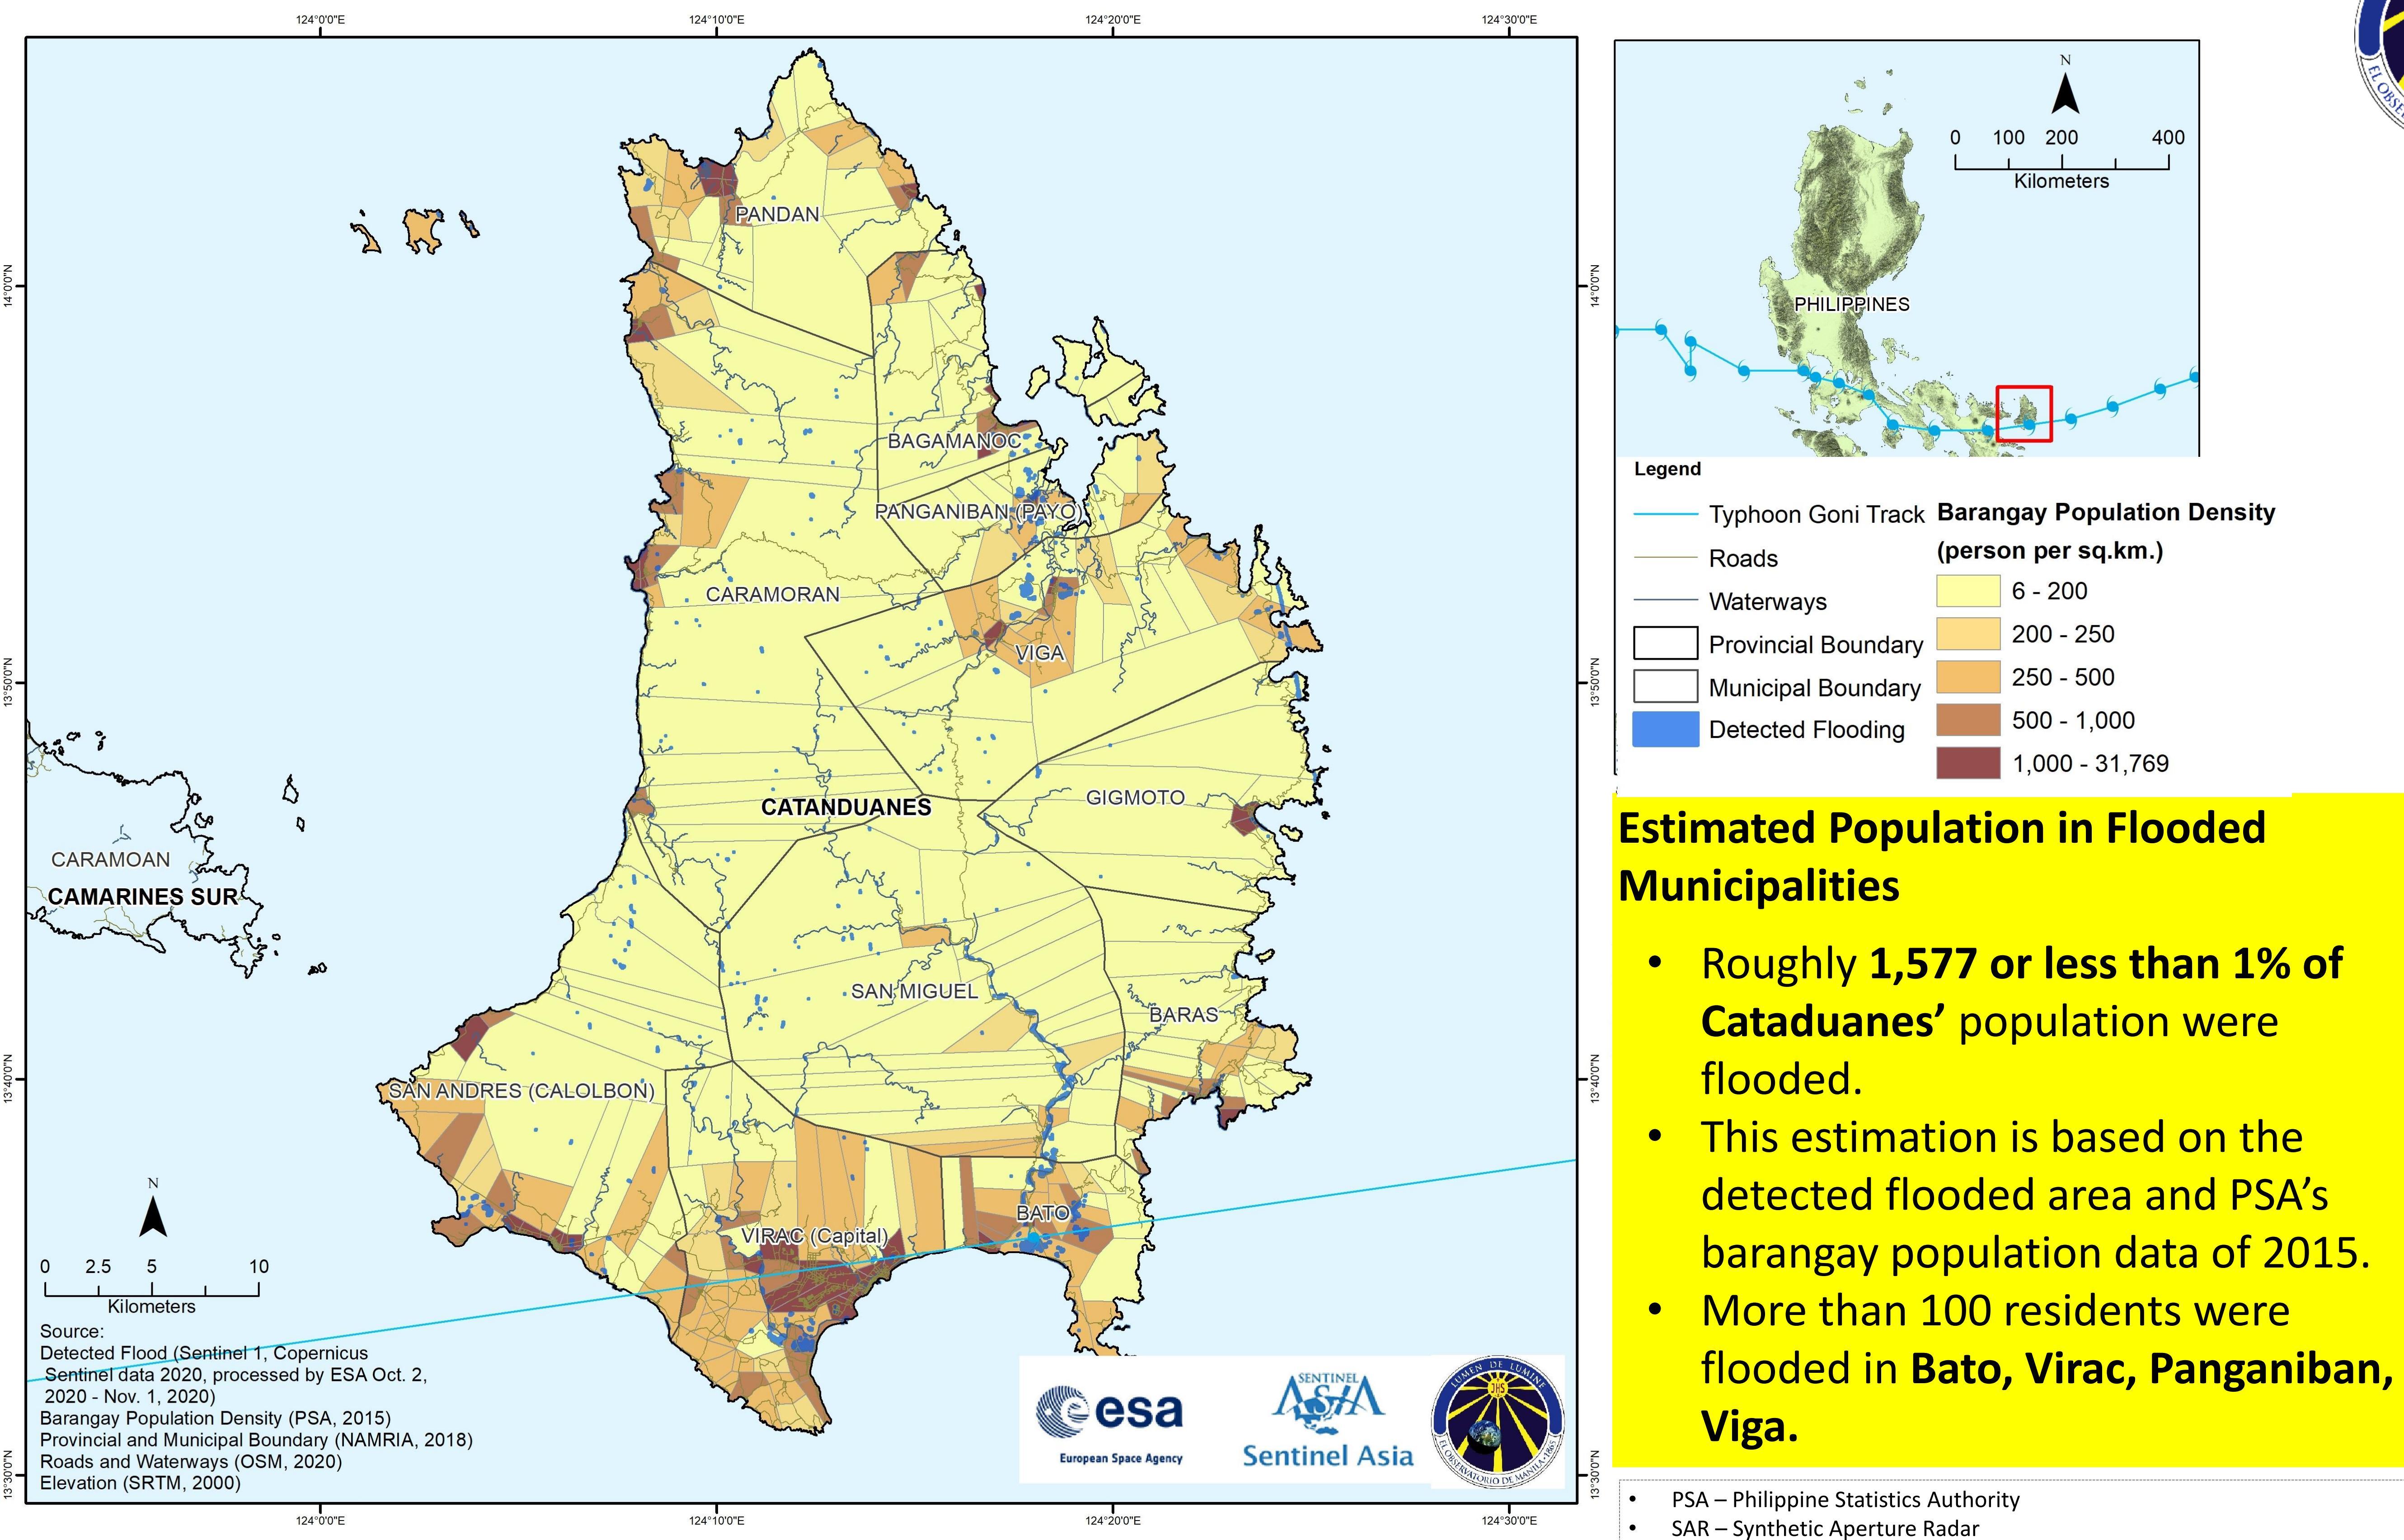
### **Flooded Population in Catanduanes**

1,577 people or less than 1% of Catanduanes' population
