Brief Analysis of Flood in Myanmar

22 July 2015

Japan Aerospace Exploration Agency
Remote Sensing Technology Center of Japan (RESTEC)

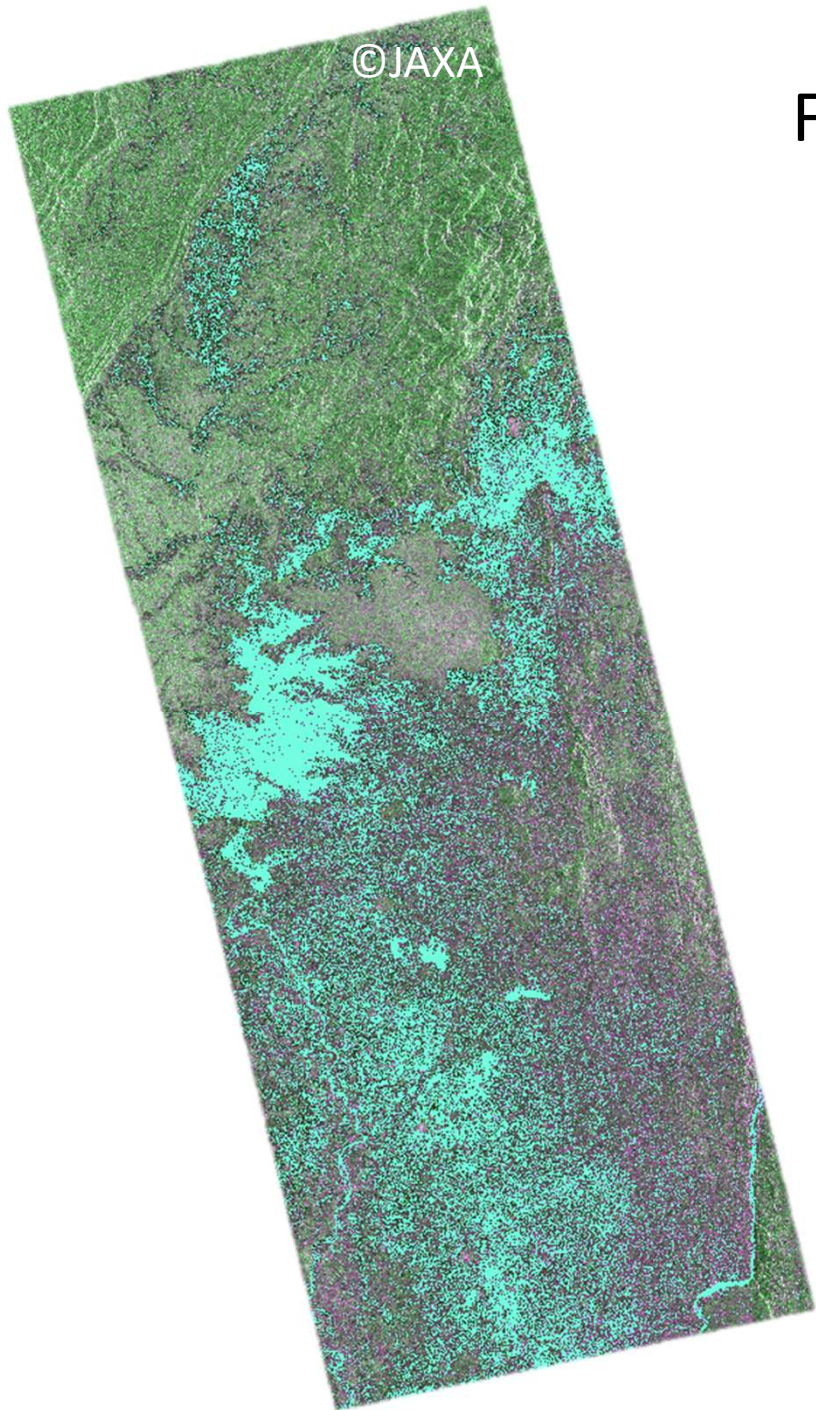
Flood situation as of July 22,2015

Possibly water area
(include normal water extent,
paddy field, flood area, or
others)

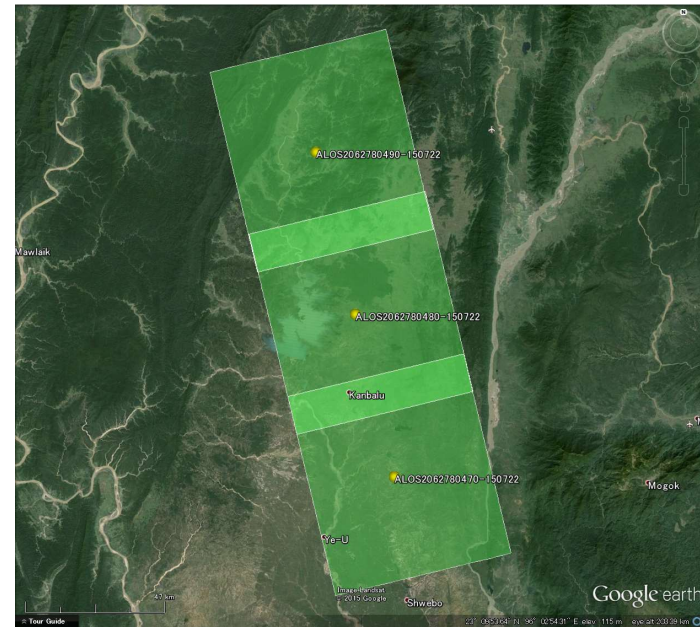
Observed area
(background image: Google Earth)

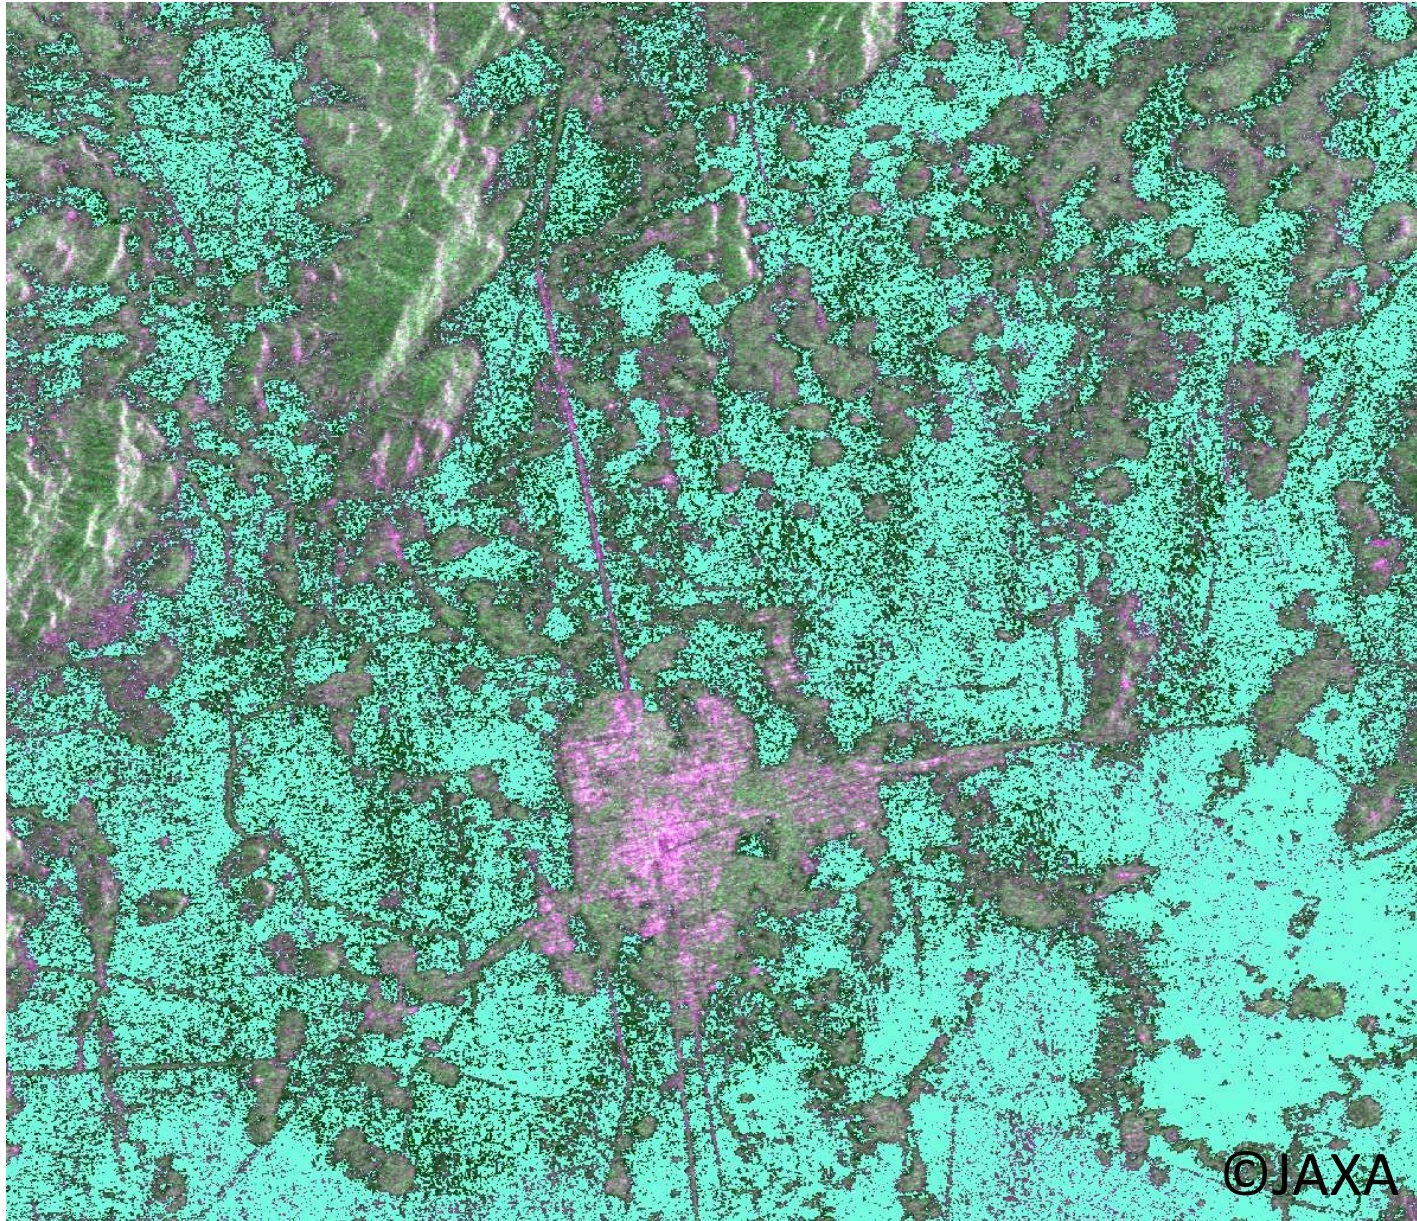
Extend image near Kawlin

Possibly flood area
