# Second Wave of Catastrophic Flooding in Chennai (Tamil Nadu), India

IWMI in cooperation with Sentinel Asia in particular Japan Aerospace Exploration Agency (JAXA) activated disaster charter for December 03, 2015 at 16:43hours using ALOS-2 PALSAR-2 images. The images clearly highlight areas of standing water in and around Chennai city. Approximately 25km<sup>2</sup> is still inundated by extreme rainfall between Nov 30 and Dec 2, 2015.

Flood Date : 03 December 2015  
Satellite Image : ALOS-2 PALSAR-2

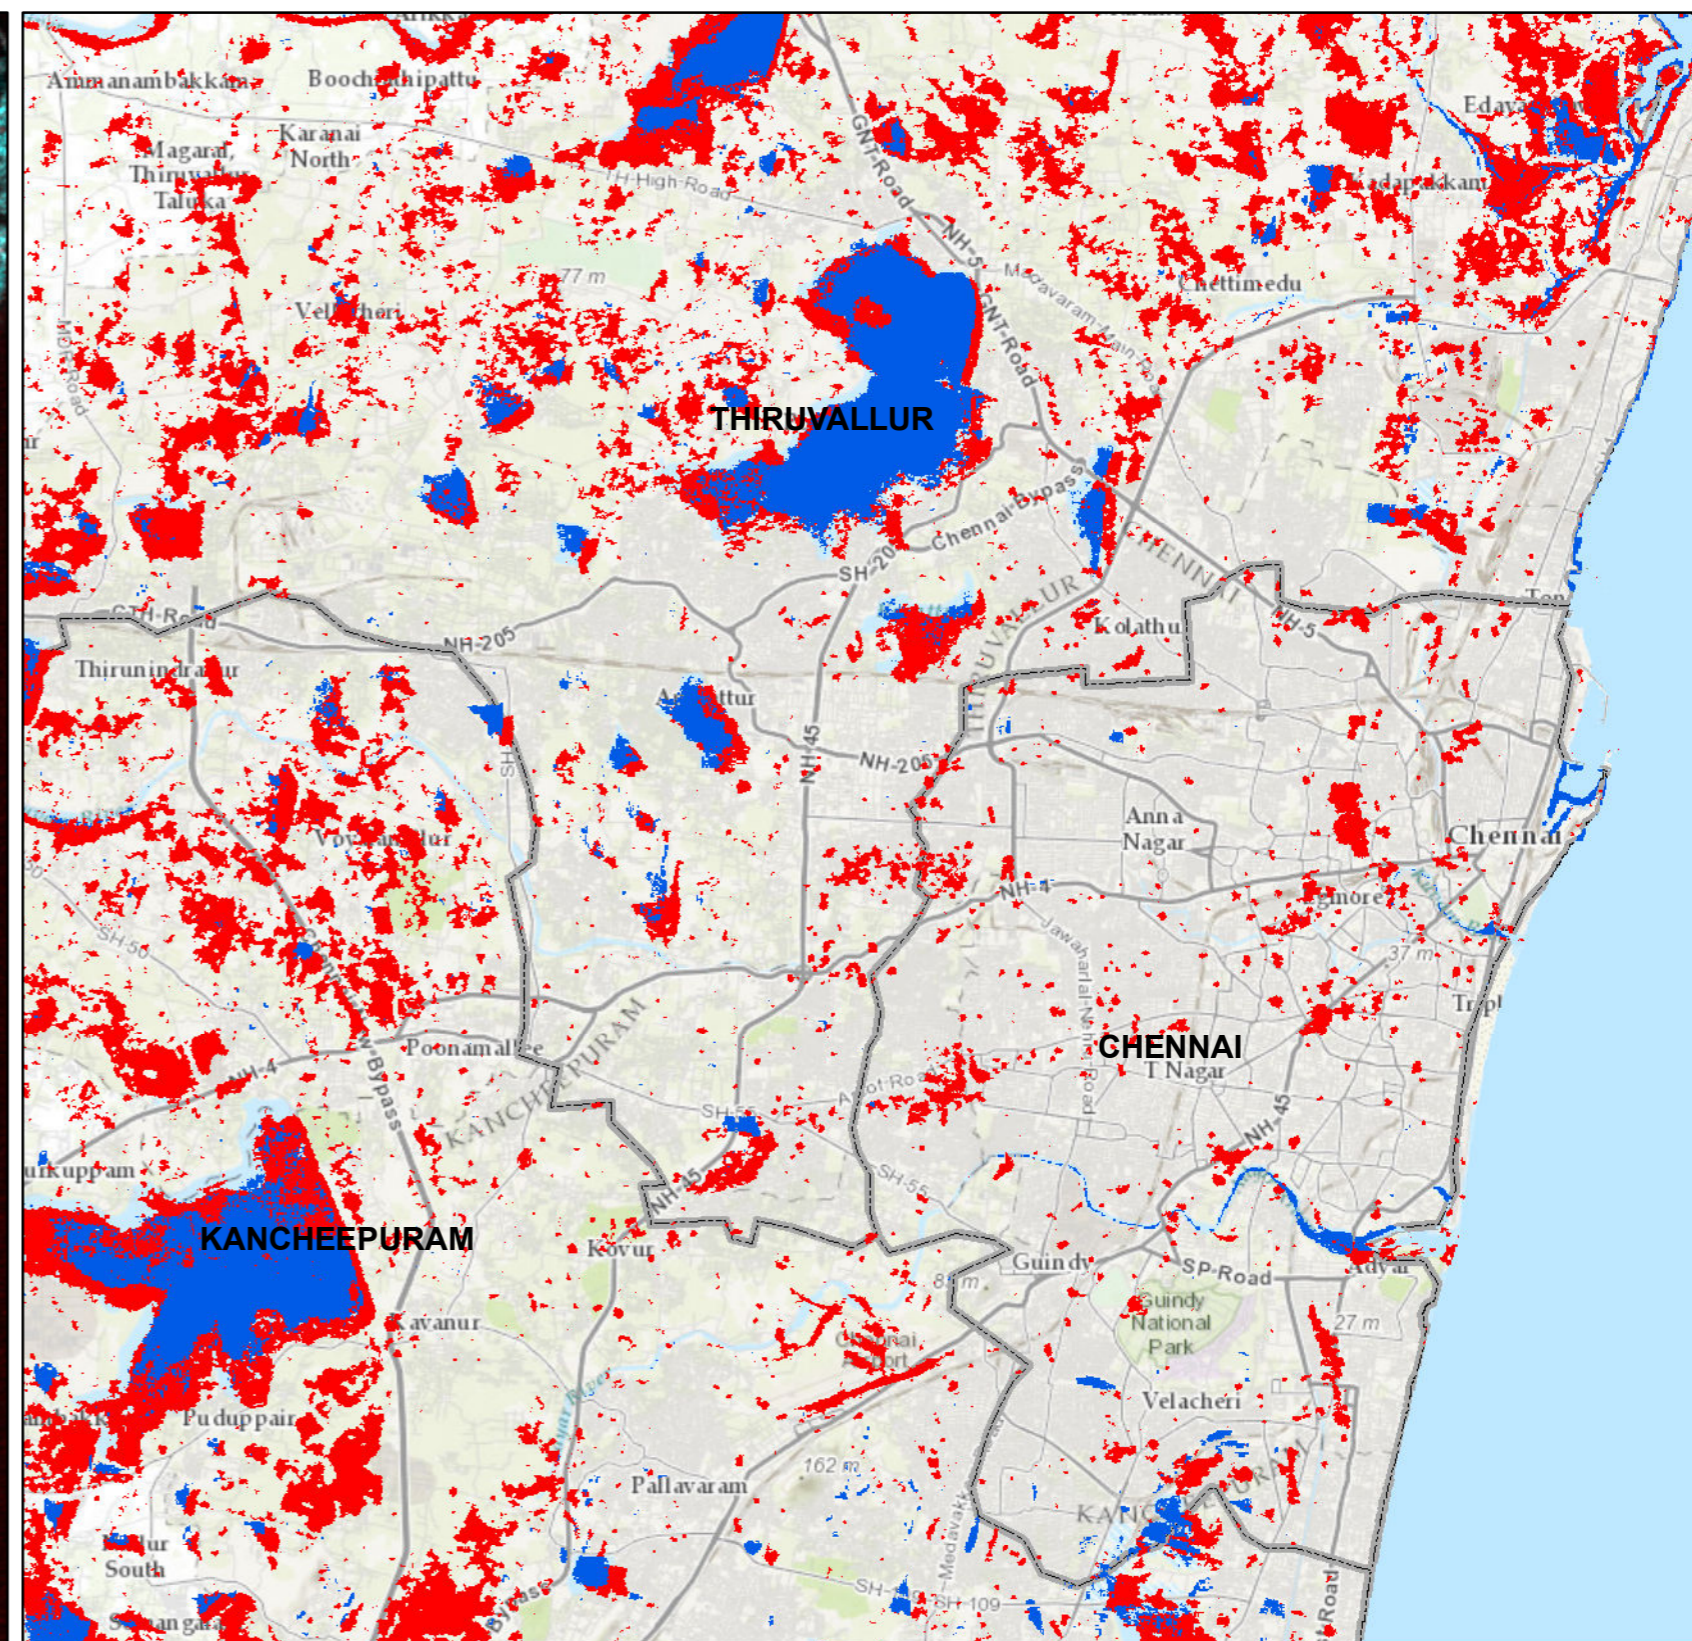
Chembarambakkam Lake

Satellite images of 03 December 2015
