Landslide in Kohistan District, Pakistan

Sentinel Asia

- A massive landslide struck at least seven houses in Kohistan district on Monday morning, burying alive at least 30 people.
- Date of Occurrence: 04/Apr/2016
- Pre Image: 25/Mar/2015 ALOS PALSAR (HH/HV)
- Post Image: 06/Apr/2016 ALOS PALSAR (HH/HV)

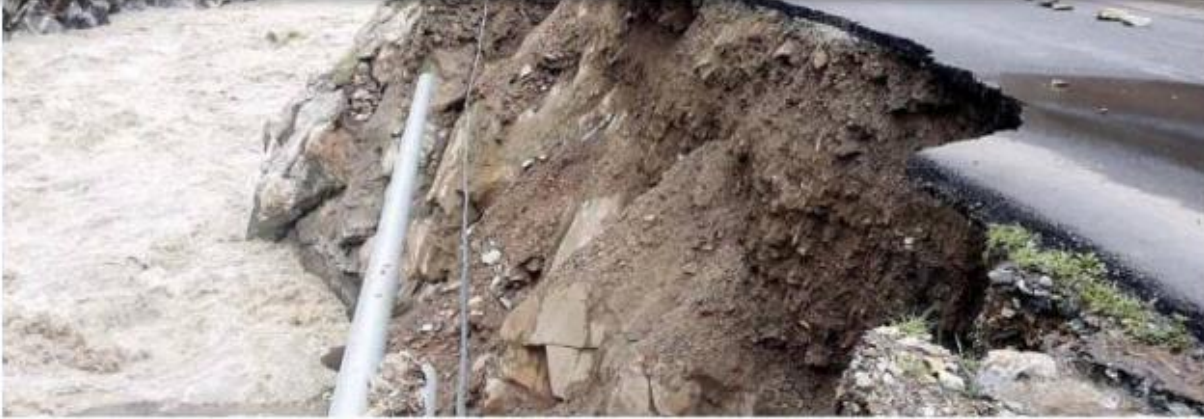
A view of Alpuri road due to landsliding in Besham, Shangla district. PHOTO: INP

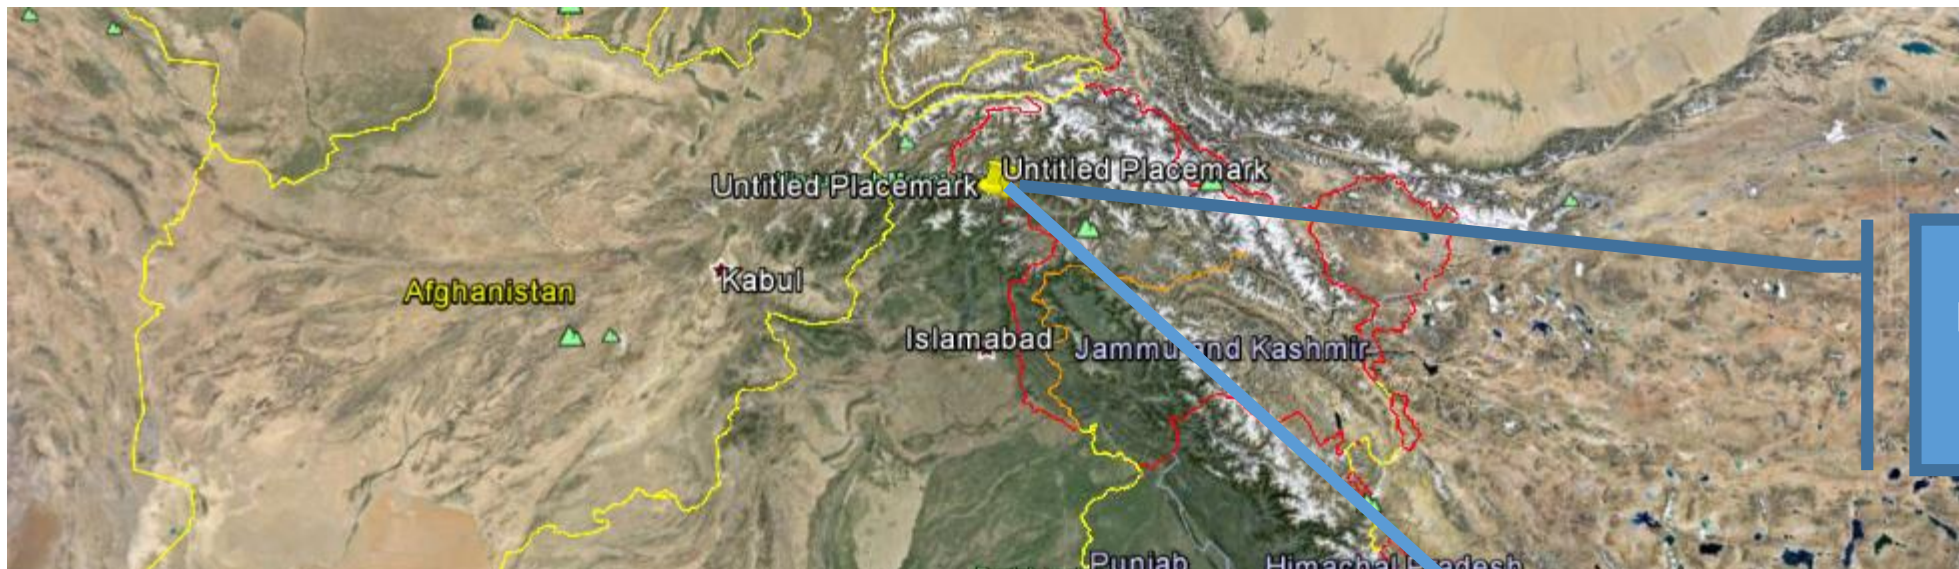
Location of Kandiya Tehsil
of Kohistan District

According to News Reports
Landslide was occurred in
Kandiya Tehsil of Kohistan
District

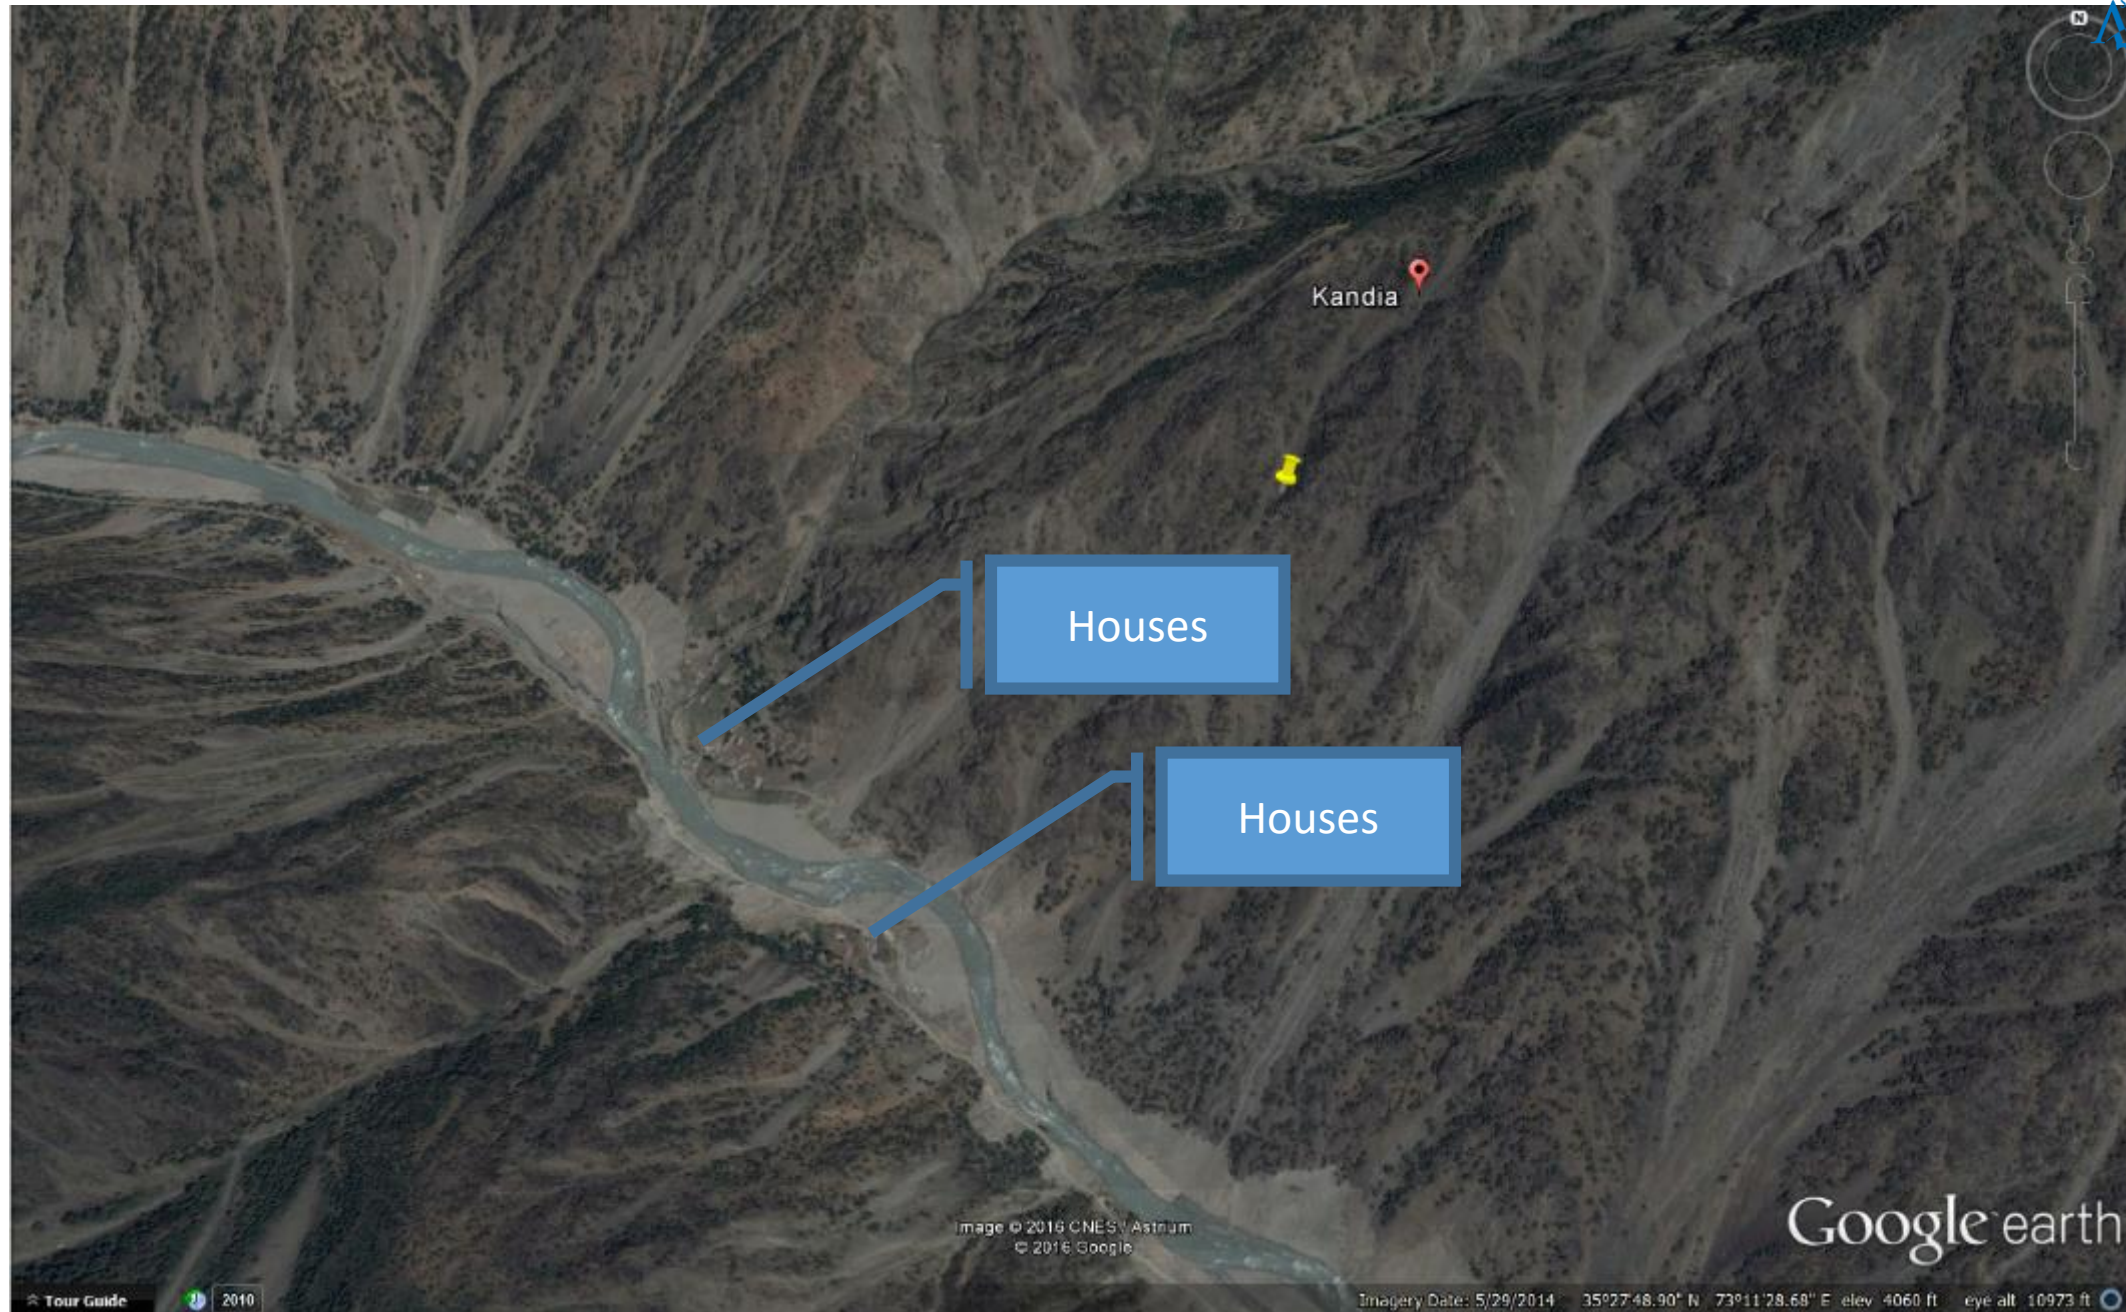
Kandia

Houses
