DETECTED FLOOD WATER NGHE AN & HA TINH PROVINCES

# VIETNAM

As Observed by Sentinel-1 image on 30 September 2023

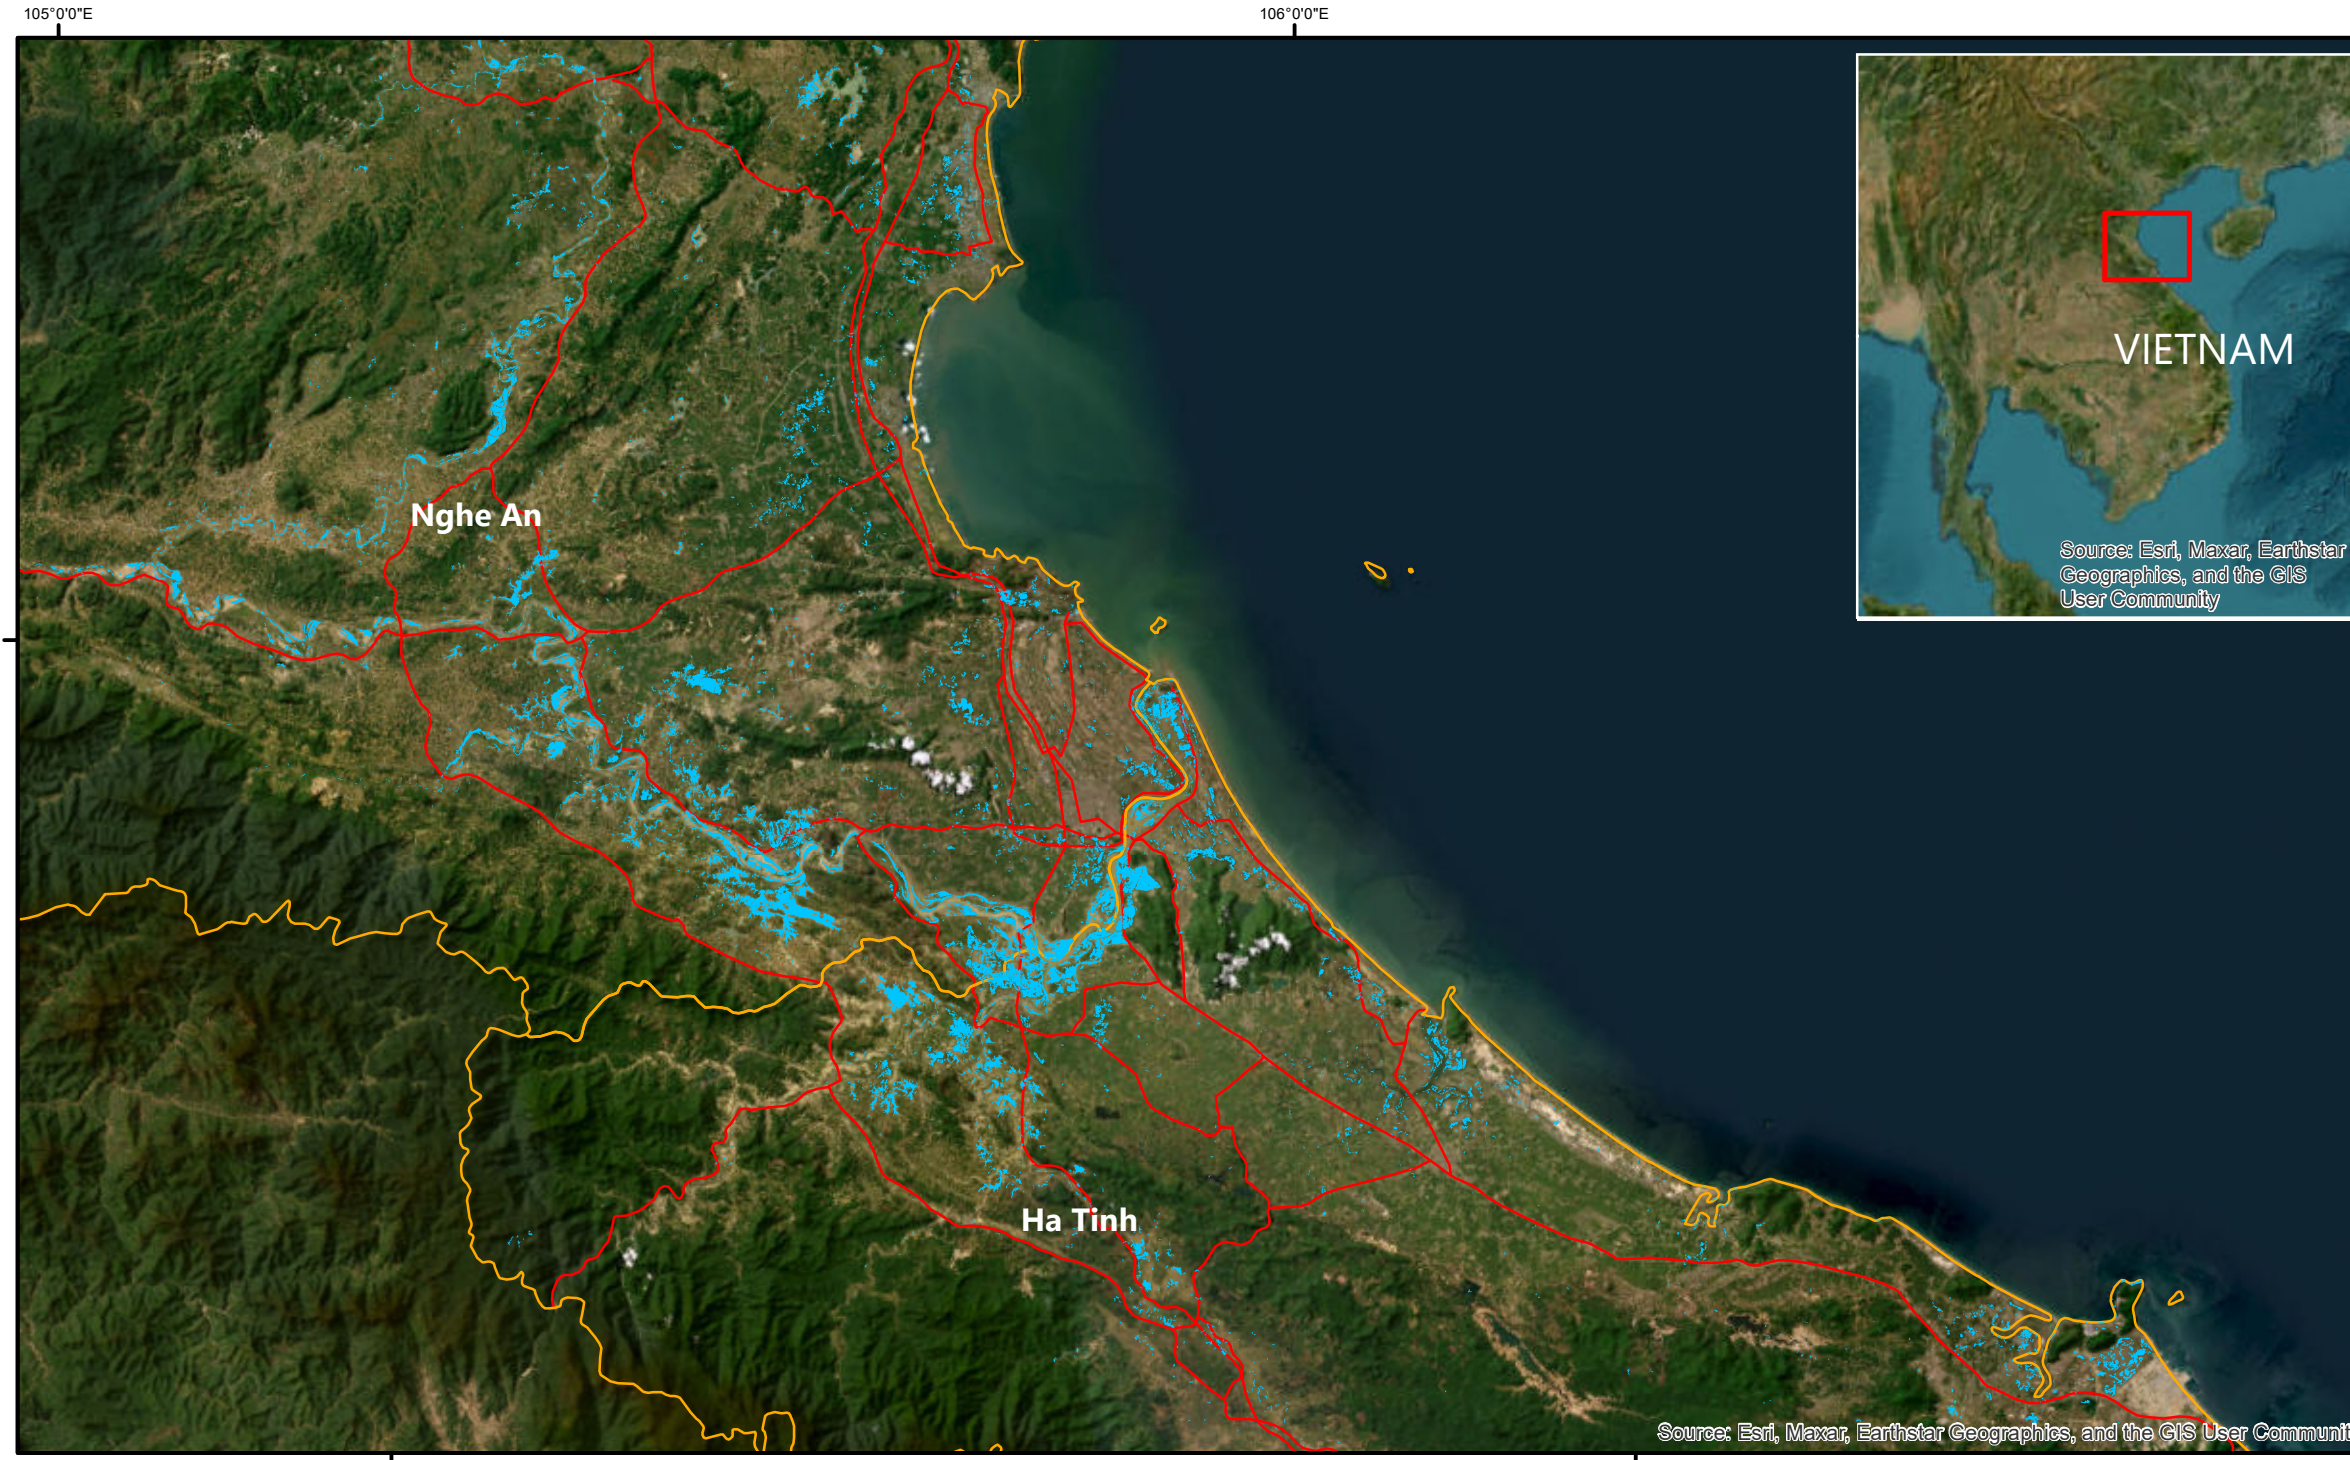
This map shows flooded area and standing water in the Nghe An & Ha Tinh provinces of Vietnam on 26 September 2023 after the heavy rainfall. Flood water detected in Thanh Chuong, Do Luong, Dien Chau, Anh Son districts of Nghe An Province and Huong Khe, Loc Ha, Duc Tho, Ky Anh, Thach Ha Districts in Ha Tinh Province.
